Pre-Construction Tree Assessment Report 114 Division Street, Cobourg, ON K9A 0B3 November 14th, 2019

Arborist Report

Pre-Construction Assessment

114 Division Street Cobourg, ON K9A 0B3

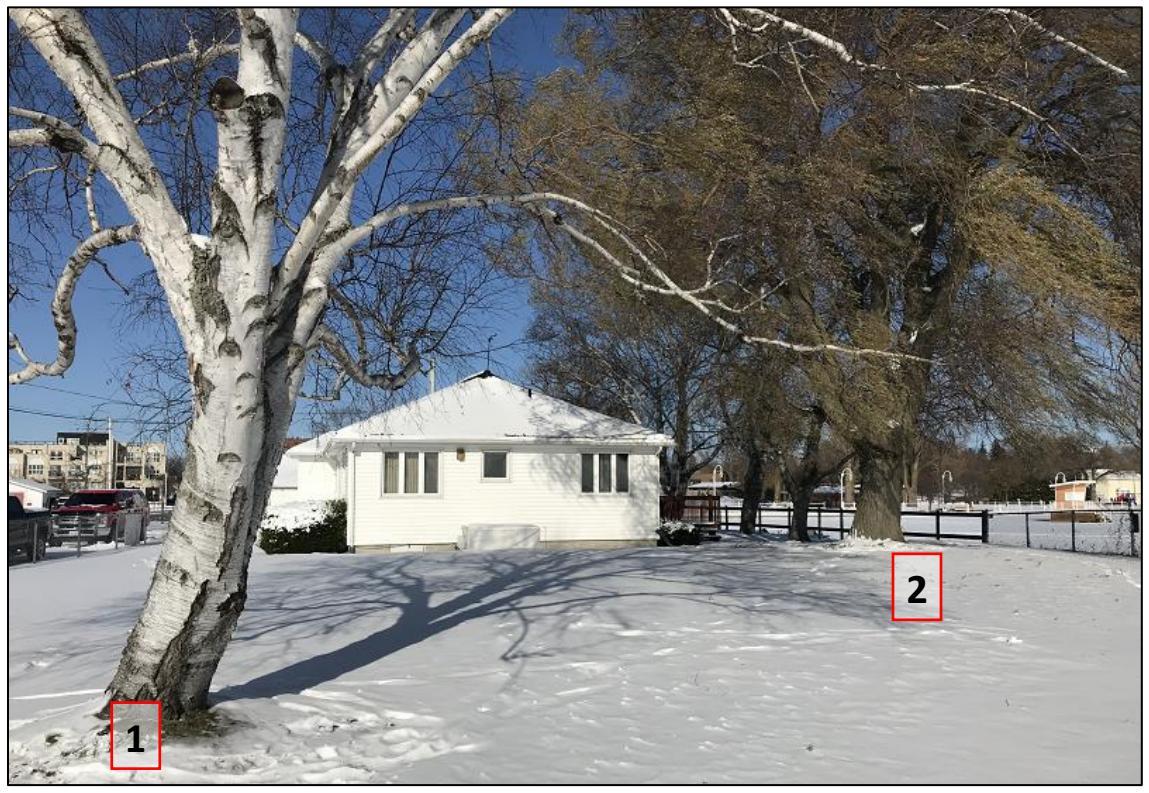
- Trees were tagged with aluminum tags and numbers sequentially from #331-339 in accordance with the inventory numbers.
- Tree #1, a 52cm multi-stem White Birch (*Betula papyrifera*) in good condition is located at the south end of the site, at least 10m away from any construction activity. It may be fully protected during construction with no disturbance to its crown branches or root system.

- Tree #2, a 90cm Weeping Willow (*Salix bablyonica*) is located 6.8m from the corner of the existing house on the site which is to be removed with a new building established 8.5m away from it. It is in fair condition with multiple dead branches and hangers in its crown.

Figure 1 – View of trees #1 and #2 viewed from the south end of the site looking north. Tree protection fencing is recommended to surround both trees. Trees #3, 4, 5 in background

- We recommend the crown of Tree #2 be pruned to clean out deadwood and hanging broken branches. This work is to be done by a qualified arborist.

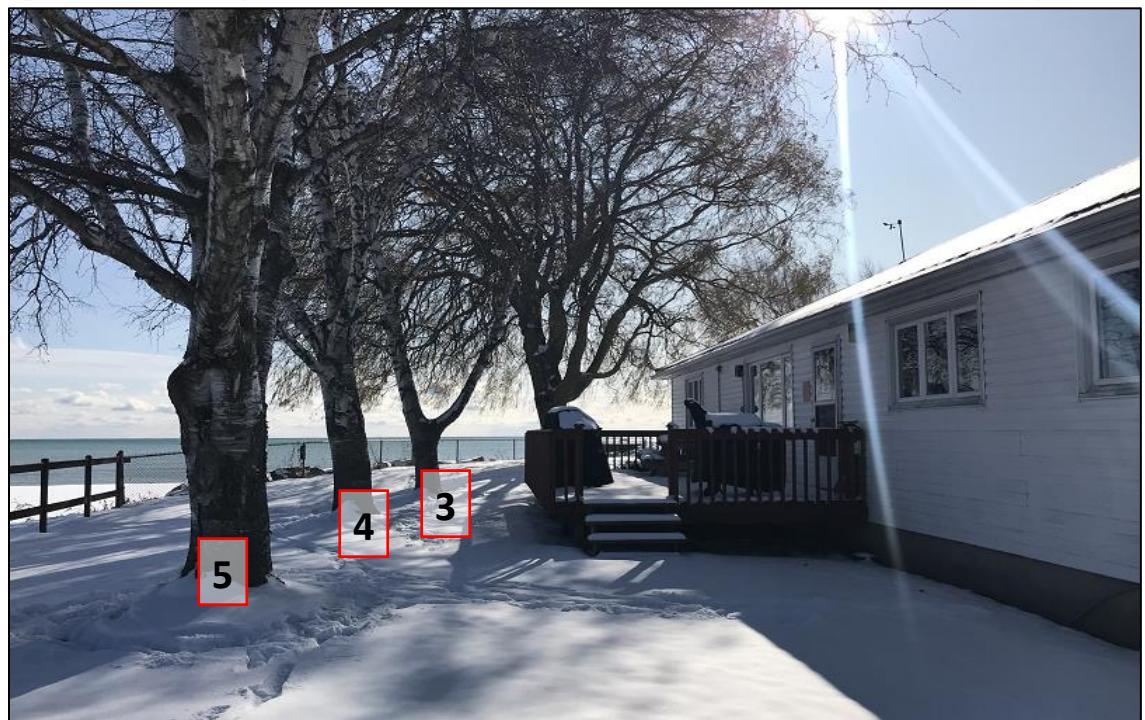
- Trees #3 and #4, 46cm and 56cm White Birch trees in good condition are located at the east side of the site, 2.6m away from an existing deck which is to be removed. New construction is planned 7m away from this tree. It may be fully protected during the work; however care must be taken when removing the deck.

- Tree #5, a 72cm White Birch in fair condition is located at the east side of the site, north of Trees #3 and #4. Due to its larger size and health defects, a greater area of roots must be protected with care during the work.

Figure 2 – View of Trees #3, 4, and 5, with #2 in background. Trees #2 and #5 will require root protection during demolition and construction to preserve their root systems.

It is recommended that root protection be utilized within the CRZ's of Trees #2 and #5, which extend further from their respective trees than all other trees on-site. These surfaces are recommended to be installed following demolition.

- We recommend horizontal root protection surfaces be laid down up to the edge of Tree Protection Fencing near Trees #2 and 5 to protect their Critical Root Zones. The root protection surface is to consist of at least 30cm deep mulch laid atop geotextile fabric with double-layer ³/₄" plywood or single-layer steel plates installed atop the mulch. This will allow for movement of heavy equipment and materials without risking harmful compaction or breakage of roots.

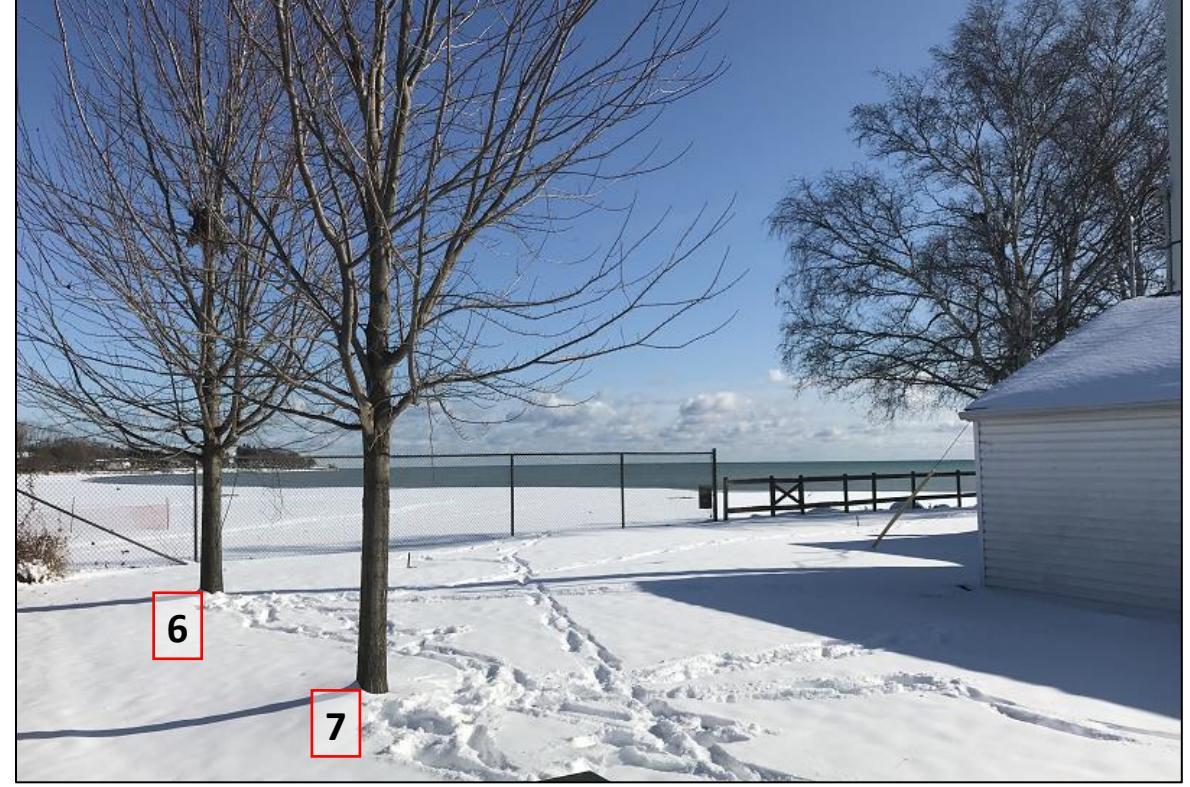
- Trees #6 and #7 consist of two semi-mature Freeman Maple trees (*Acer x freemanii*) located at the north end of the site. These trees are small enough to be fully protected during construction.

Figure 3 – View of trees #6 and 7, looking east. Both trees are small in stature and far enough away from the construction work to be fully protected.

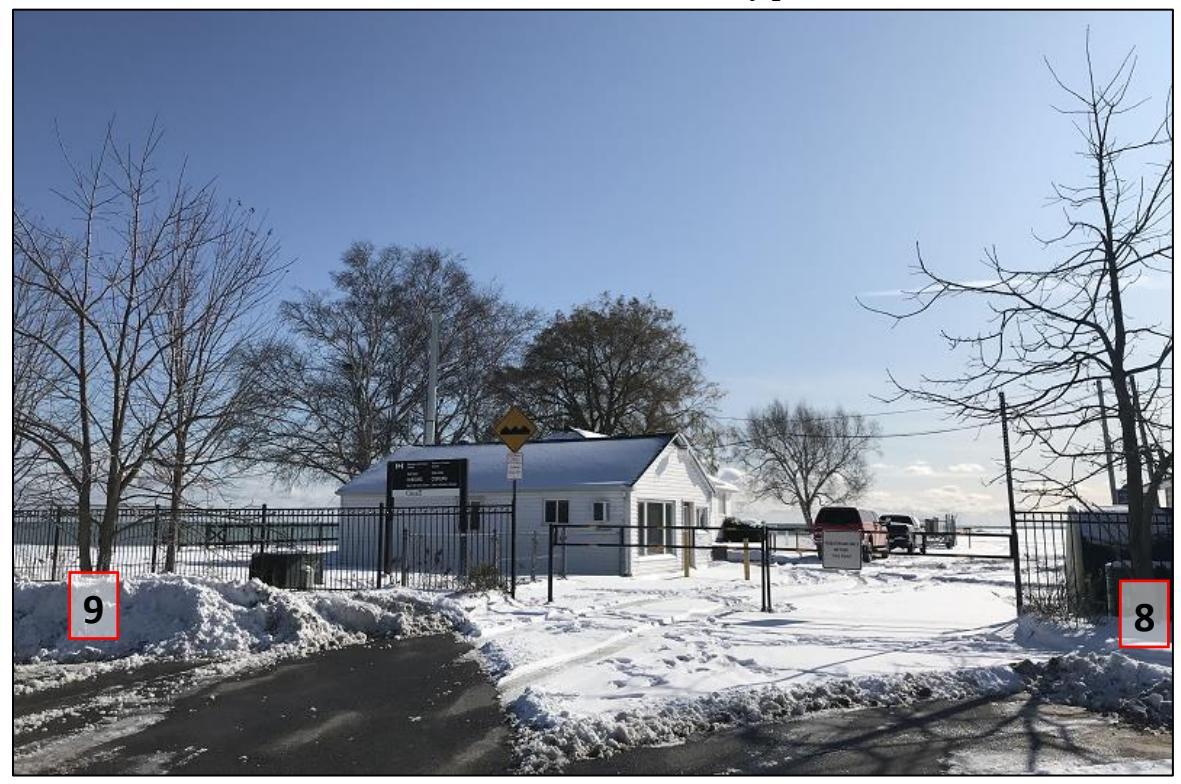
- Trees #8 and 9 consist of two semi-mature Black Walnut trees (*Juglans nigra*) located on either side of the driveway at the north end of the site. These trees were included in the inventory and are recommended for protection to avoid any unwarranted injury during movement of construction equipment and materials in and out of the site.

Figure 4 – View of Trees #8 and 9 on either side of the driveway to the site. These trees are recommended to be protected to avoid injury during movement of equipment/materials.
