# ARBORIST REPORT

1144 Division Street  
Cobourg, Ontario

December 2, 2020 / 20-47

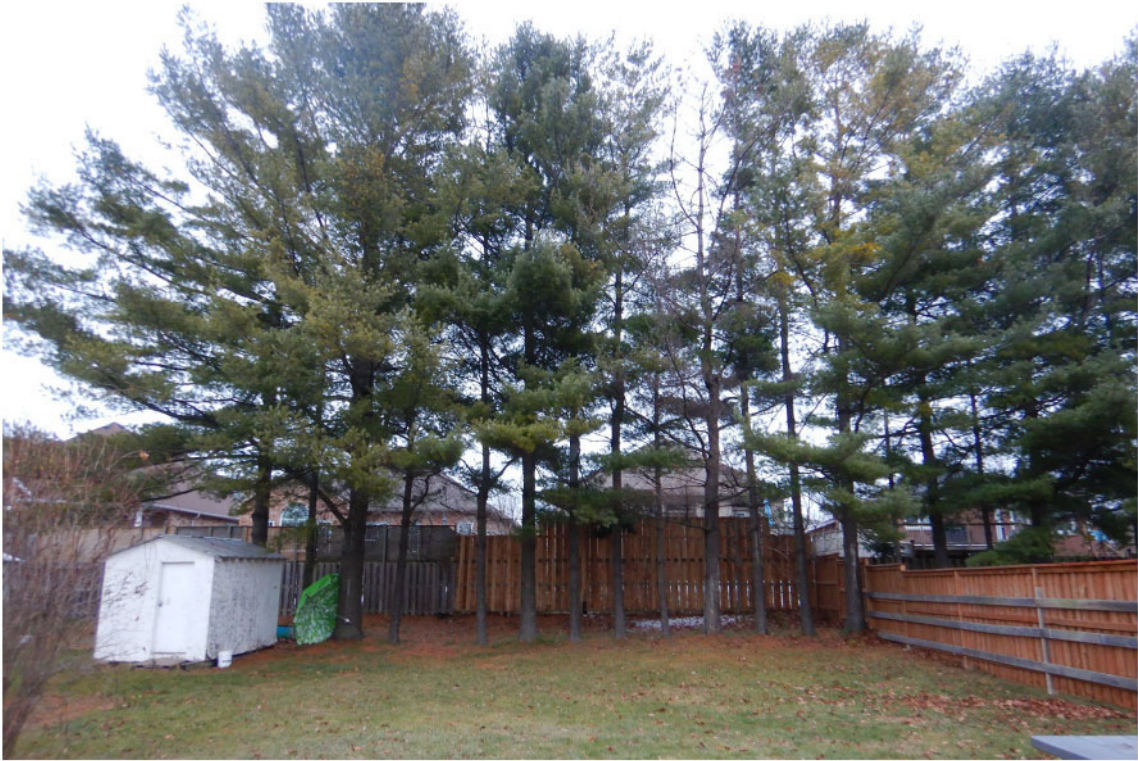
### Trees 2-15

TREE #	Species	Botanical Name	DBH (cm)	TPZ (m)	Category	Condition Rating	Comments	Action
1	Norway Maple	Acer platanoides	27		Private	Good	Botanically in good condition. Vine covered trunk.	Preserve
2	White Pine	Pinus strobus	45	4	Private	Good-Fair	Minor amount of small diameter deadwood present. Raised crown. Shaded by adjacent trees. Moderate amount of small diameter deadwood present.	Injure
3	White Pine	Pinus strobus	22		Private	Fair		Preserve
4	White Pine	Pinus strobus	63	5	Private	Good-Fair	Minor amount of small diameter deadwood present. Raised crown.	Injure
5	White Pine	Pinus strobus	23		Private	Good-Fair	Minor amount of small diameter deadwood present. Raised crown.	Preserve
6	White Pine	Pinus strobus	28		Private	Good-Fair	Minor amount of small diameter deadwood present. Raised crown.	Preserve
7	White Pine	Pinus strobus	42	4	Private	Good-Fair	Minor amount of small diameter deadwood present. Raised crown.	Preserve

8	White Pine	Pinus strobus	28		Private	Good-Fair	Minor amount of small diameter deadwood present. Raised crown.	Preserve
9	White Pine	Pinus strobus	28		Private	Good-Fair	Minor amount of small diameter deadwood present. Raised crown.	Preserve
10	White Pine	Pinus strobus	18		Private	Poor	Dead	Preserve
11	White Pine	Pinus strobus	41	4	Private	Good-Fair	Minor amount of small diameter deadwood present.	Preserve
12	White Pine	Pinus strobus	27		Private	Good-Fair	Minor amount of small diameter deadwood present.	Preserve
13	White Pine	Pinus strobus	27		Private	Good-Fair	Minor amount of small diameter deadwood present.	Preserve
14	White Pine	Pinus strobus	38.5	3.5	Neighbour	Good-Fair	Minor amount of small diameter deadwood present.	Preserve
15	White Pine	Pinus strobus	20		Neighbour	Fair	Shaded by adjacent trees. Moderate amount of small diameter deadwood present.	Preserve
16	Honeylocust	Gleditsia triacanthos	15		Neighbour	Good-Fair	Minor amount of small diameter deadwood present. Growing between fence and curb.	Preserve

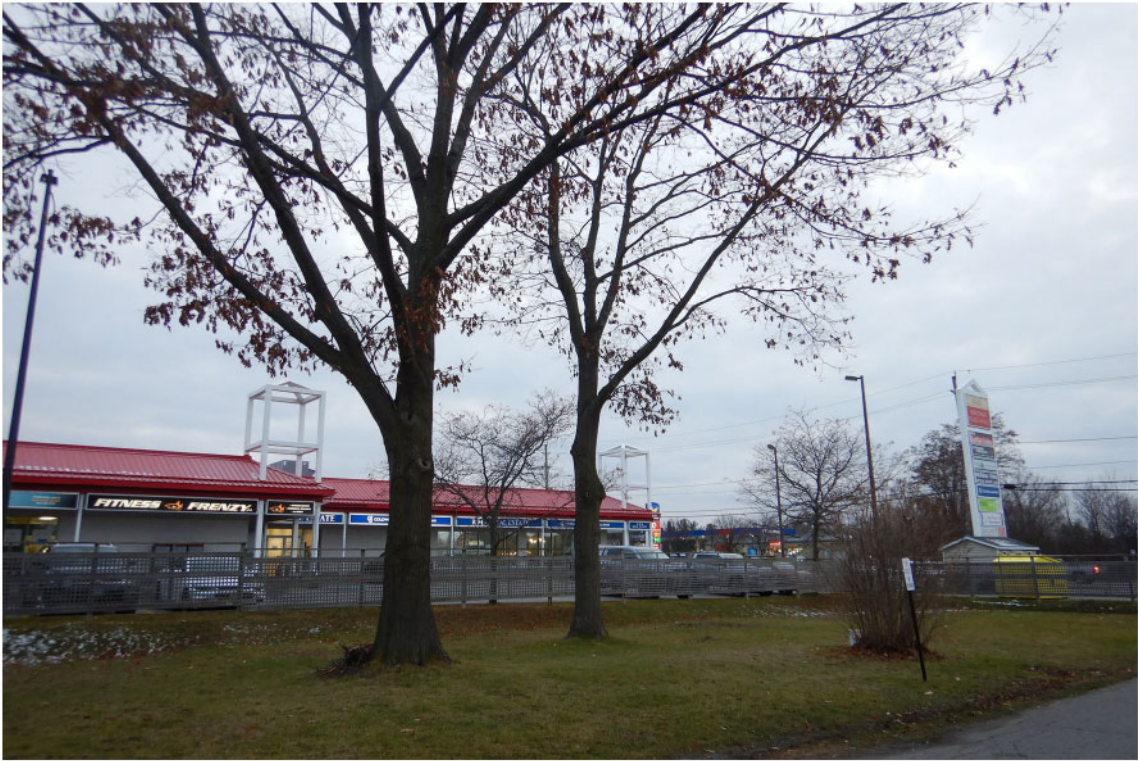
Trees 18, 19, 20 & 21

There are 3 trees (# 18, 19 & 22) that appears to be growing on the boundary of the subject property.

The removal of 2 by-law regulated trees (#20 & 21) will be required to accommodate the proposed new hotel building and facility site alterations based on consideration of the anticipated impacts to trees. Refer to Appendix A - Tree Inventory for specific comments pertaining to condition each tree.

17	Honeylocust	Gleditsia triacanthos	12		Neighbour	Good-Fair	Minor amount of small diameter deadwood present. Growing between fence and curb.	Preserve
18	Honeylocust	Gleditsia triacanthos	15		Boundary	Good-Fair	Minor amount of small diameter deadwood present. Growing between fence and curb.	Preserve
19	Honeylocust	Gleditsia triacanthos	15		Boundary	Good-Fair	Minor amount of small diameter deadwood present. Growing between fence and curb.	Preserve
20	Red Oak	Quercus rubra	69	5	Private	Good-Fair	Minor amount of small diameter deadwood present. Small cavities forming.	Remove
21	Red Oak	Quercus rubra	53.5	4.5	Private	Fair	Numerous small cavities present. Moderate amount of small diameter deadwood present.	Remove
22	Cherry	Prunus spp.	18		Boundary	Good-Fair	Growing close to fence. Botanically in good condition.	Preserve
23	Green Ash	Fraxinus pennsylvanica	18.5		Neighbour	Fair	Moderate amount of small diameter deadwood present.	Preserve

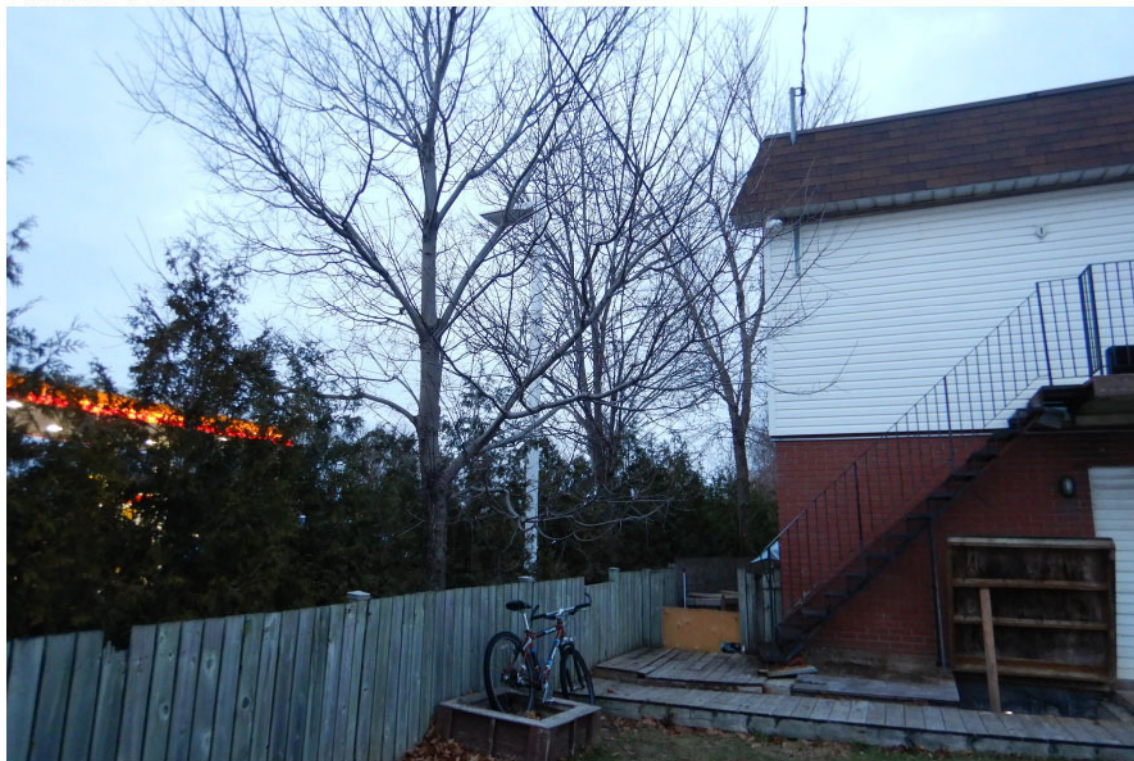
Trees 22-24

24	Yellow Birch	Betula alleghaniensis	24		Neighbour	Good-Fair	Crack present on one stem. Minor amount of small diameter deadwood present.	Preserve
