ELGIN PARK REDEVELOPMENT PROJECT
 265 - 327 ELGIN STREET COBOURG, ON
 NORTHUMBERLAND COUNTY

TREE PRESERVATION PLAN

Designed By: GB Project #: 65-157
 Drawn By: GB Drawing #: TP1
 Approved By: BBA
 Date: OCT 2020

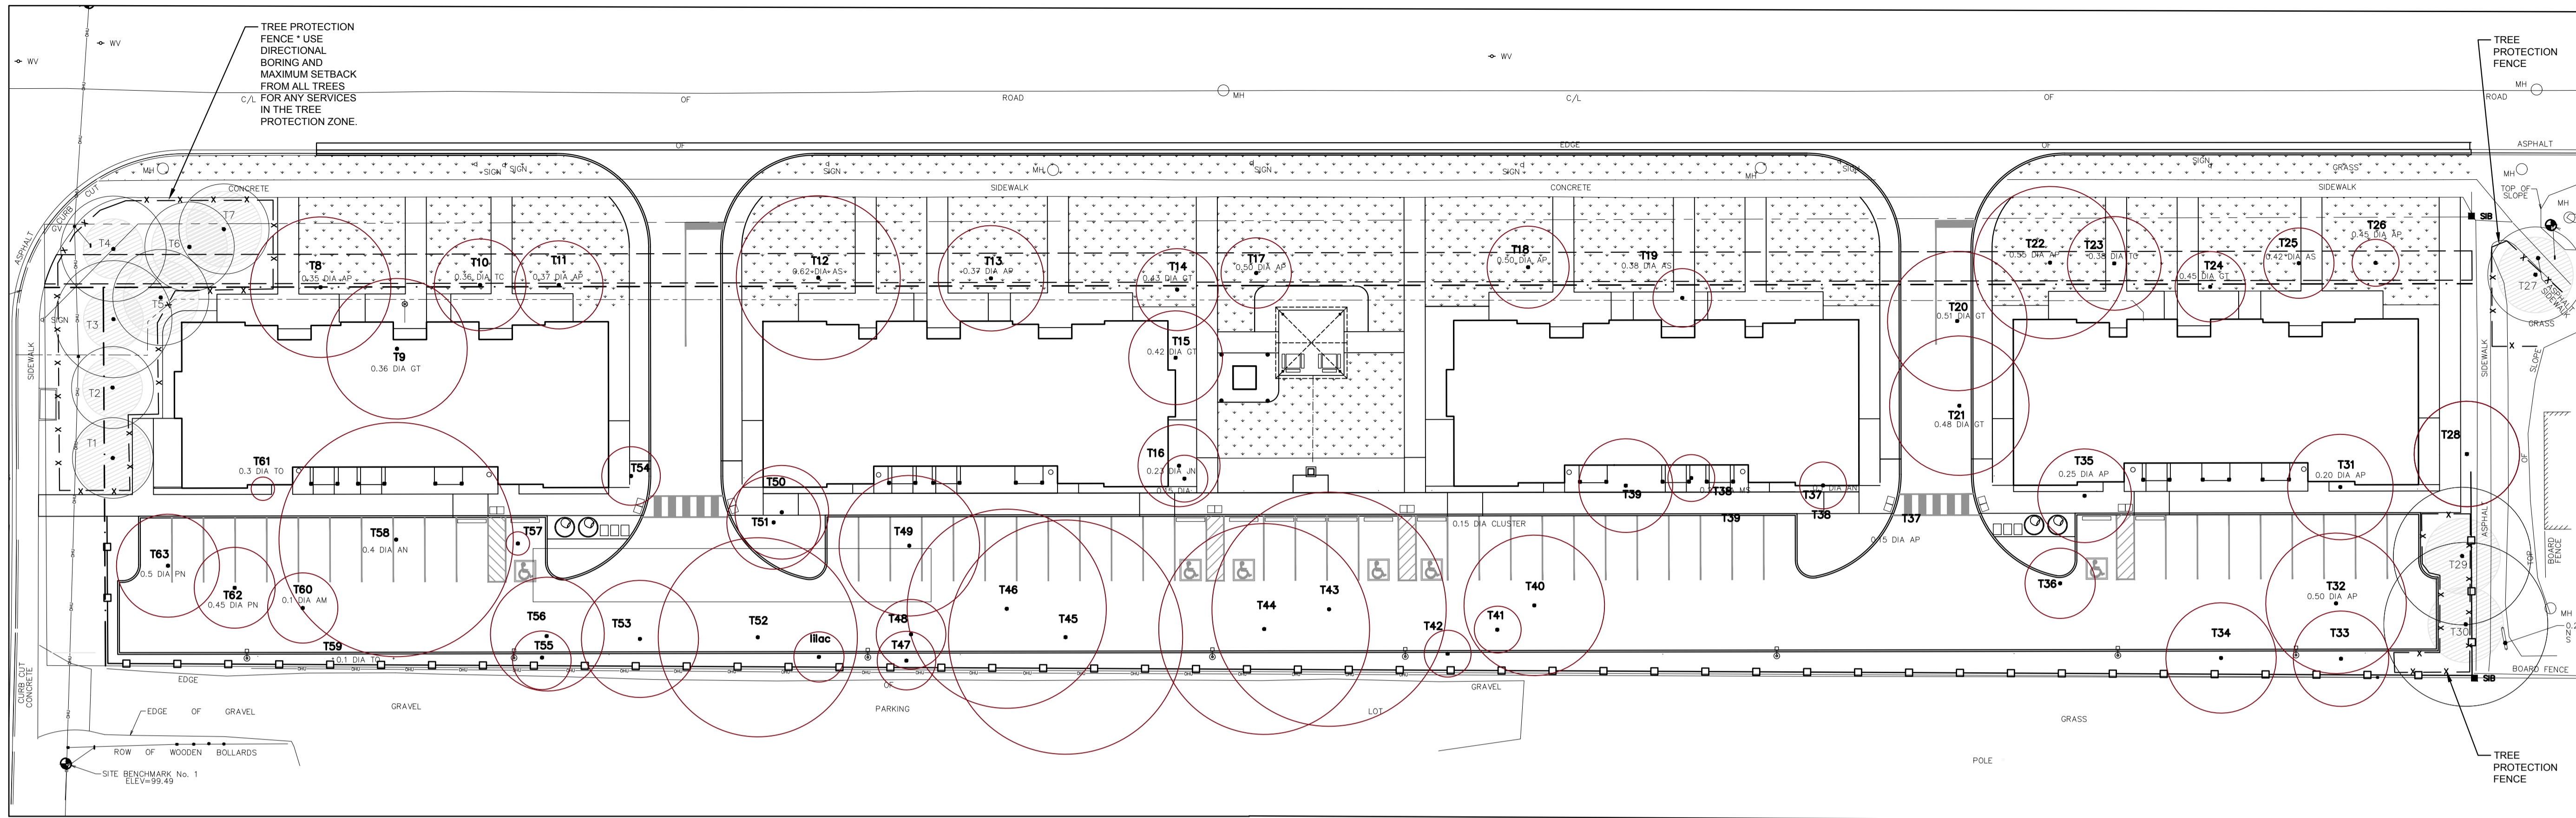
TREE PRESERVATION PLAN
SCALE: 1:300

Vegetation inventory is based on site visit conducted by Certified Arborist Gina Brouwer (ISA ON-0937A) on June 5, 2020. The inventory includes all trees (over 5cm diameter) on the subject site and within 6m of the property line. The assessment presented has been made using accepted standard arboriculture techniques as outlined in the Council of Tree & Landscape Appraisers Guide for Plant Appraisal, 9th Edition (2000). These techniques include limited visual examination of above-ground parts of each tree. Except where specifically noted, the trees observed were not climbed, probed, cored, or dissected, and excavation for detailed root crown inspection was not performed. Since some symptoms may only be present seasonally, the extent of observations that can be made may be limited by the time of year in which the inspection took place. Trees are living organisms, and their health and vigour continually change over time due to seasonal variations, changes in site conditions, and other factors. For this reason, the assessment presented in this report is valid at the time of inspection, and no guarantee is made about the continued health of trees. It is recommended that the trees be re-assessed periodically. While every standing tree has the potential for failure and therefore poses some risk, a tree assessment is a good indication of present health and potential problems that could arise in the future.

TREE NO.	SPECIES	SIZE	CONDITION	COMMENT	ACTION
1	Honeylocust (Gleditsia triacanthos)	45cm DBH	Good	suckering at base, large branches pruned from overhead wires	PRESERVE
2	Honeylocust (Gleditsia triacanthos)	25cm DBH	Good-Fair	narrow branch angles, pruned from overhead wires	PRESERVE
3	Honeylocust (Gleditsia triacanthos)	25cm DBH	Fair	suckering at base, pruned from overhead wires, sparse canopy	PRESERVE
4	Honeylocust (Gleditsia triacanthos)	25cm DBH	Good	suckering at base, pruned from overhead wires	PRESERVE
5	Austrian Pine (Pinus nigra)	34/35cm DBH	Fair-Good	forked at 1m height, narrow, pruned from adjacent tree	PRESERVE
6	Austrian Pine (Pinus nigra)	44.5cm DBH	Fair-Good	bulged roof flare, pruned up	PRESERVE
7	Austrian Pine (Pinus nigra)	53cm DBH	Fair-Good	4 stems at 2m height, pruned up	PRESERVE
8	Crimson Norway Maple (Acer platanoides)	30/30cm DBH	Fair-Poor	forked with included seam at 0.6m height, 25% dieback, dead branches	REMOVE - DEVELOPMENT CONFLICT

9	Honeylocust (Gleditsia triacanthos)	36cm DBH	Good	narrow rooting space	REMOVE - DEVELOPMENT CONFLICT
10	Linden (Tilia cordata)	36.5cm DBH	Good-Fair	multiple branch union, basketball net, service wires in canopy	REMOVE - DEVELOPMENT CONFLICT
11	Crimson Norway Maple (Acer platanoides)	37cm DBH	Good	exposed surface roots, lights strung in tree, service wire in canopy	REMOVE - DEVELOPMENT CONFLICT
12	Sugar Maple (Acer saccharum)	62cm DBH	Fair-Poor	included bark, dense branching, poor branch unions, central decay, 20% dieback	REMOVE - DEVELOPMENT CONFLICT
13	Crimson Norway Maple (Acer platanoides)	42cm DBH	Good	brick edge and perennials at base, twisted trunk, multiple branch union	REMOVE - DEVELOPMENT CONFLICT
14	Honeylocust (Gleditsia triacanthos)	43.5cm DBH	Fair	poor branch structure, large pruning wounds, service wire in canopy	REMOVE - DEVELOPMENT CONFLICT
15	Honeylocust (Gleditsia triacanthos)	42cm DBH	Good	large pruning wounds, but on trunk	REMOVE - DEVELOPMENT CONFLICT

16	Black Walnut (Juglans nigra)	23/15cm DBH	Good	trunks 1m apart	REMOVE - DEVELOPMENT CONFLICT
17	Crimson Norway Maple (Acer platanoides)	50.5cm DBH	Good	service wires in canopy	REMOVE - DEVELOPMENT CONFLICT
18	Crimson Norway Maple (Acer platanoides)	50cm DBH	Good	suckering at base, canker at base, twisted trunk	REMOVE - DEVELOPMENT CONFLICT
19	Sugar Maple (Acer saccharum)	38cm DBH	Fair	narrow branch angles, large pruning wounds, pruned from service wires	REMOVE - DEVELOPMENT CONFLICT
20	Honeylocust (Gleditsia triacanthos)	51.5cm DBH	Good	pruned up	REMOVE - DEVELOPMENT CONFLICT
21	Honeylocust (Gleditsia triacanthos)	48cm DBH	Good	pruned up	REMOVE - DEVELOPMENT CONFLICT
22	Norway Maple (Acer platanoides)	55cm DBH	Fair	multiple branch union, uneven canopy, pruned from service wires	REMOVE - DEVELOPMENT CONFLICT
23	Linden (Tilia cordata)	38cm DBH	Fair-Poor	poor structure, large branch failure, pruned from service wires	REMOVE - DEVELOPMENT CONFLICT

24	Honeylocust (Gleditsia triacanthos)	45cm DBH	Fair	suckering, pruned up, large pruning wounds, 20% dieback	REMOVE - DEVELOPMENT CONFLICT
25	Sugar Maple (Acer saccharum)	42.5cm DBH	Poor-Fair	large branch removed, 50% dieback, poor structure	REMOVE - DEVELOPMENT CONFLICT
26	Crimson Norway Maple (Acer platanoides)	45cm DBH	Poor-Fair	suckering at base, pruned up, large target canker	REMOVE - DEVELOPMENT CONFLICT
27	Austrian Pine (Pinus nigra)	46.5cm DBH	Good-Fair	buckthorn along fence	PRESERVE
28	Black Walnut (Juglans nigra)	32cm DBH	Good		REMOVE - DEVELOPMENT CONFLICT
29	Austrian Pine (Pinus nigra)	30cm DBH	Good-Fair	crowded by adjacent maple	PRESERVE
30	Sugar Maple (Acer saccharum)	50cm DBH	Good		PRESERVE
31	Norway Maple (Acer platanoides)	20cm DBH	Fair-Good	trunk next to building	REMOVE - DEVELOPMENT CONFLICT
32	Norway Maple (Acer platanoides)	50cm DBH	Good	dense canopy	REMOVE - DEVELOPMENT CONFLICT

33	Red Cedar (Juniperus virginiana)	20cm DBH	Good		REMOVE - DEVELOPMENT CONFLICT
34	Red Cedar (Juniperus virginiana)	40cm DBH	Good	pruned from service wire	REMOVE - DEVELOPMENT CONFLICT
35	Norway Maple (Acer platanoides)	25cm DBH	Good-Fair	trunk next to building	REMOVE - DEVELOPMENT CONFLICT
36	Serviceberry (Amelanchier canadensis)	18cm DBH	Good-Fair	trunk lean	REMOVE - DEVELOPMENT CONFLICT
37	Norway Maple (Acer platanoides)	suckers	--	group along fence with lilac, buckthorn and grape vine	REMOVE - DEVELOPMENT CONFLICT
38	Norway Maple (Acer platanoides)	suckers	--	suckers with buckthorn along fence	REMOVE - DEVELOPMENT CONFLICT
39	Flowering Crabapple (Malus spp.)	20/25cm DBH	Good	forked at 1m height, close to building	REMOVE - DEVELOPMENT CONFLICT
40	Sugar Maple (Acer saccharum)	80cm DBH	Fair-Good	multi-stem with crossing and included branches	REMOVE - DEVELOPMENT CONFLICT
41	Eastern White Cedar (Thuja occidentalis)	20cm DBH	Good-Fair	crowded by adjacent maple	REMOVE - DEVELOPMENT CONFLICT

42	Common Lilac (Syringa vulgaris)	5.10cm DBH	Fair	clump suckering along fence, deadwood at base, Norway Maple suckers	REMOVE - DEVELOPMENT CONFLICT
43	Honeylocust (Gleditsia triacanthos)	55cm DBH	Good	large pruning wounds	REMOVE - DEVELOPMENT CONFLICT
44	Honeylocust (Gleditsia triacanthos)	50cm DBH	Good	large pruning wounds, removed branch included stump	REMOVE - DEVELOPMENT CONFLICT
45	Sugar Maple (Acer saccharum)	55cm DBH	Fair-Good	pruned from overhead wires, included branch attachments, vertical seam, dense canopy	REMOVE - DEVELOPMENT CONFLICT
46	Sugar Maple (Acer saccharum)	55cm DBH	Fair-Good	pruned from overhead wires, narrow branch attachments, dead branches, included rope	REMOVE - DEVELOPMENT CONFLICT
47	Norway Maple (Acer platanoides)	sucker	--	included stems suckering along fence	REMOVE - DEVELOPMENT CONFLICT
48	Norway Maple (Acer platanoides)	sucker	--	included stems suckering along fence	REMOVE - DEVELOPMENT CONFLICT

49	Manitoba Maple (Acer negundo)	38/10cm DBH	Fair	3 stems around fence between yards	REMOVE - DEVELOPMENT CONFLICT
50	Elm (Ulmus spp.)	15cm DBH	Good	suckering from dead trunk at base	REMOVE - DEVELOPMENT CONFLICT
51	Black Walnut (Juglans nigra)	15cm DBH	Good		REMOVE - DEVELOPMENT CONFLICT
52	Sugar Maple (Acer saccharum)	50cm DBH	Fair-Good	narrow branch angles, included and split branch attachments, pruned up	REMOVE - DEVELOPMENT CONFLICT
53	Elm (Ulmus spp.)	30-40cm DBH	Fair	4 stem from base, suckering, pruned from overhead wires	REMOVE - DEVELOPMENT CONFLICT
54	Balsam Fir (Abies balsamea)	15cm DBH	Fair-Good	aparse, pruned up	REMOVE - DEVELOPMENT CONFLICT
55	Balsam Fir (Abies balsamea)	30cm DBH	Fair-Good	broken branch, pruned from locust	REMOVE - DEVELOPMENT CONFLICT
56	Honeylocust (Gleditsia triacanthos)	40cm DBH	Good-Fair		REMOVE - DEVELOPMENT CONFLICT
57	Elm (Ulmus spp.)	sucker	--	sucker along fence	REMOVE - DEVELOPMENT CONFLICT

58	Manitoba Maple (Acer negundo)	38/40cm DBH	Good-Fair	forked and suckering at base	REMOVE - DEVELOPMENT CONFLICT
59	Eastern White Cedar (Thuja occidentalis)	10/5-10cm	Good	elm sucker at end	REMOVE - DEVELOPMENT CONFLICT
60	Serviceberry (Amelanchier canadensis)	4@10-15cm	Fair	30% dieback, pruned	REMOVE - DEVELOPMENT CONFLICT
61	Eastern White Cedar (Thuja occidentalis)	30cm DBH	Good	dog strangling vine along fence	REMOVE - DEVELOPMENT CONFLICT
62	Austrian Pine (Pinus nigra)	45cm DBH	Fair	topped, pruned up	REMOVE - DEVELOPMENT CONFLICT
63	Austrian Pine (Pinus nigra)	50cm DBH	Fair	pruned up, limb in overhead wire	REMOVE - DEVELOPMENT CONFLICT
