Tree Inventory & Preservation Plan

Infill Development 425 King Street East Cobourg, ON

February 2018 REVISED April 2020

Treescape Consulting Project TC258

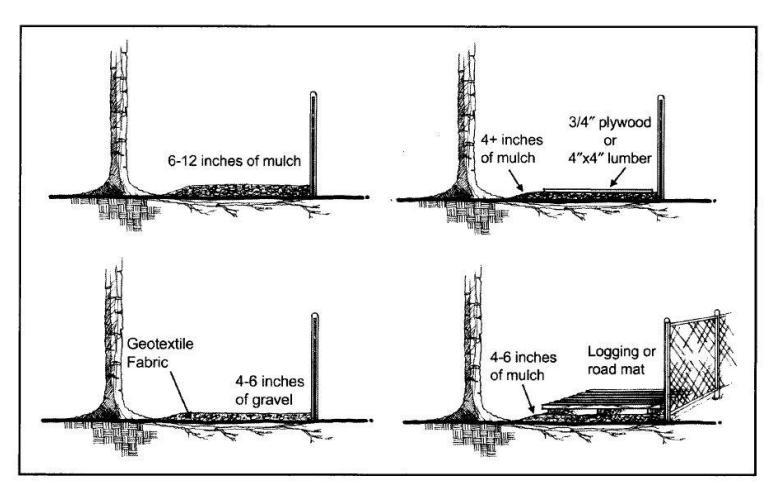
Figure 3. Soil and root protection options within the TPZ.

"If traffic cannot be kept outside of the TPZ for the entire duration of construction, actions can be taken to disperse the vehicular load and protect roots, minimizing soil compaction and mechanical root damage. These include:

- Applying 15-30cm (6-12") of wood chip mulch to the area
- Laying 2cm (¾") thick plywood or 10 x 10cm (4x4") wood beams over a 10+ cm (4+ ") thick layer of wood chip mulch
- Applying 10-15cm (4-6") of gravel over a taut, staked geotextile fabric; or
- Placing commercial logging or road mats on top of a mulch layer
- Stone, geotextile and mulch exceeding 10cm (4") thick will need to be removed from the TPZ once the threat of soil or root damage has passed."

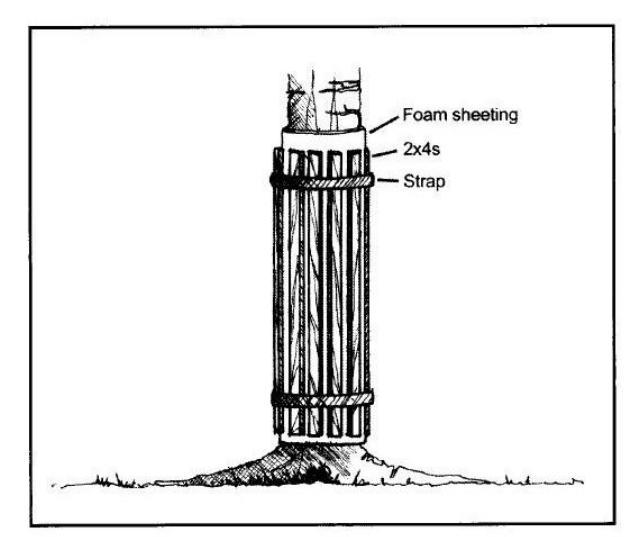
Figure 4. Trunk protection structure.

"When trees are so close to construction activities that the trunk or buttress roots may be mechanically damaged, those parts should be protected. This can be done by installing 5cm (2") thick wood planks, such as 5x10cm or 5x15cm (2x4"s or 2x6"s) around the trunk, preferably on a closed-cell foam pad. Straps or wire are used to bind the planks in place. No fasteners should be driven into the tree. Trunk protection should be adjusted to allow growth if it is in place during periods of trunk diameter growth."
