Final Environmental Study Report

Schedule C Municipal Class Environmental Assessment

Midtown Creek Flood Ponding Area and Kerr Street Extension - Division Street West to Railway Spur

November 2018

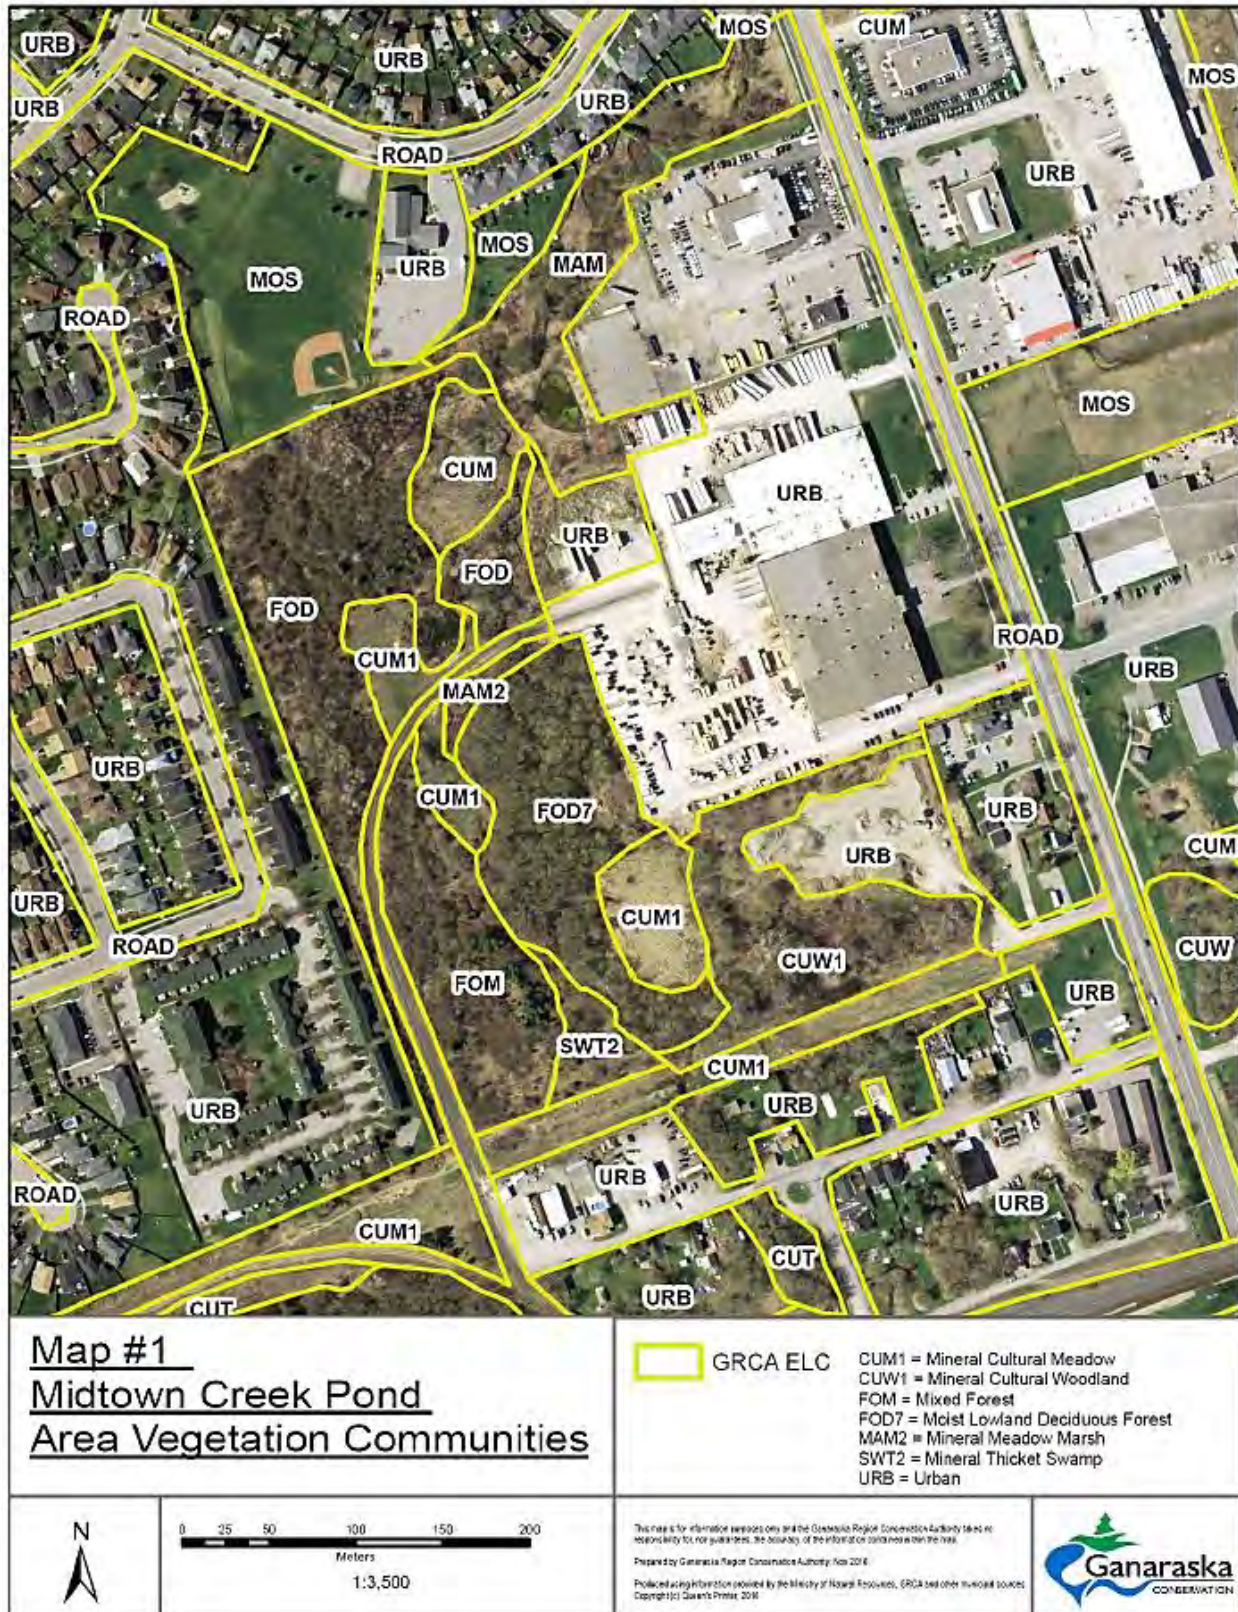
Figure 3 – GRCA Ecological Land Classification Mapping

Field visits to the study area were completed by the GRCA on three separate occasions during July and August of 2016. Ecological Land Classification (ELC) mapping was done to determine habitat community types throughout the study area. Soil samples were also taken and it was found that inconsistency of soil types combined with drainage patterns and human disturbance are the determining factor for the vegetation present in the area.

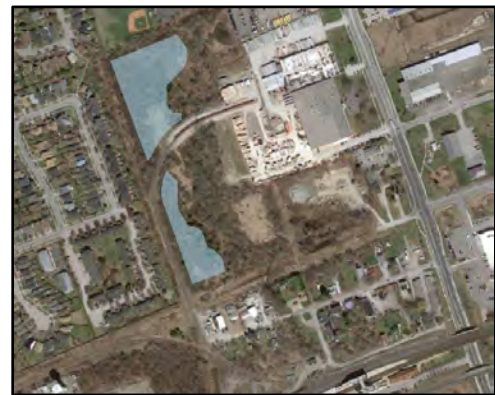
This alternative would involve the excavation of a two-cell off-line flood ponding area, separated by the Canada Pallet railway spur, west of Midtown Creek. The preliminary analysis indicates that the 100-year flow can be attenuated to 5.77 m³/s, which is above the recommended target. Midtown Creek would not require reconstruction on Canada Pallet property, and the east side of the creek would remain untouched, somewhat limiting tree cutting and property acquisition requirements.

The alternative does not meet flow targets and introduces a wet area north of the spur line. Pond flows must be conveyed between the two cells through the railway spur. An offset from Midtown Creek is required, which limits the area available for storage. The diversion structure is complex to design and the alternative would require upsizing Buchanan and George Street culverts to control the backwater from these structures. There is also an increased maintenance difficulty. Concerns include flooding the condominiums in subdivisions adjacent to Division Street.

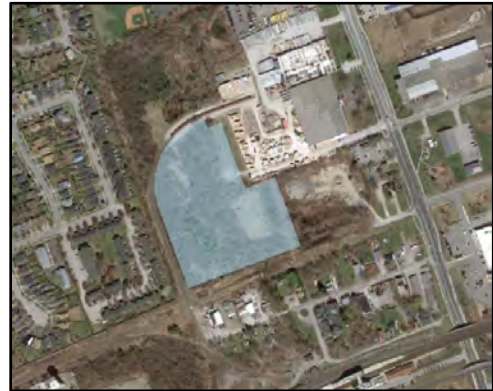
This alternative would involve excavating an on-line flood ponding area and reconstructing the Midtown Creek natural channel through the basin. The preliminary analysis indicates that the 100-year flow can be attenuated to the recommended target of 4.1 m³/s. This alternative does not require flooding the area north of the railway spur. Significant tree cutting would be required and more earthworks are required than in Alternative 2.

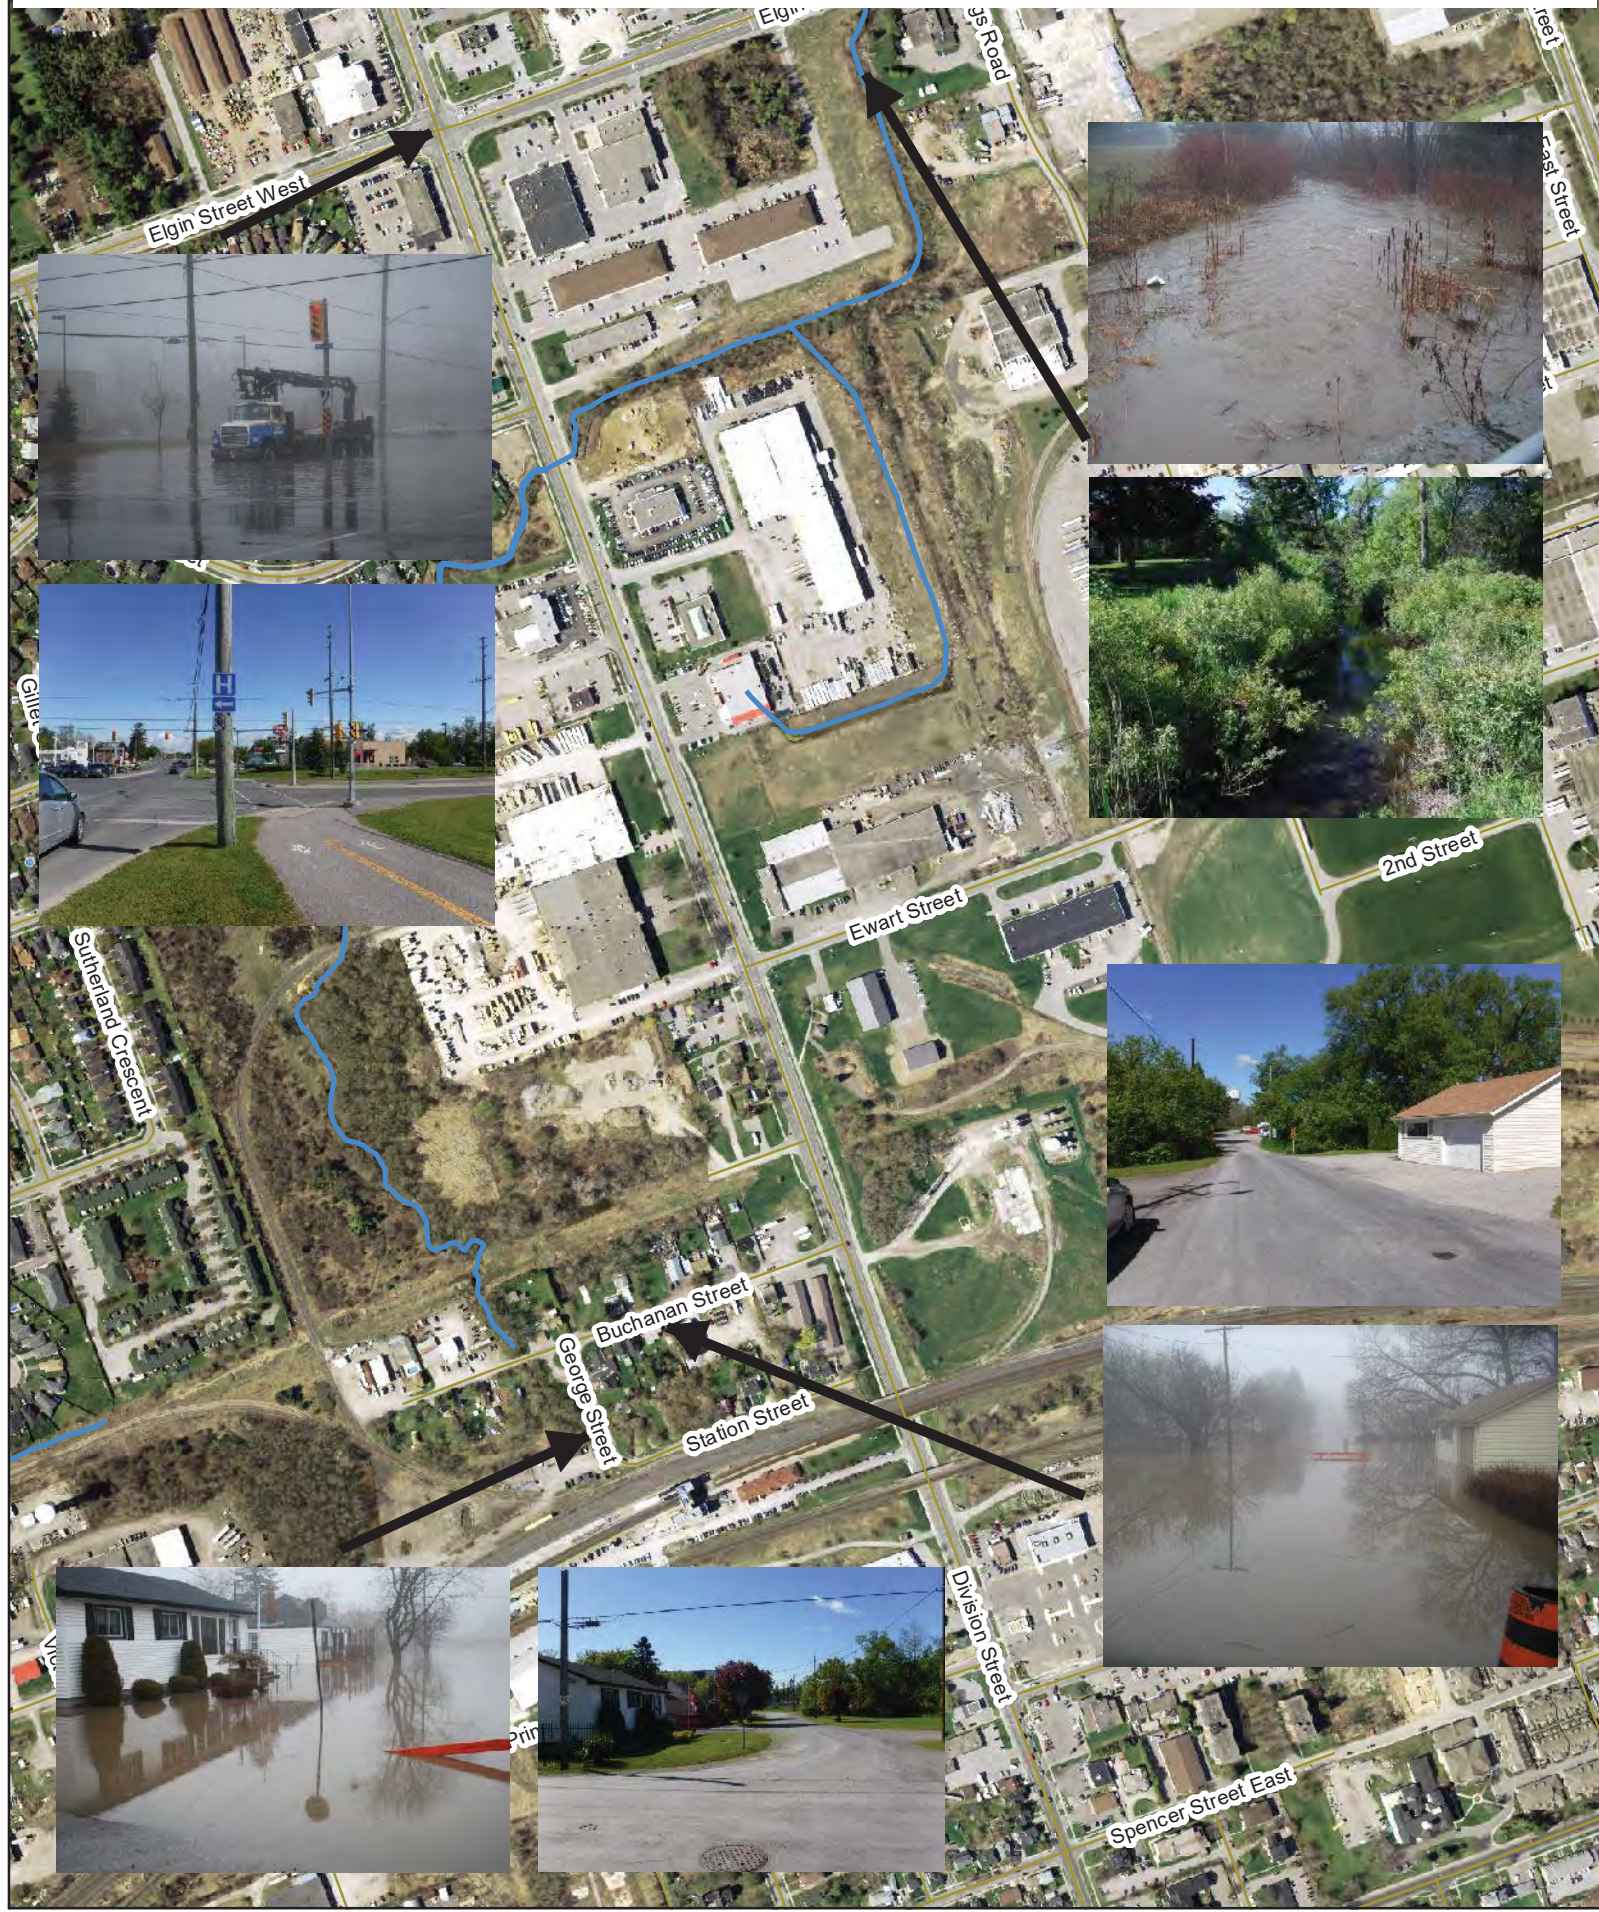
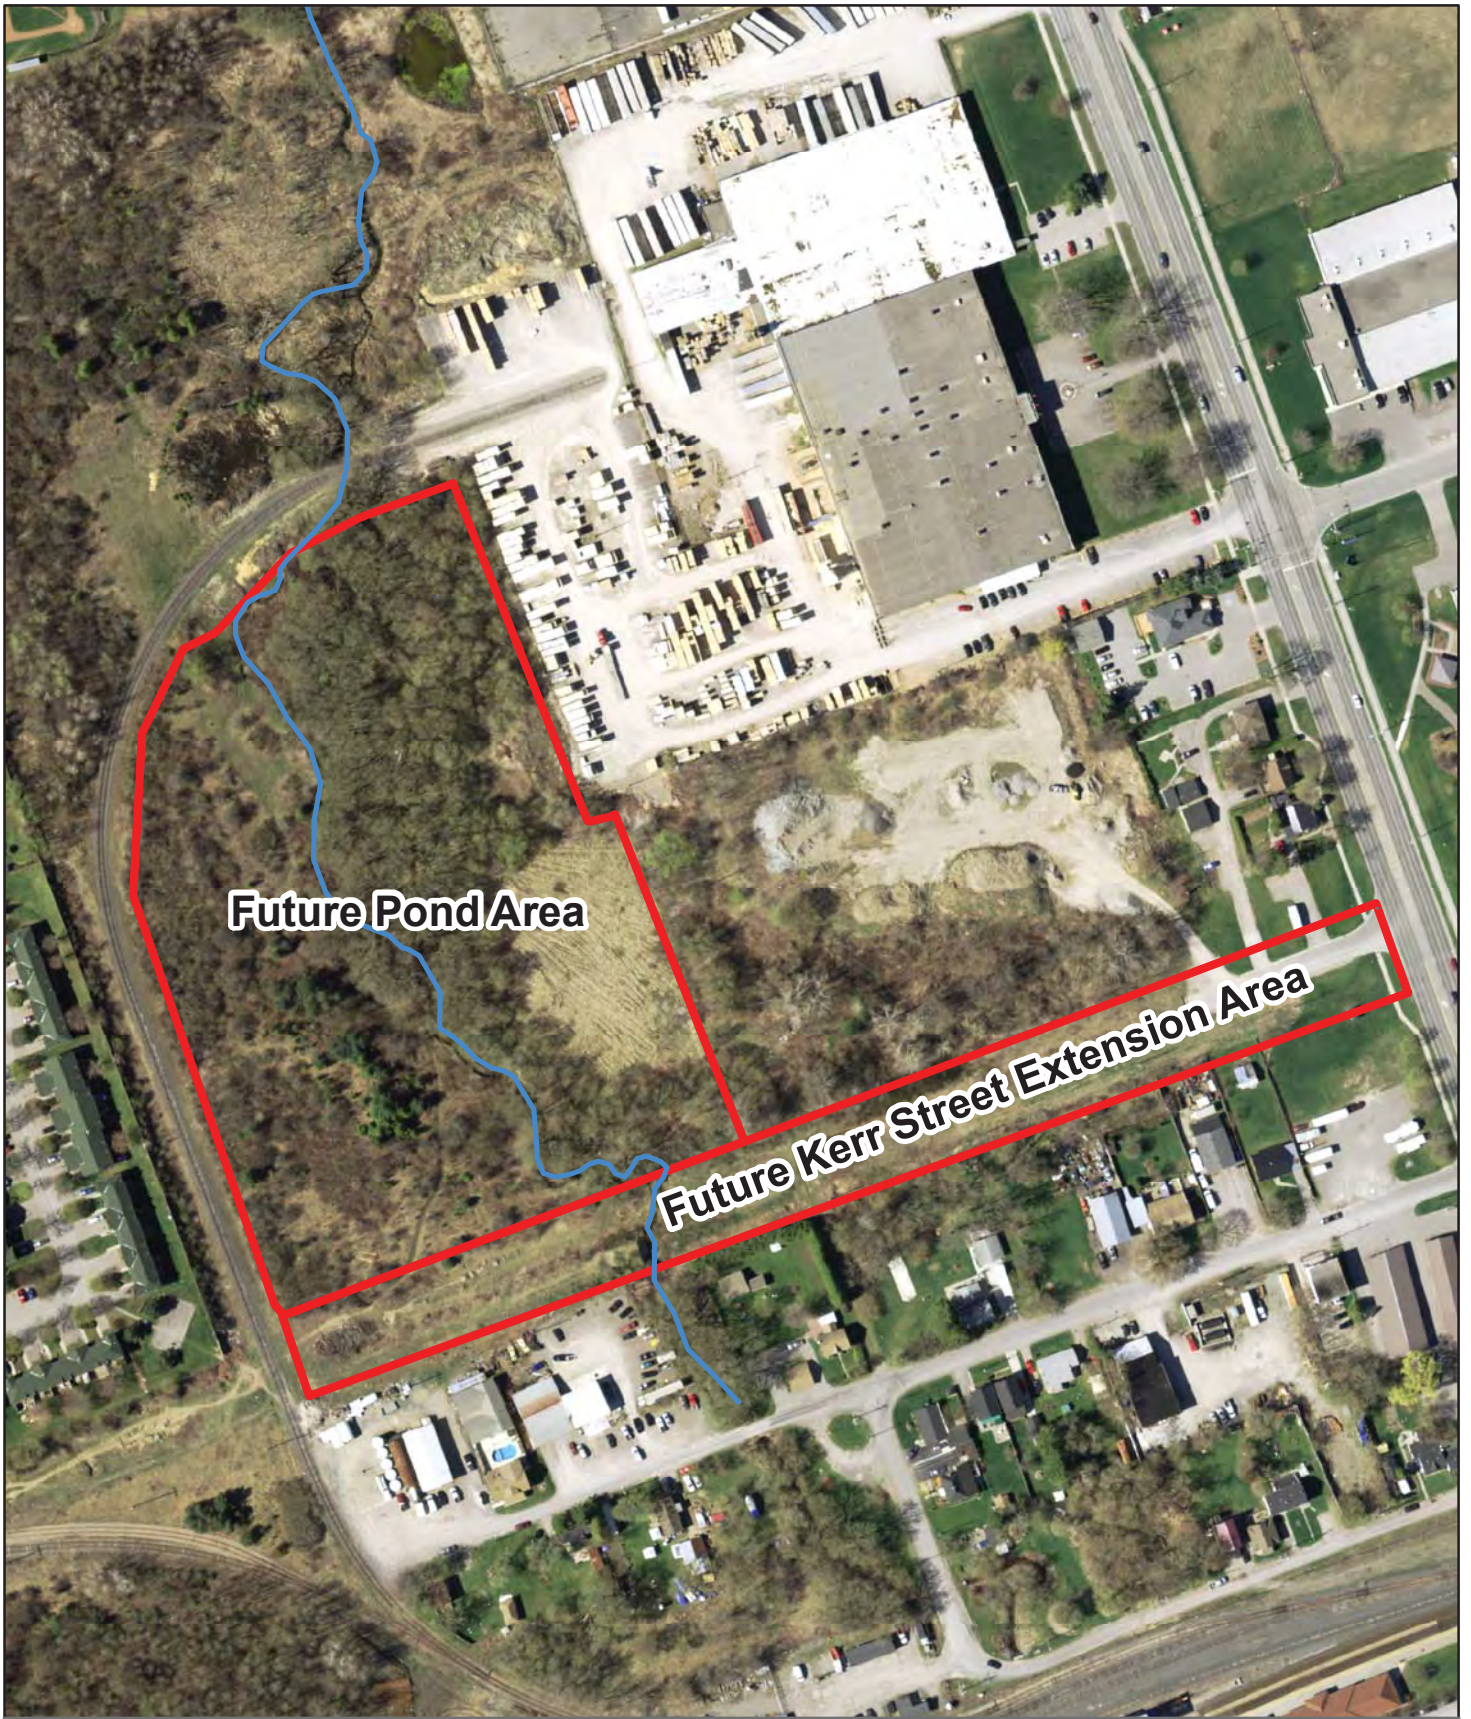
Midtown Creek Flooding January 25, 2010 versus Typical Flow, June 2, 2017

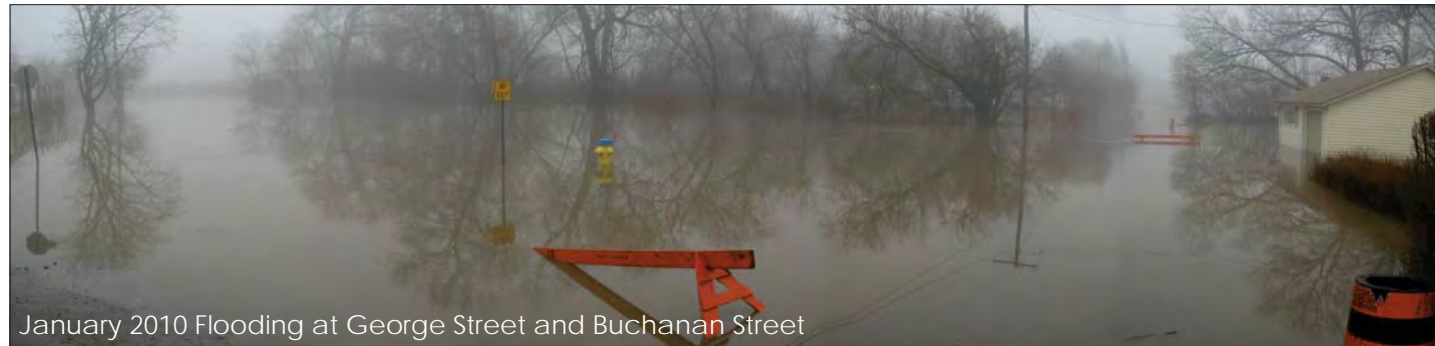
January 2010 Flooding at George Street and Buchanan Street

- There is a history of flooding along Midtown Creek upstream of the CNR and CPR corridor that has caused substantial flood damages to private properties in the area of Buchanan Street, George Street and Station Street as well as frequent flooding of the Division Street Railway Underpass.

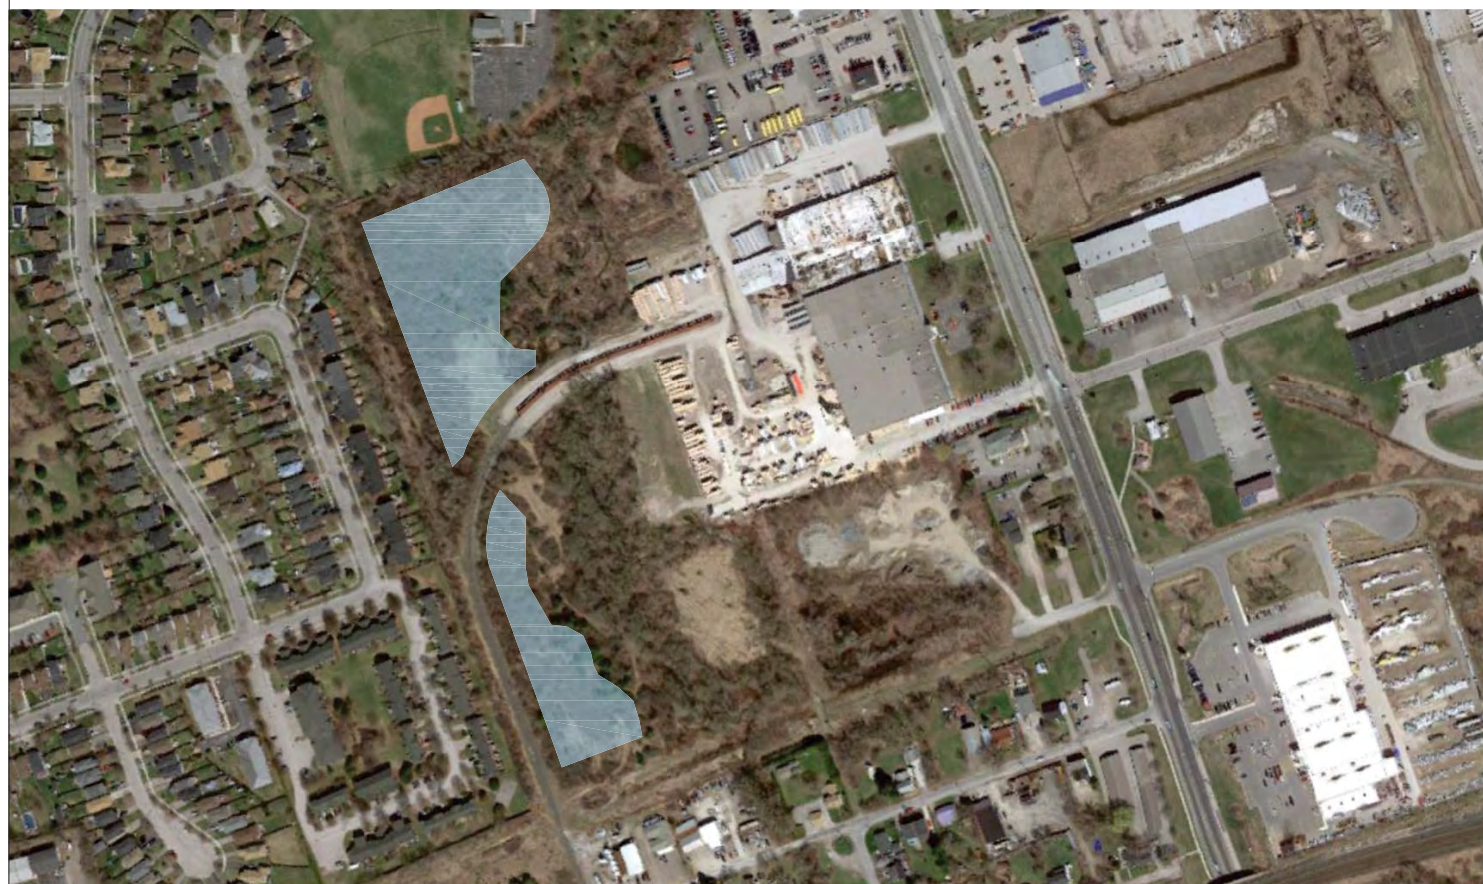
Alternative #3 - On-Line Flood Ponding Area Upstream of Kerr Street Right of Way

- One online pond can attenuate the 100-year flow to the recommended target of 4.1 m³/s.
- The alternative meets flow targets and does not include use of the flooded area north of the railway spur.
- The scenario would require natural channel design of Midtown Creek, significant tree removal, and more earthworks than Alternative #2.

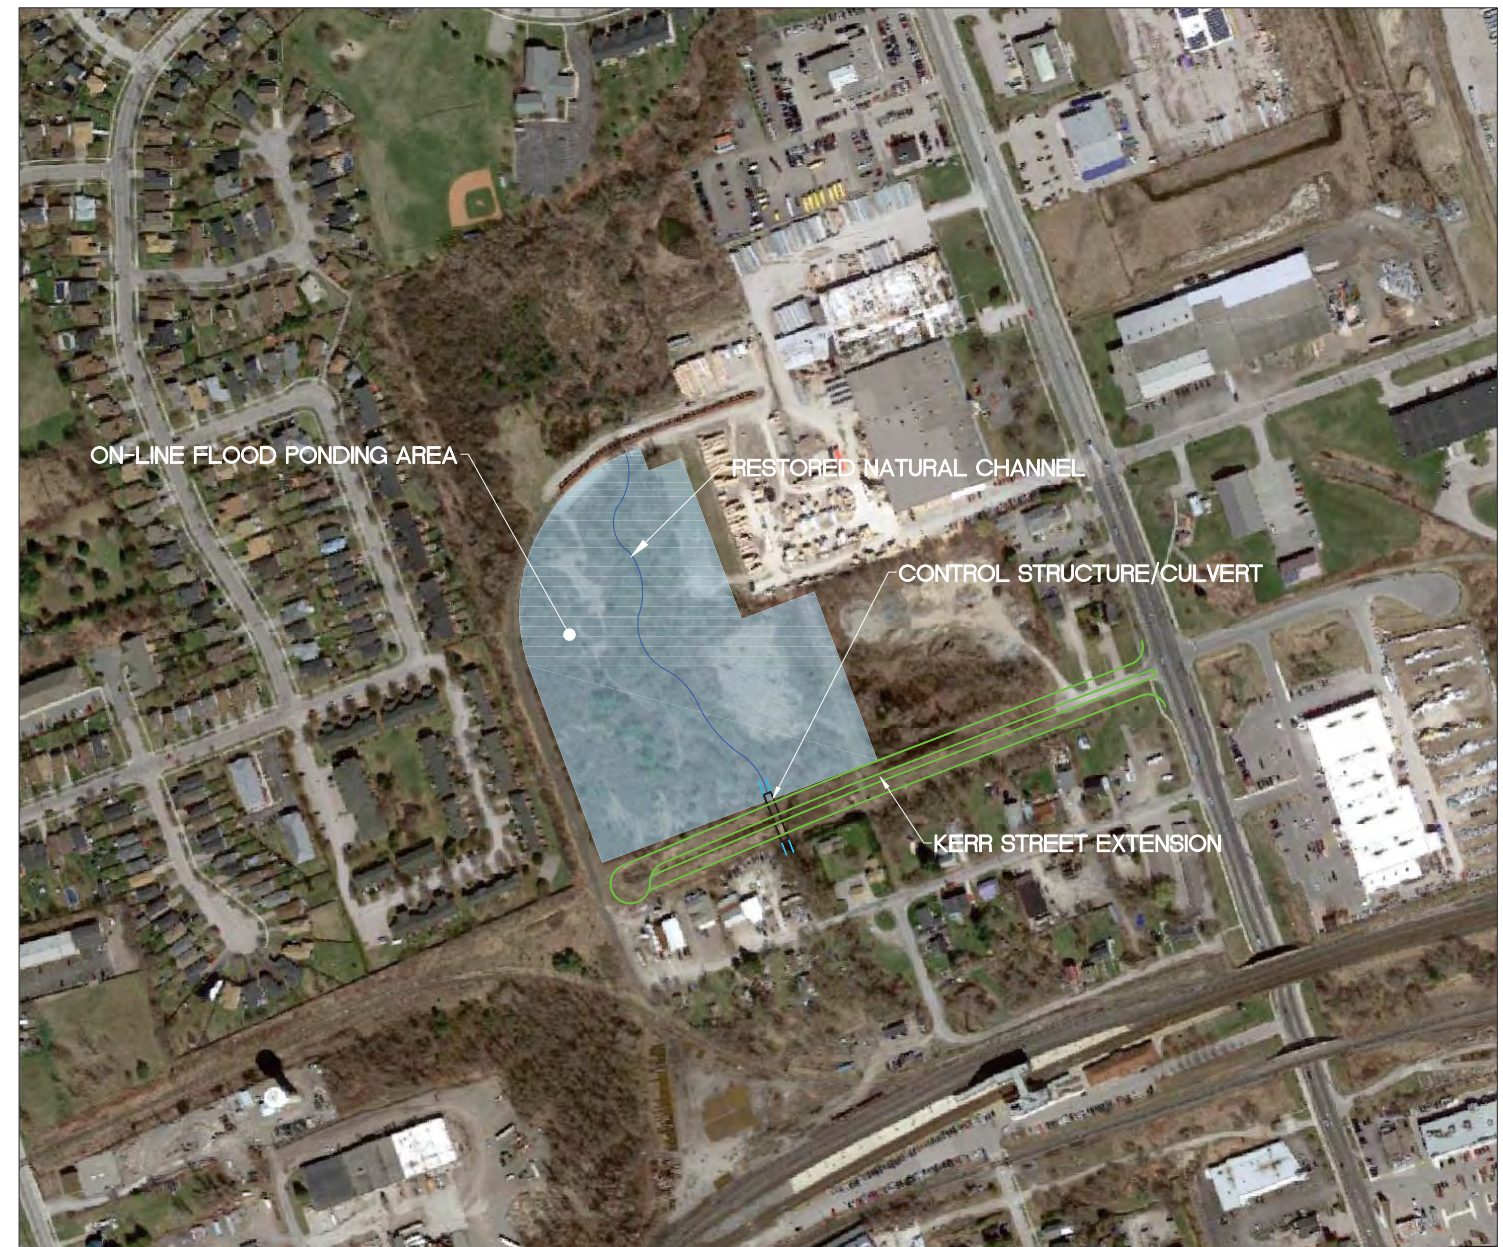
Kerr Street Conceptual Design

- Construction of Kerr Street between Division Street and the railway spur.
- Removal of trees within the flood ponding area.
- Excavation/removal of soil and grading for the proposed flood ponding area.
- Construction of a restored natural channel between the railway spur and Kerr Street.
- Construction of a control structure/culvert that:
 1. Conveys base flows (up to the 2-year peak flow) without restriction.
 2. Restricts/reduces peak flows for the 5-year to 50-year (or 100-year) storm events to the target flow rate.
 3. Conveys the Regional/Regulatory Storm (Hurricane Hazel) with no flooding impacts upstream or downstream of the study area.
 4. Ensures safe access (flood depth of less than 0.30 m) across Kerr Street.

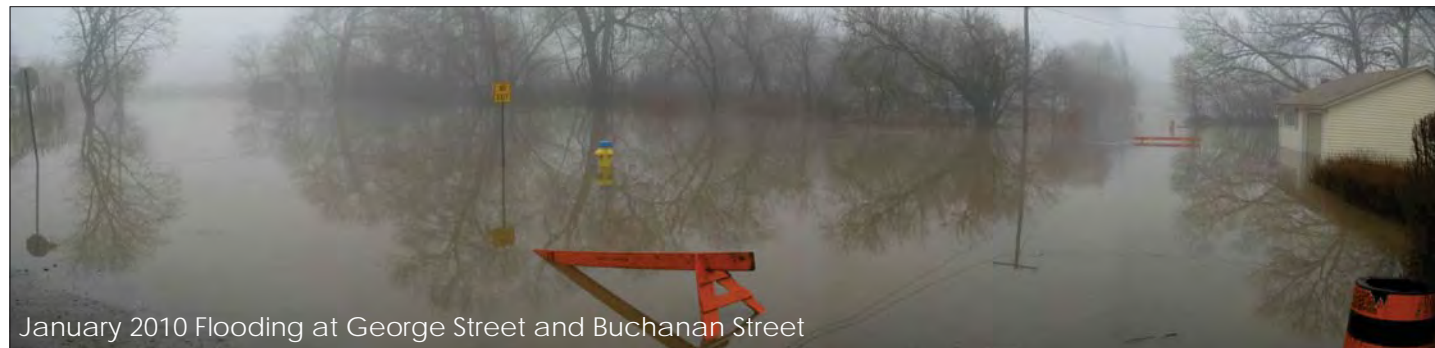
January 2010 Flooding at George Street and Buchanan Street

- There is a history of flooding along Midtown Creek upstream of the CNR and CPR corridor that has caused substantial flood damages to private properties in the area of Buchanan Street, George Street and Station Street as well as frequent flooding of the Division Street Railway Underpass.

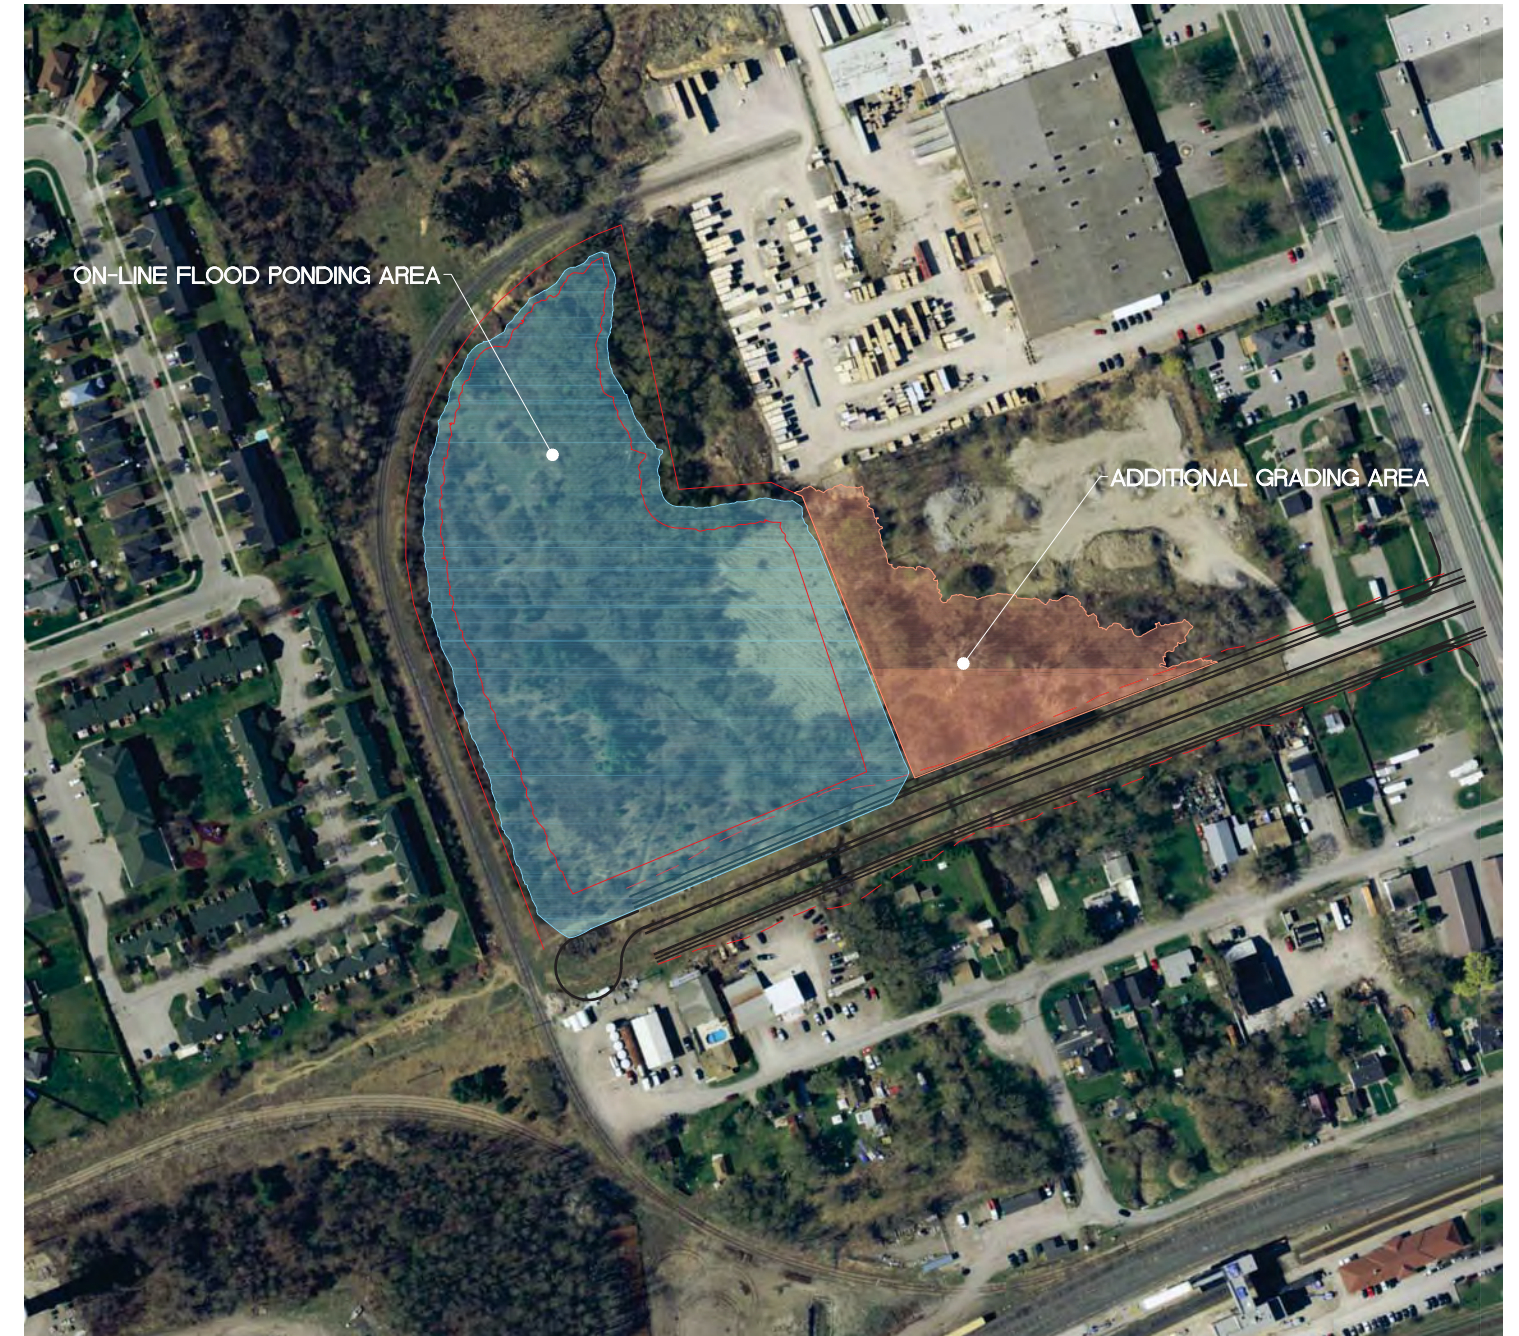
Phase 3 - Alternative Design Concepts

Alternative Design Concepts #5 to #8

1. Orifice/pipe sizing details are considered preliminary and are included for the purpose of evaluating the alternative design concepts and to ensure that the alternative design concepts are feasible. Actual orifice/pipe sizing may change during detailed design.
2. Results are provided to demonstrate how each alternative design concept performs. Ponding Elevations, Storage Volumes and Controlled Flow Rates may change during detailed design.

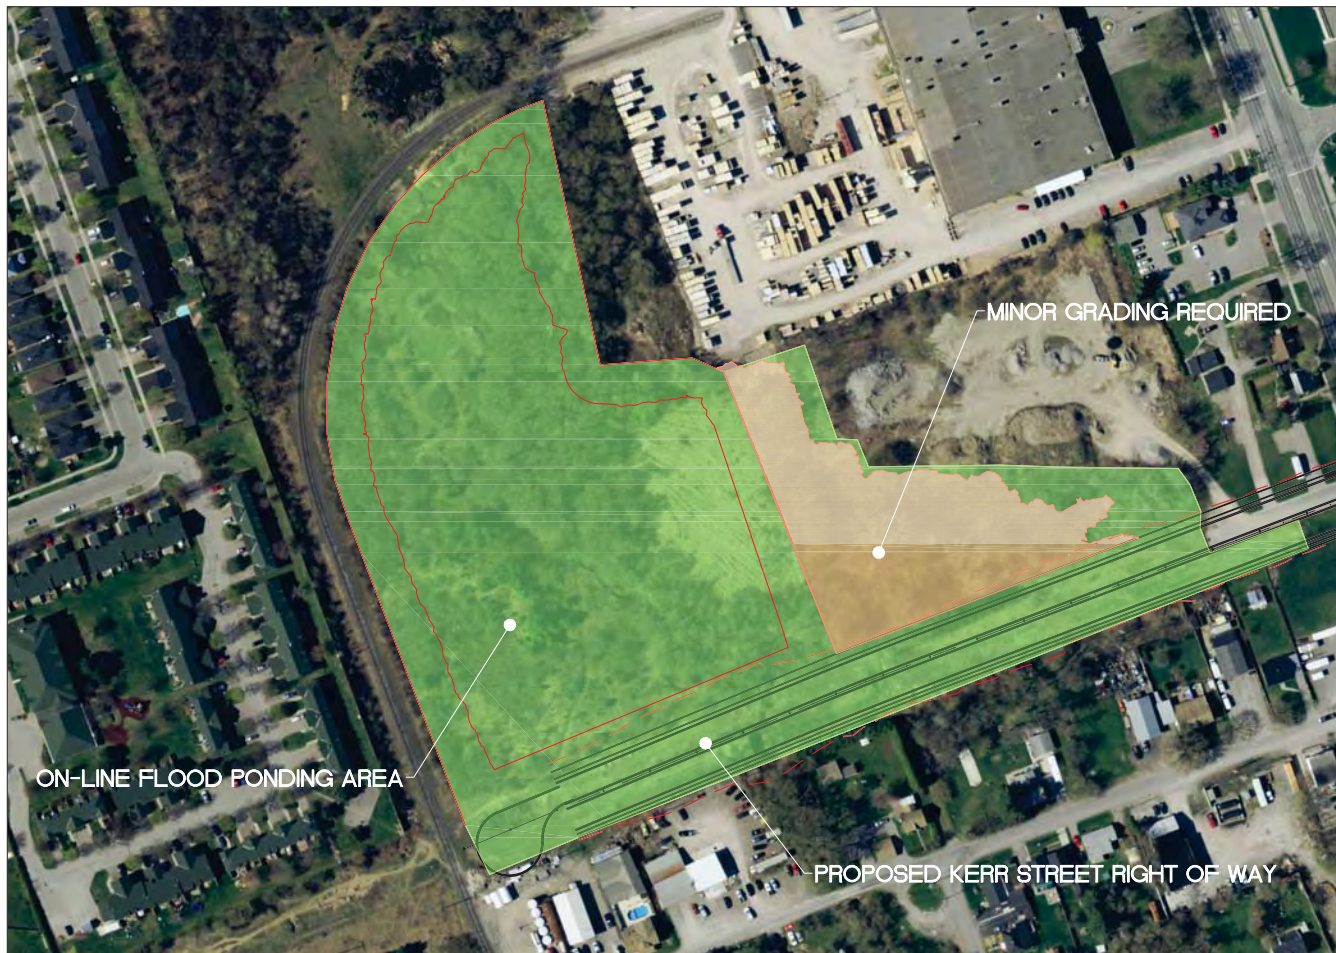
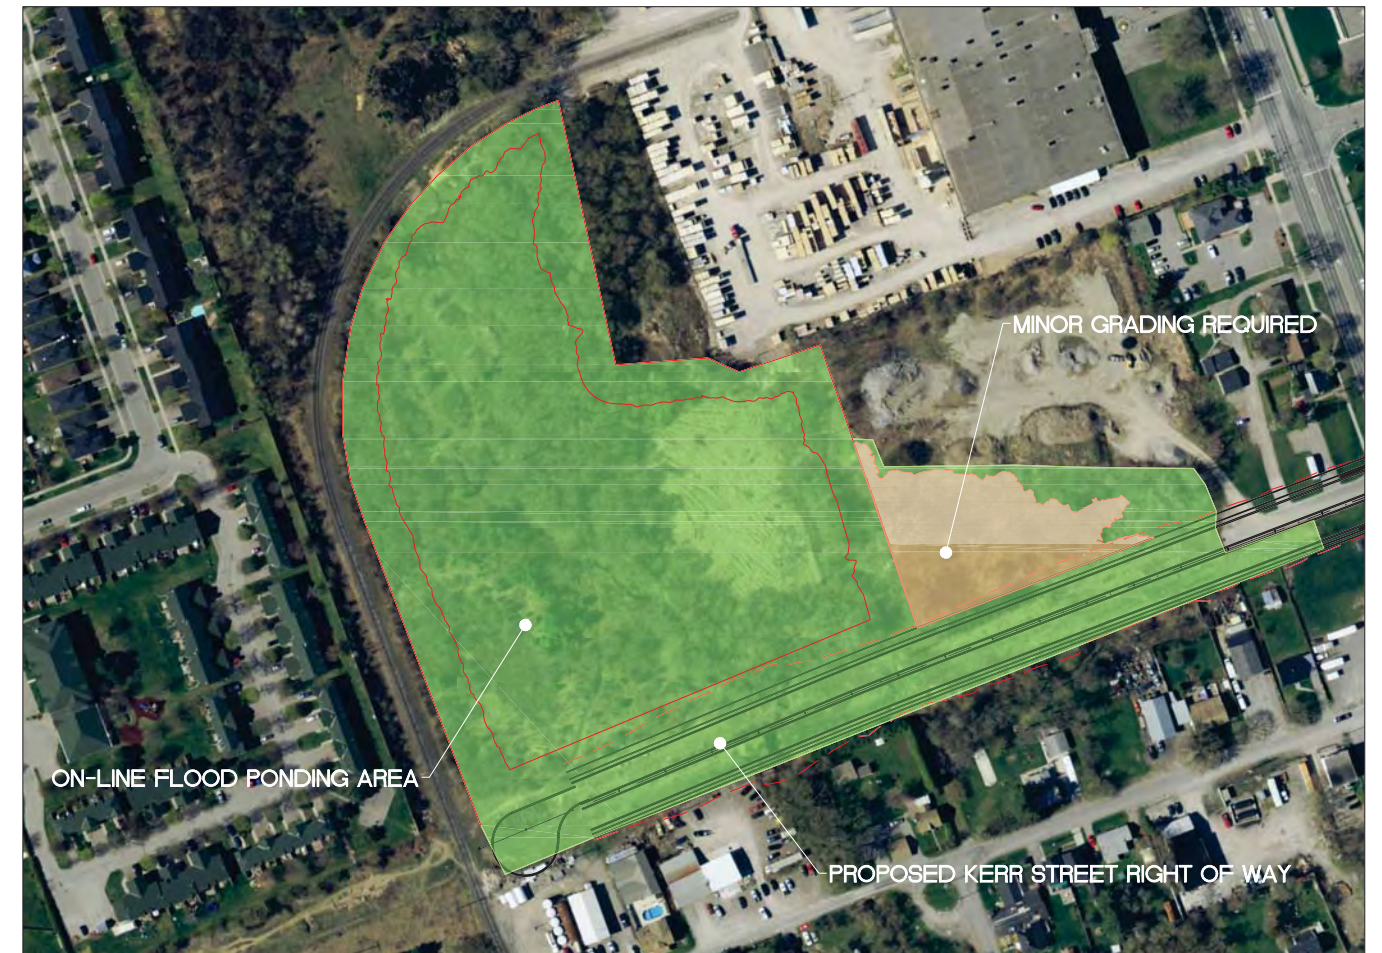
Vegetation Clearing Requirements

- Vegetation clearing is required in order to facilitate construction and grading of the flood ponding area.
- These design concepts would require approximately 5.11 ha of land to be cleared.
- Vegetation clearing is proposed to be completed in two (2) phases. Phase 1 will include the clearing and removal of trees prior to the Migratory Birds Convention Act timing window and Phase 2 will include removal of all other low level vegetation.
- A planting plan will be incorporated into the detailed design for the restored natural channel.

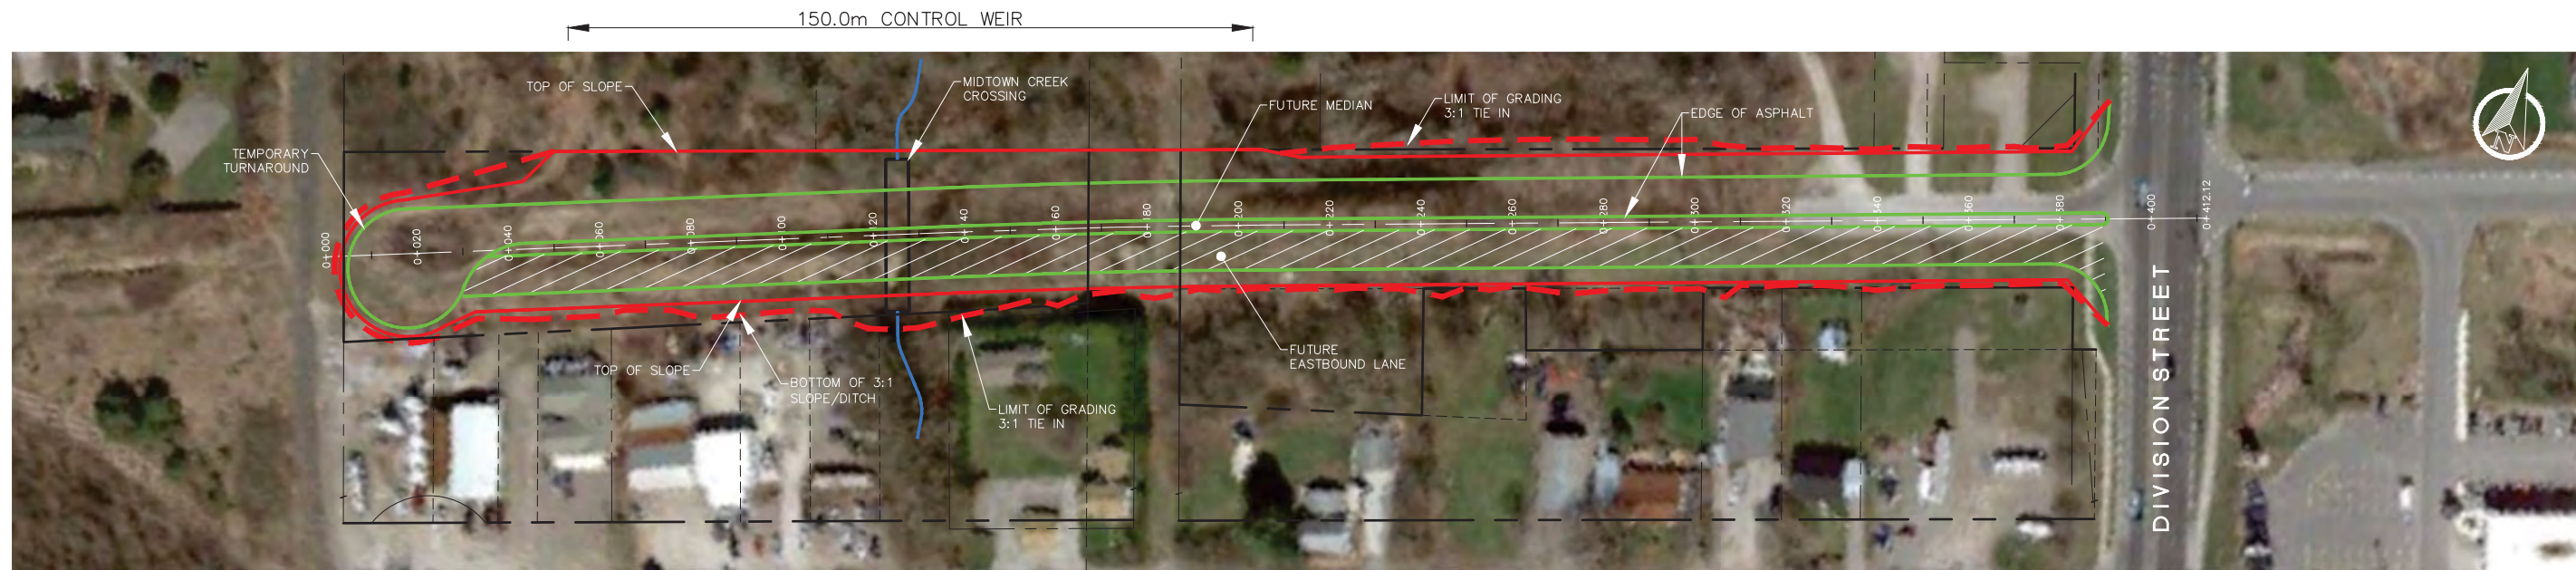
Kerr Street Conceptual Design

KERR STREET EXTENSION
