Final Environmental Study Report

Schedule C Municipal Class Environmental Assessment

Midtown Creek Flood Ponding Area and Kerr Street Extension - Division Street West to Railway Spur

November 2018

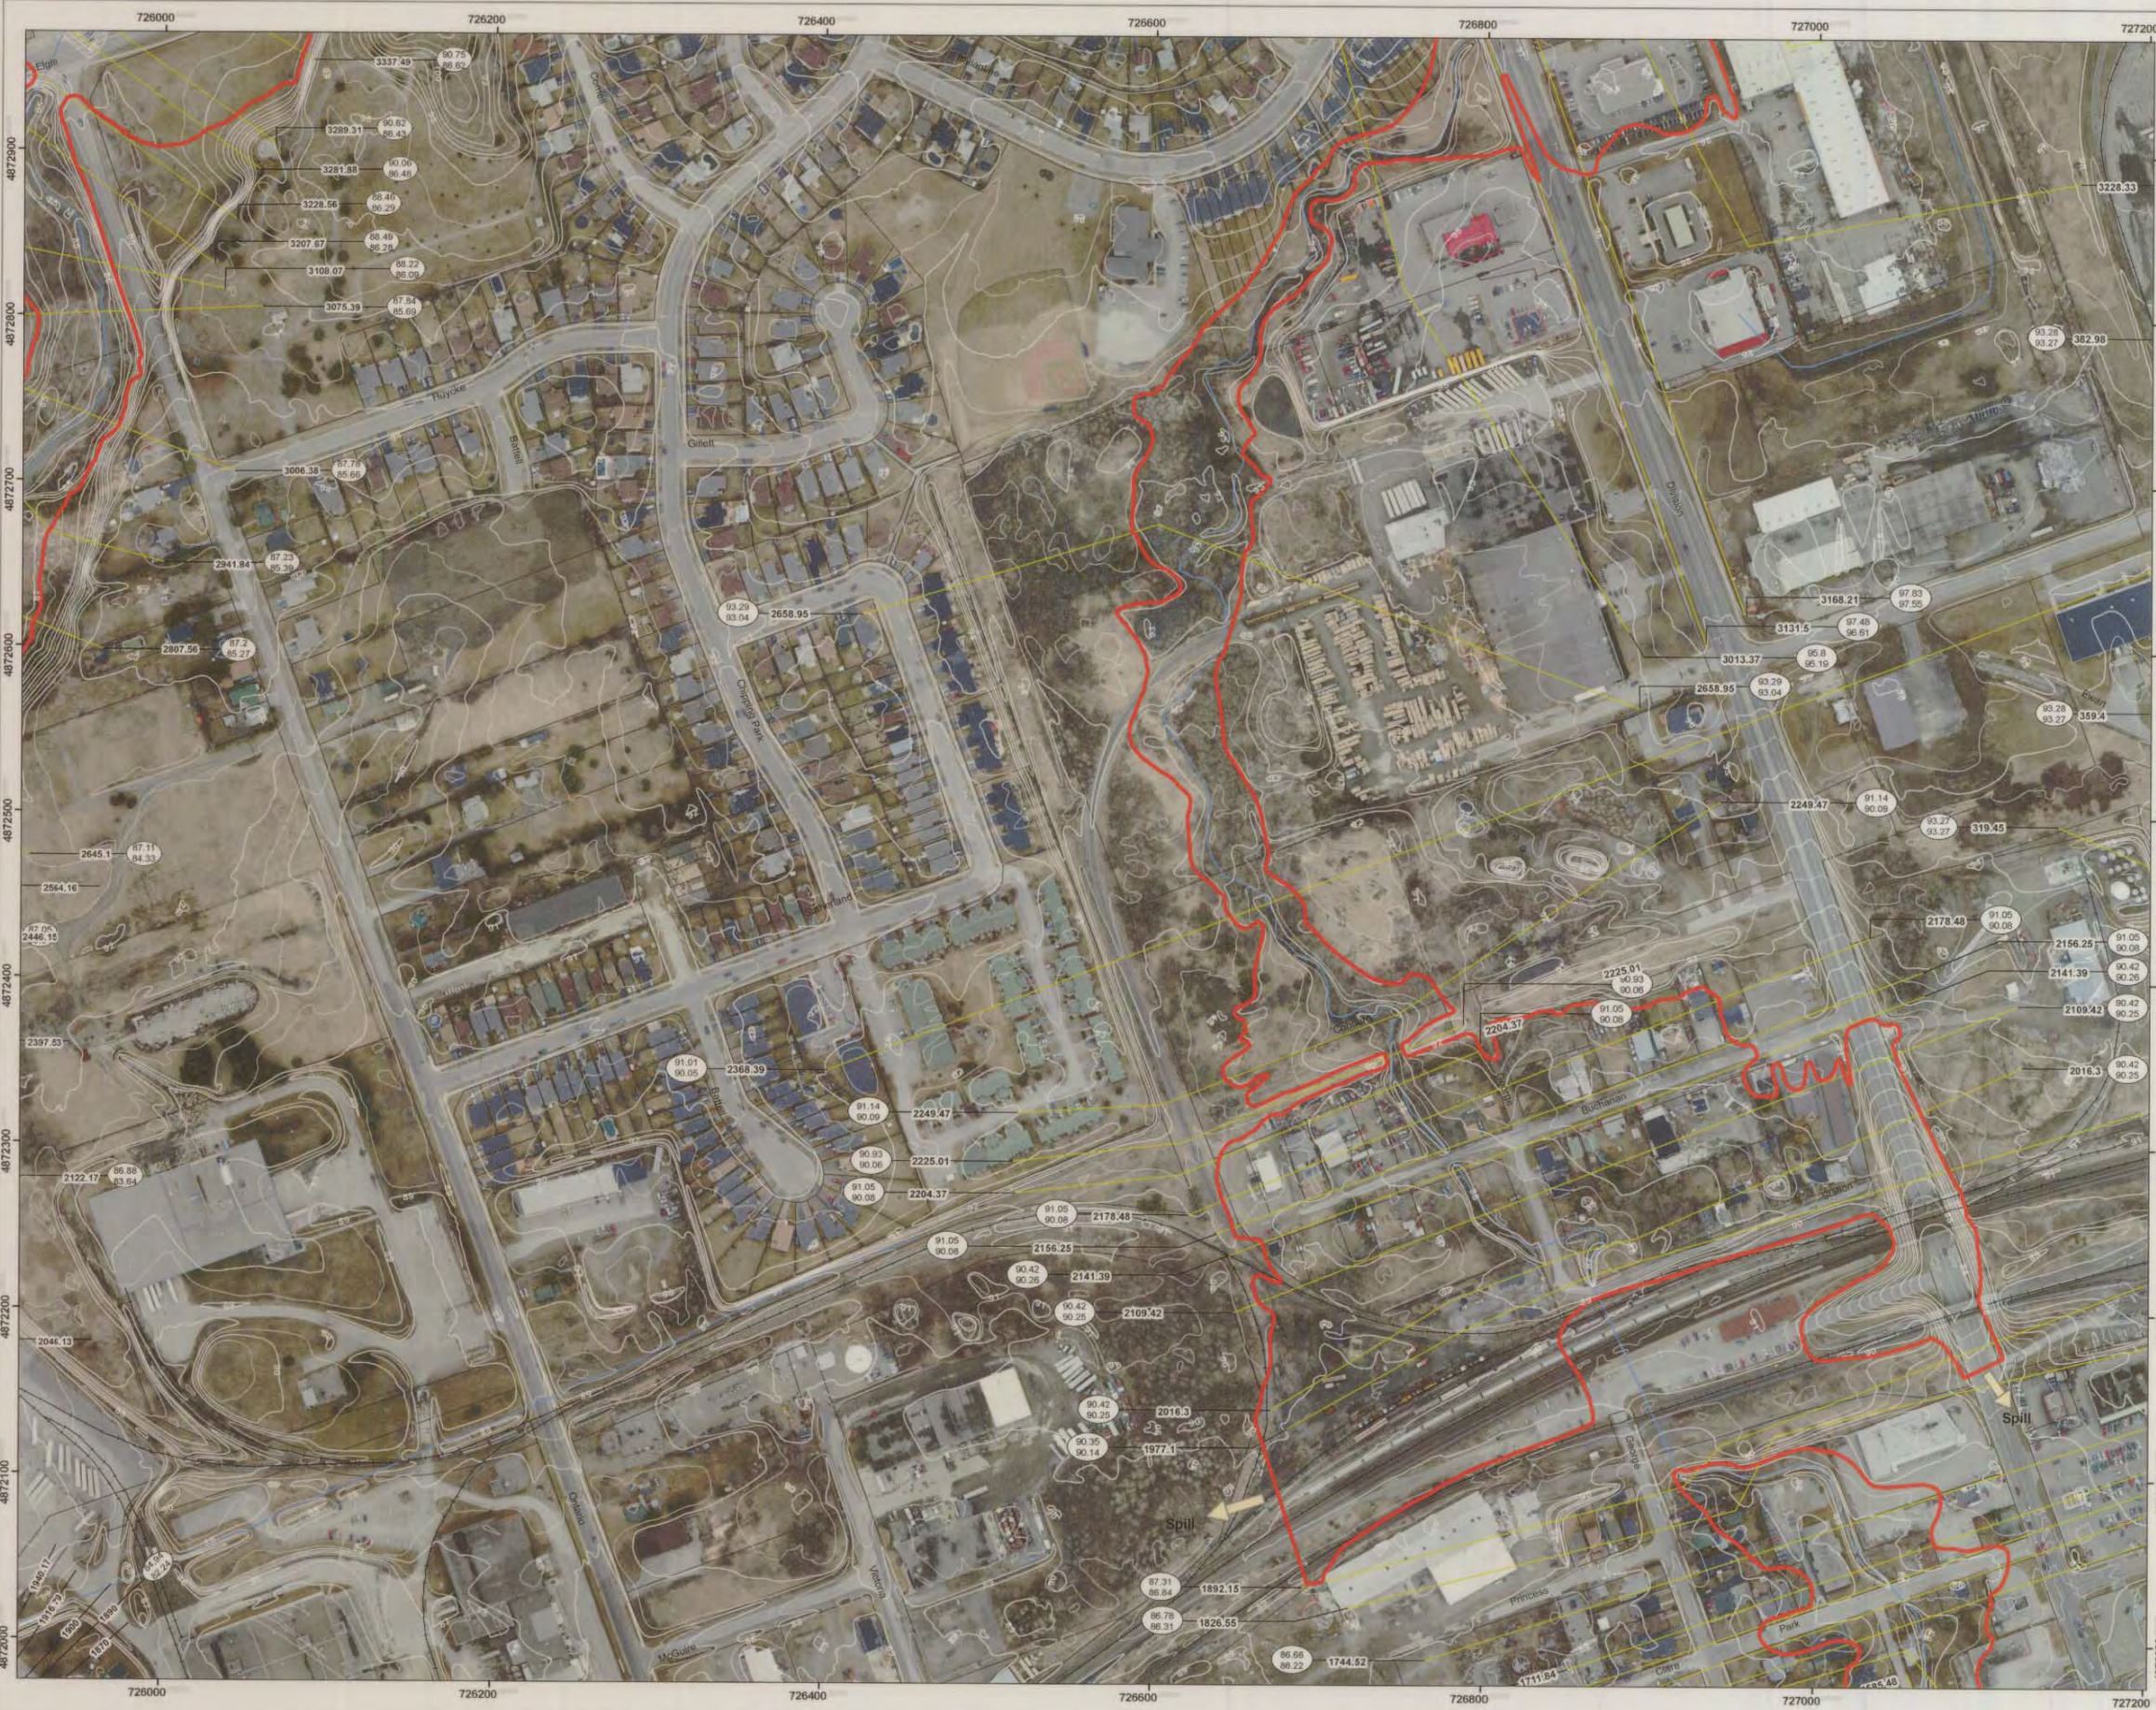
Flood Plain Map Town of Cobourg
Cobourg, Midtown, Brook and Massey Creeks

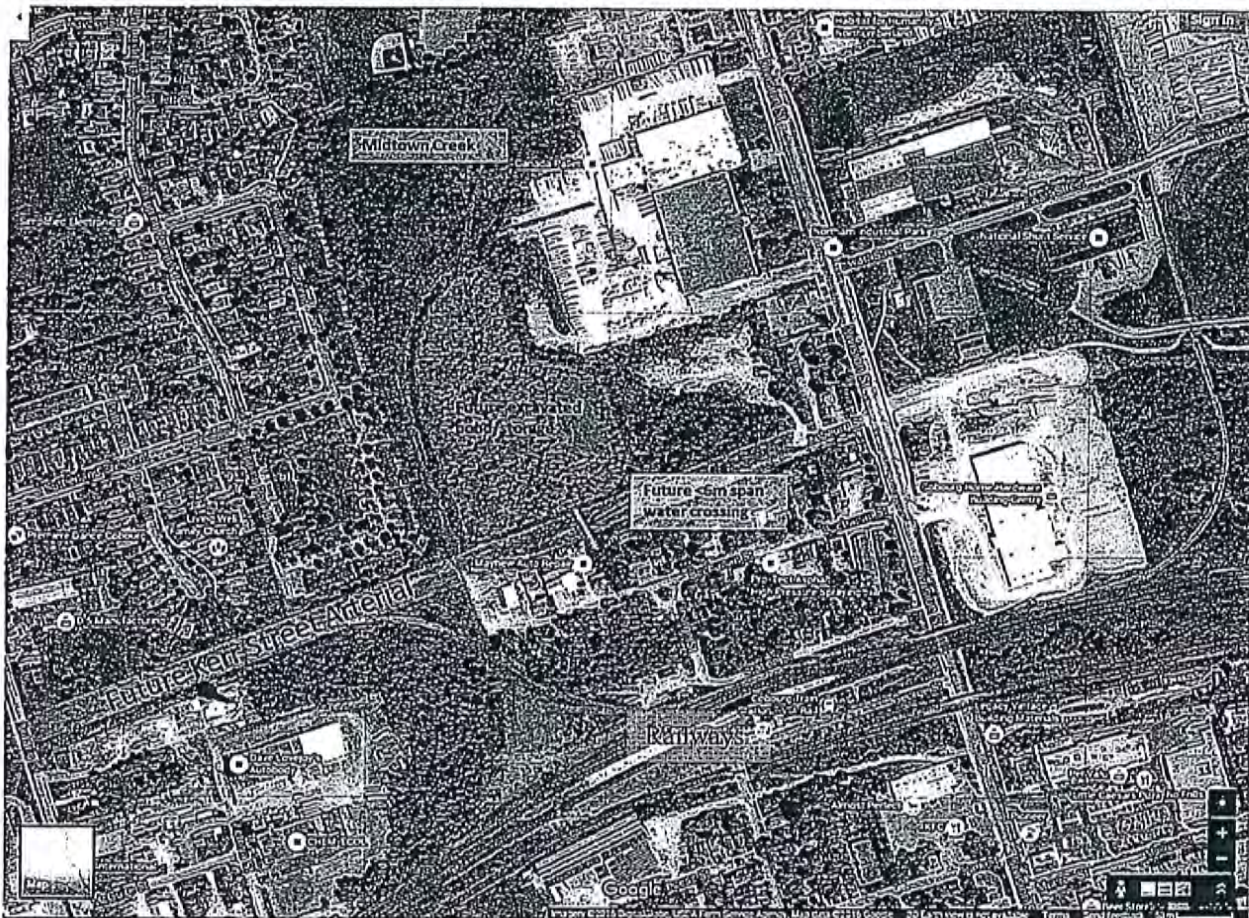
Figure 1: Conceptual Kerr St. Placement and Ponding Area

Please see the following figure illustrating the conceptual design of the works.

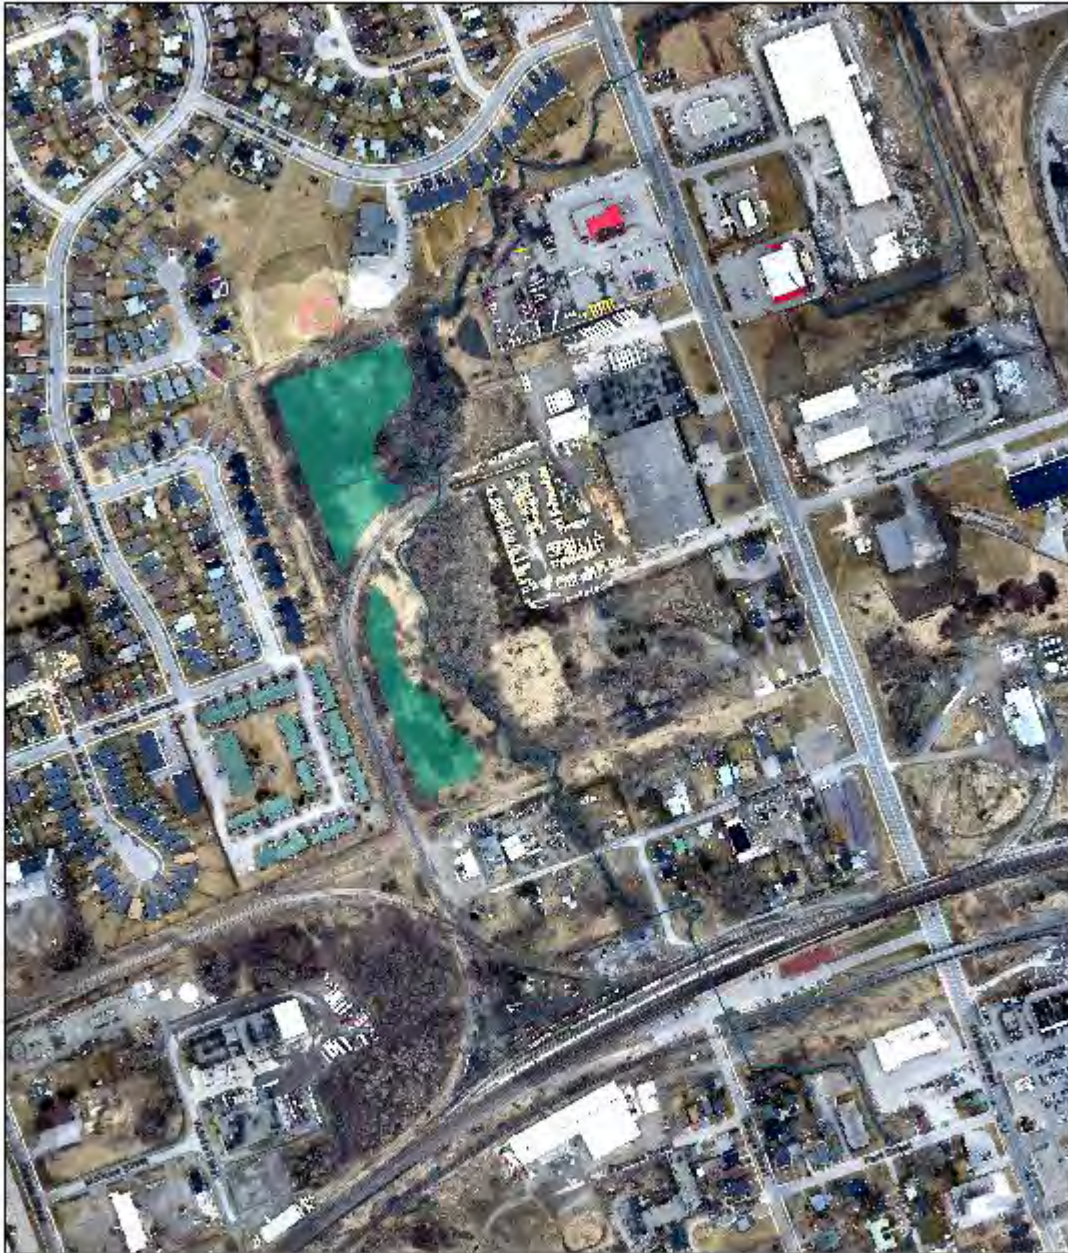
Figure # 4
Offline Ponds Location
2 Pond Scenario

The scenario's benefits are as follows:

- Does not have to rebuild Midtown Creek on Pallet Property
- Does not have to use east side of creek thereby somewhat limiting tree cutting requirements

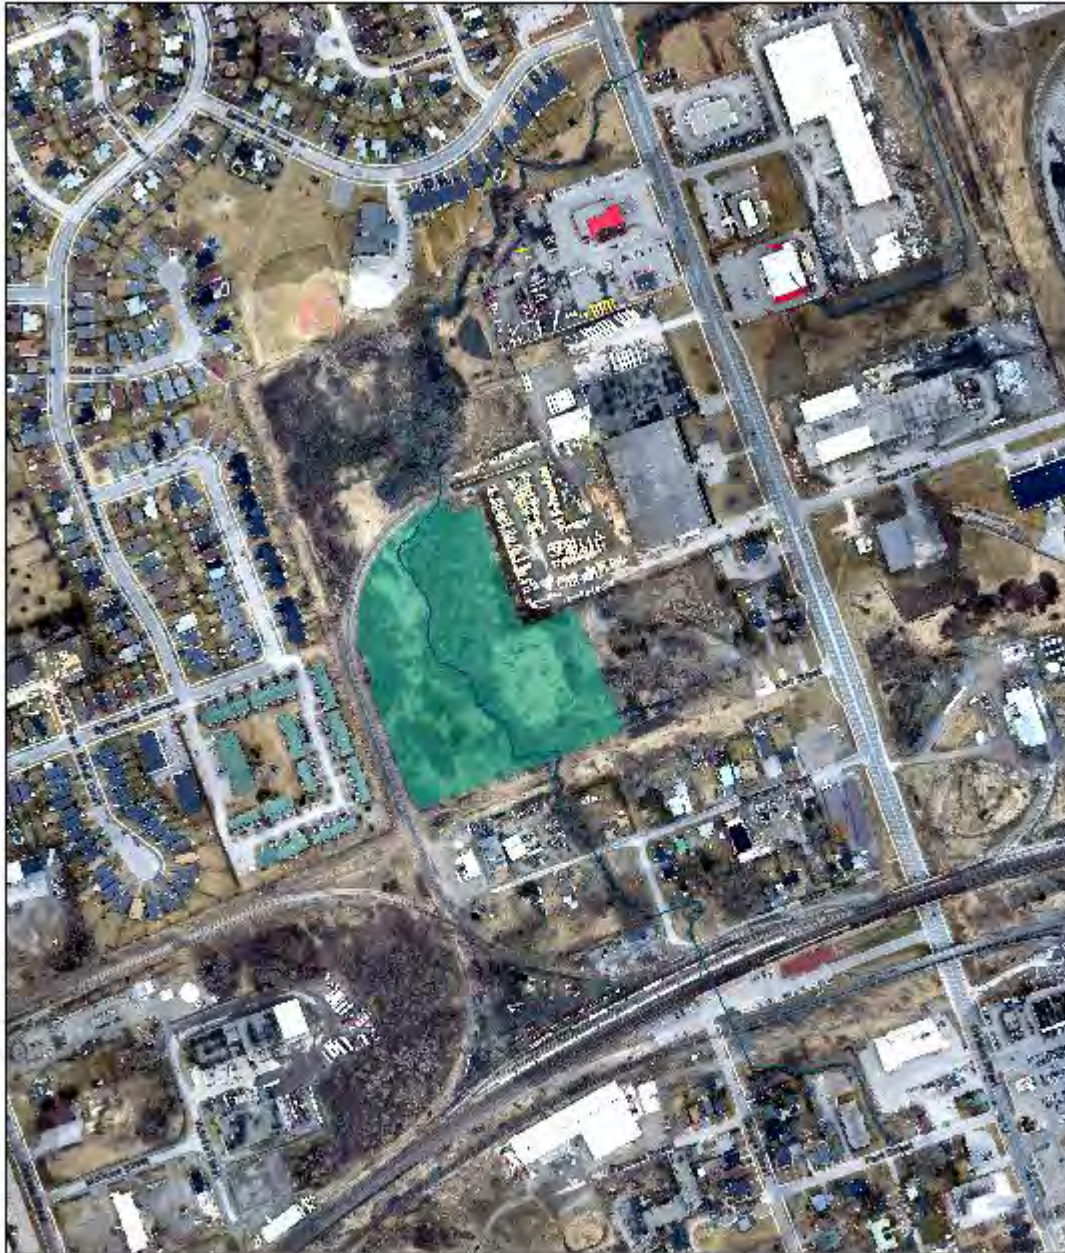
Figure # 5
Online Pond Location

The final on line pond scenario controls outlet discharge to the recommended target 4.1m³/sec – which is the capacity of the Buchanan St Structure. This provides control of all storms including the 5 year to 100 year storm flows. **Figure 5** shows the general layout of the on line pond design.

Benefits of this scenario:

- Meets flow targets
- Access off of Kerr Street
- Does not include use of flooded area north of spur line (north pond area)

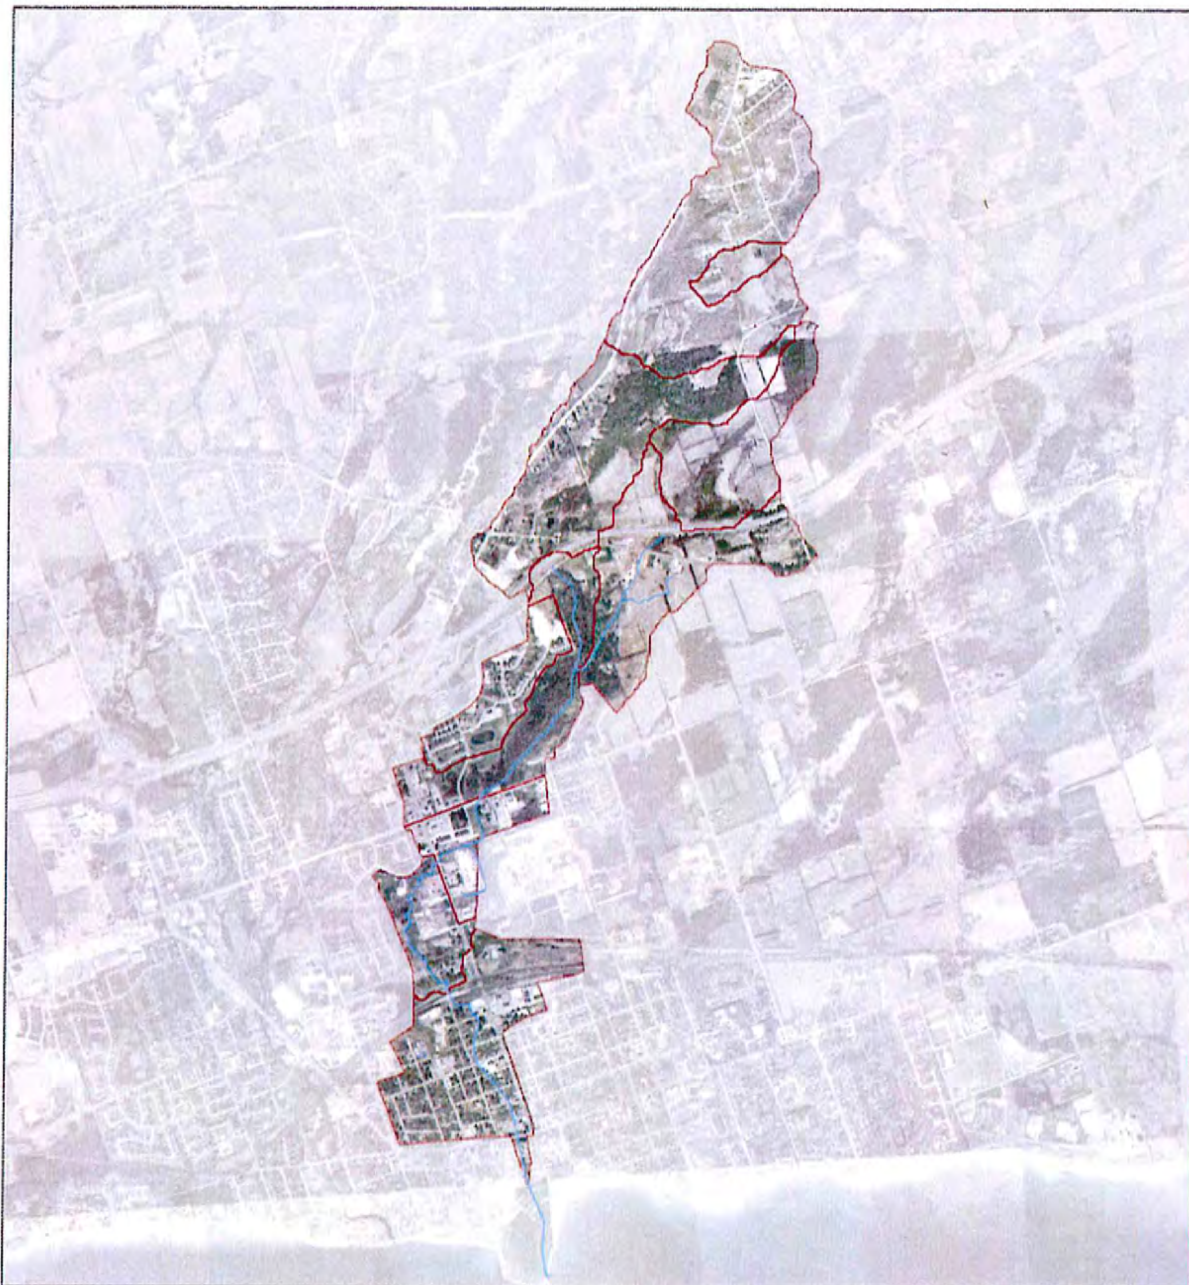
Figure 1
Midtown Creek Watershed

The following report provides a review of a possible a flood control pond within the Midtown Creek catchment in the Town of Cobourg. The upper portion of the creek's catchment is mainly rural in a neighbouring municipality. The lower section of Midtown Creek passes through heavily developed land to Lake Ontario. Refer to **Figure 1**.

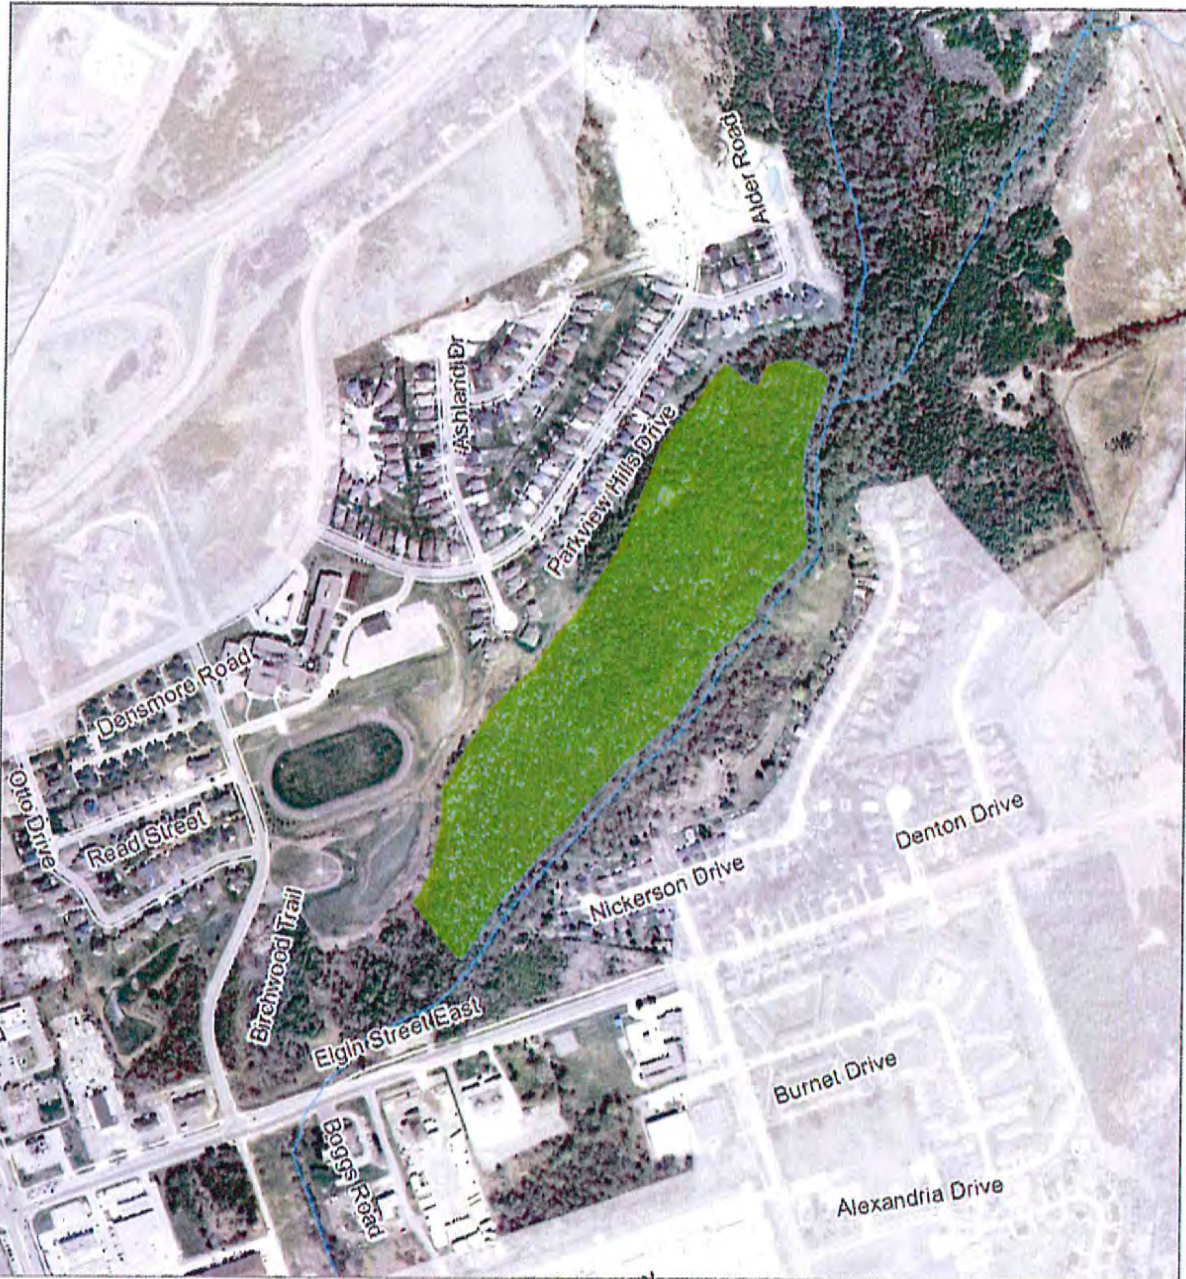
Figure 6
Pond Location

Figure 6 shows the general location of the off-line pond option, while **Figure 7** shows the preliminary grading for the pond. The base for the map is the scanned 1:2000 Ortho imagery rectified to the detailed LIDAR survey of the Town of Cobourg.

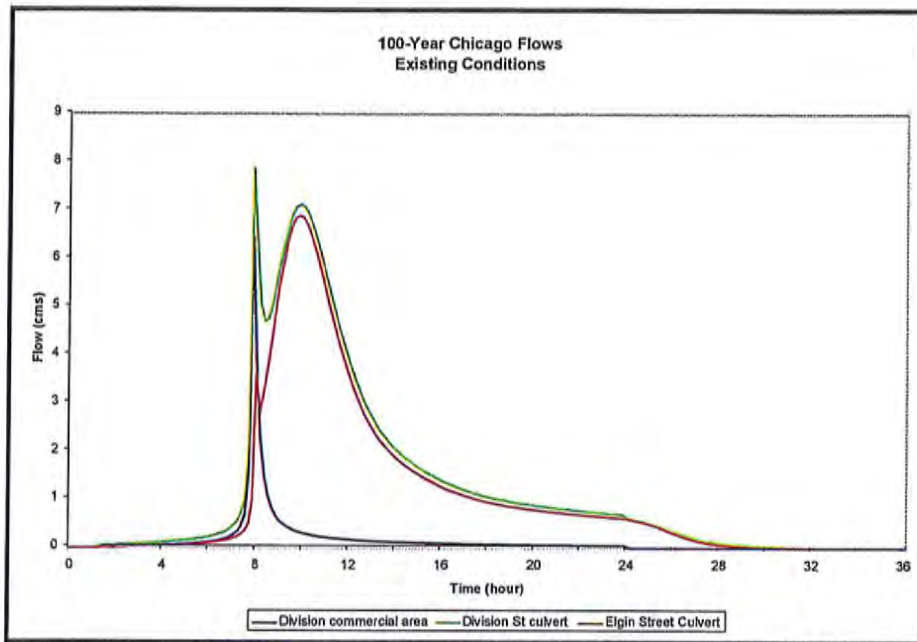
Figure 8: 100-year Flows (existing land use)

No flow attenuation was realized at the Division Street culvert, even though it is only 600m downstream of the Elgin Street crossing. The highly-impervious commercial area centered on the intersection of Division and Elgin Streets drains to the Division Street culvert with no stormwater controls. As can be seen in **Figure 8**, under existing conditions its runoff has the highest peak flow. **Figure 9** demonstrates that even though the pond in Chris Garrett Park is controlling runoff from the upstream 418Ha rural catchment, the immediate response from the 29Ha commercial catchment negates any flood controls in Chris Garrett Park.

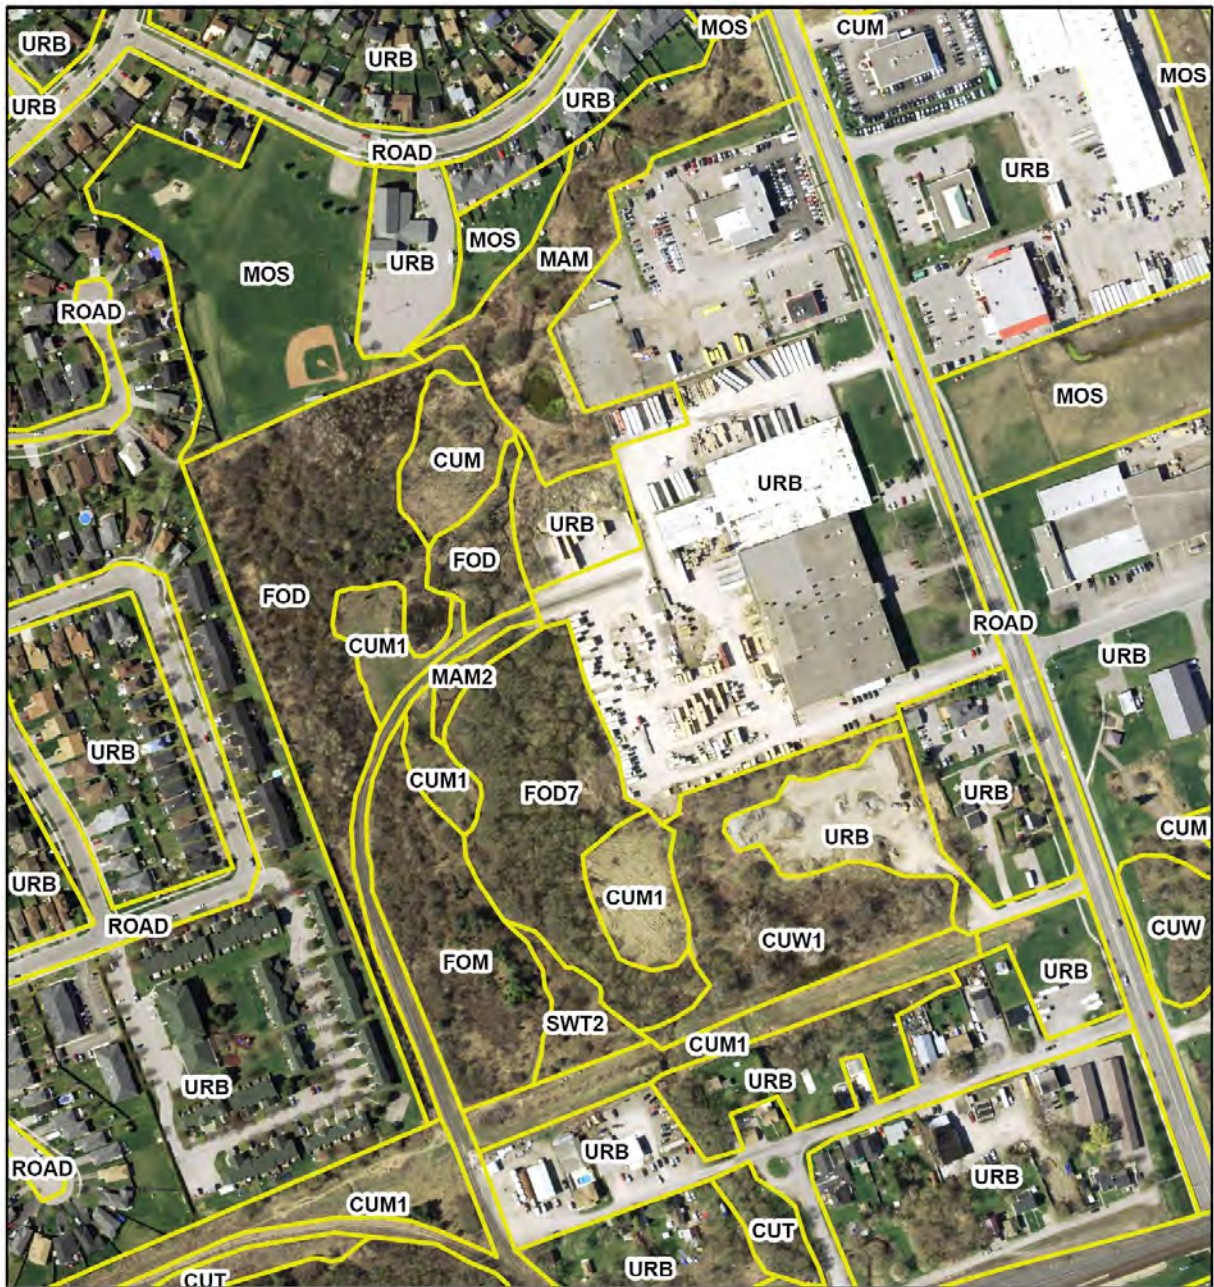
Map #1
Midtown Creek Pond
Area Vegetation Communities

- GRCA ELC
- CUM1 = Mineral Cultural Meadow
- CUW1 = Mineral Cultural Woodland
- FOM = Mixed Forest
- FOD7 = Moist Lowland Deciduous Forest
- MAM2 = Mineral Meadow Marsh
- SWT2 = Mineral Thicket Swamp
- URB = Urban

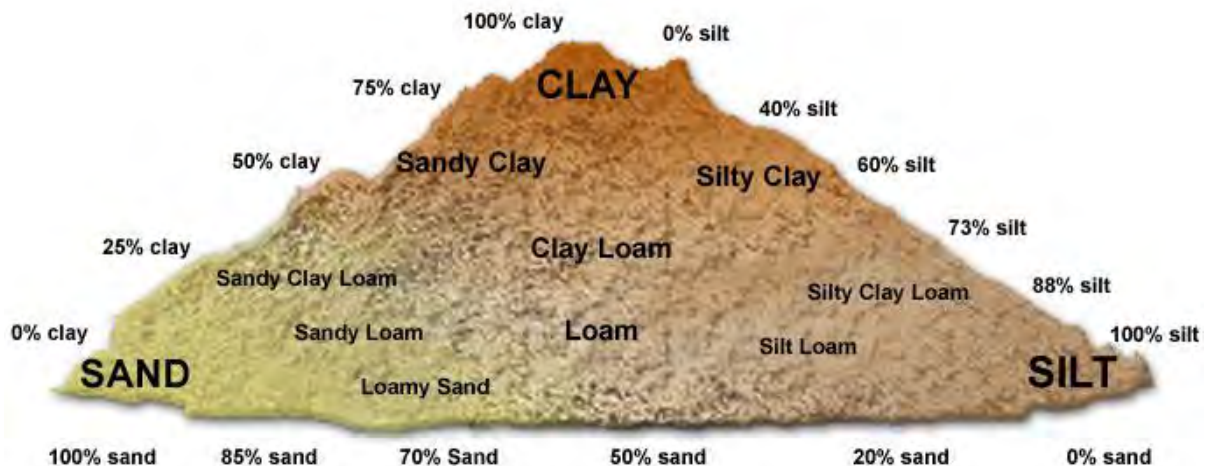
The image below (Kuhlmann, Stacy 2017) shows the consistencies of soil types and how they compare to one another. The lower percentage of clay allows the soil to break up from the action of ploughing alone when not compacted or bound by extensive root masses.

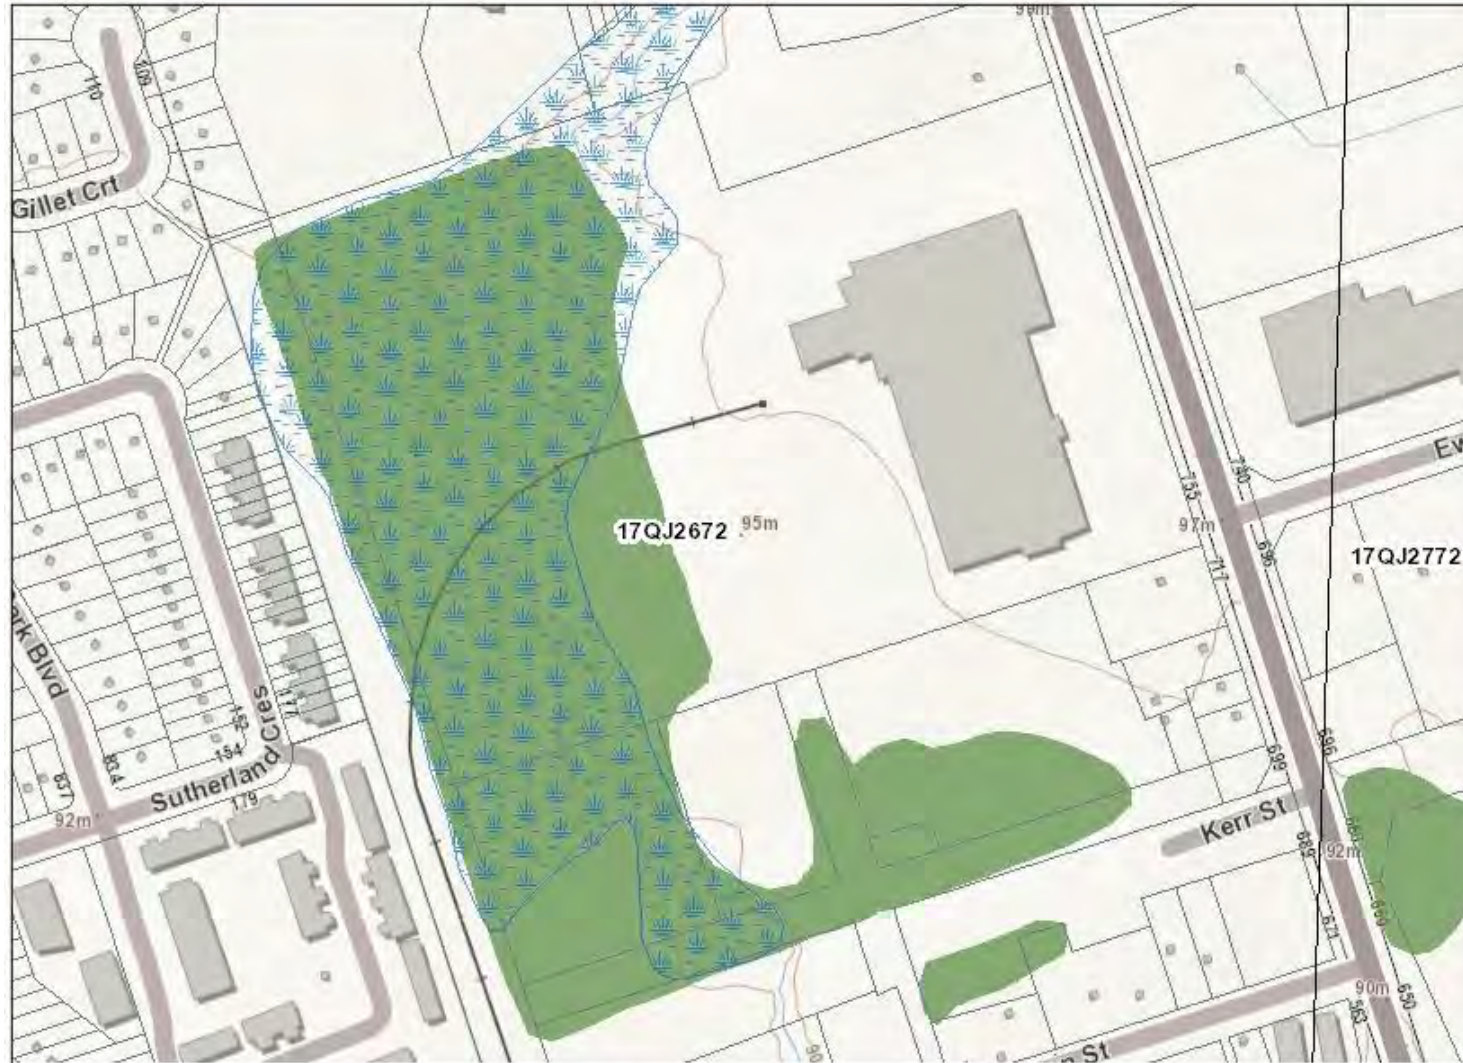
The NHIC database identifies an unevaluated wetland covering a portion of land on the west side of the Study Area (see **Figure 3 – NHIC Map**).

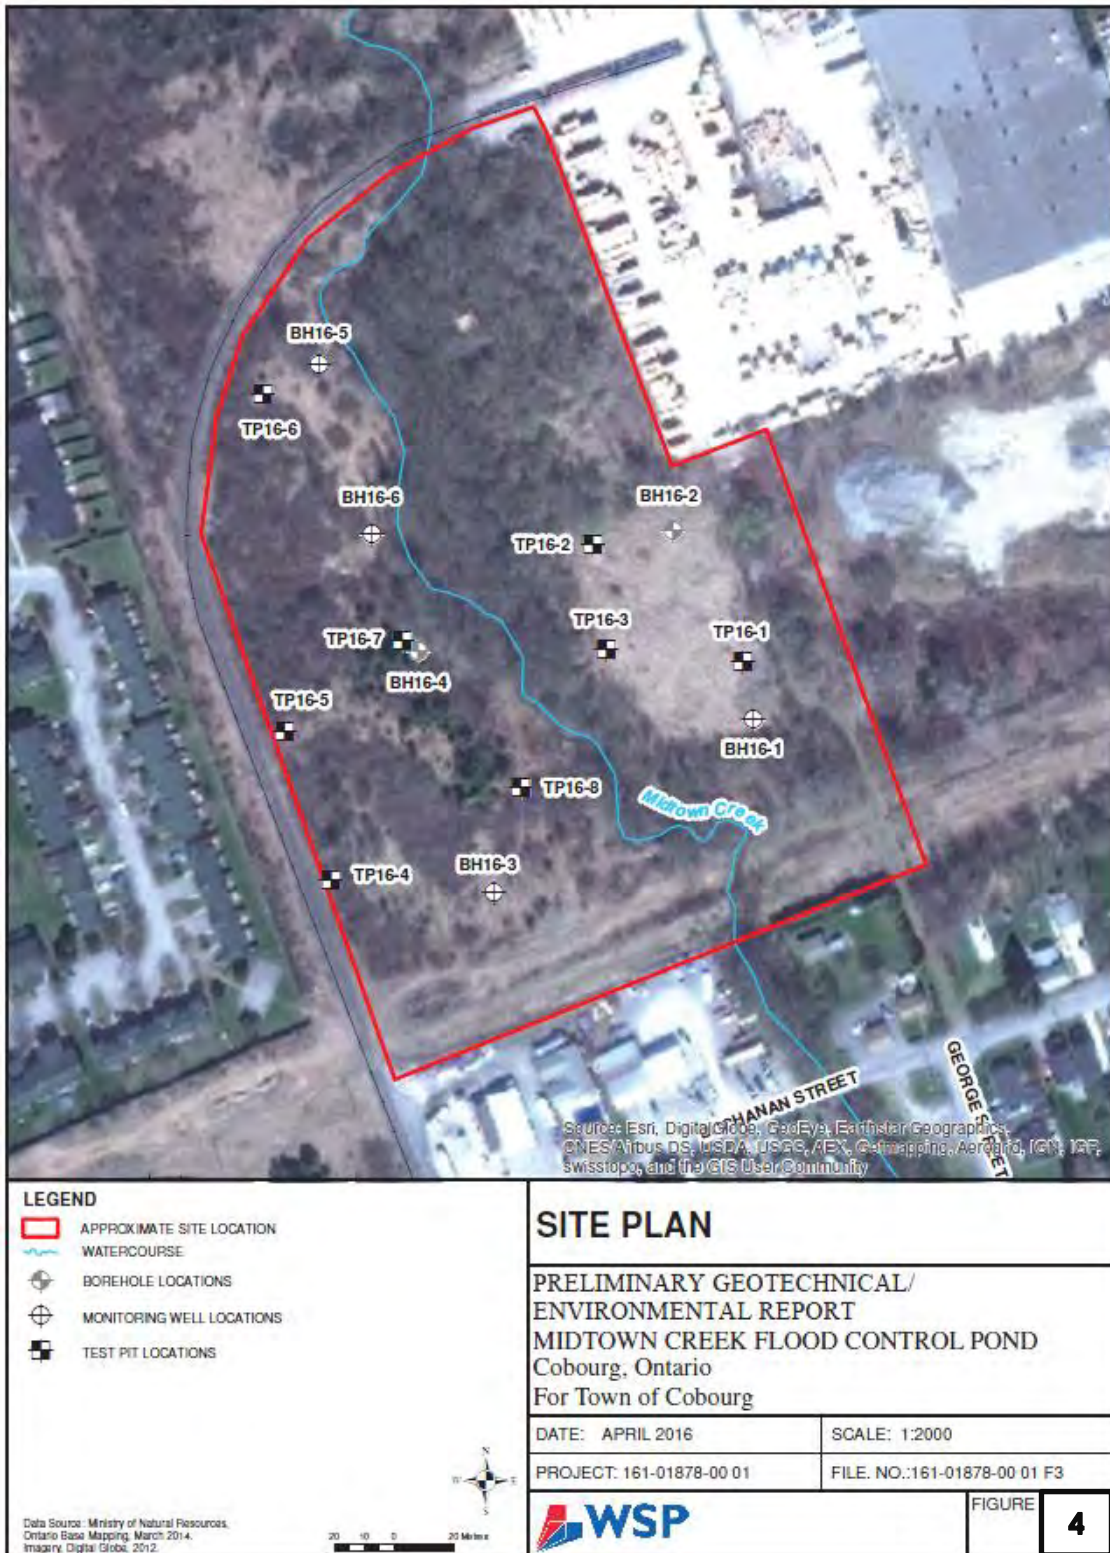
Figure 4 – Borehole and Test Pit Locations (WSP 2016)

A layer of fill material was encountered at TP16-1 and TP16-3 in a grassy clearing that may have been used as a dump site. The fill deposit ranges in thickness from greater than 2.1 m at TP-16-1 to 1.3 m at TP16-3, and consists of silty sand fill containing concrete slabs, bricks, plastic and other construction waste debris. The fill is covered by 150 mm thick concrete and topsoil in these areas.

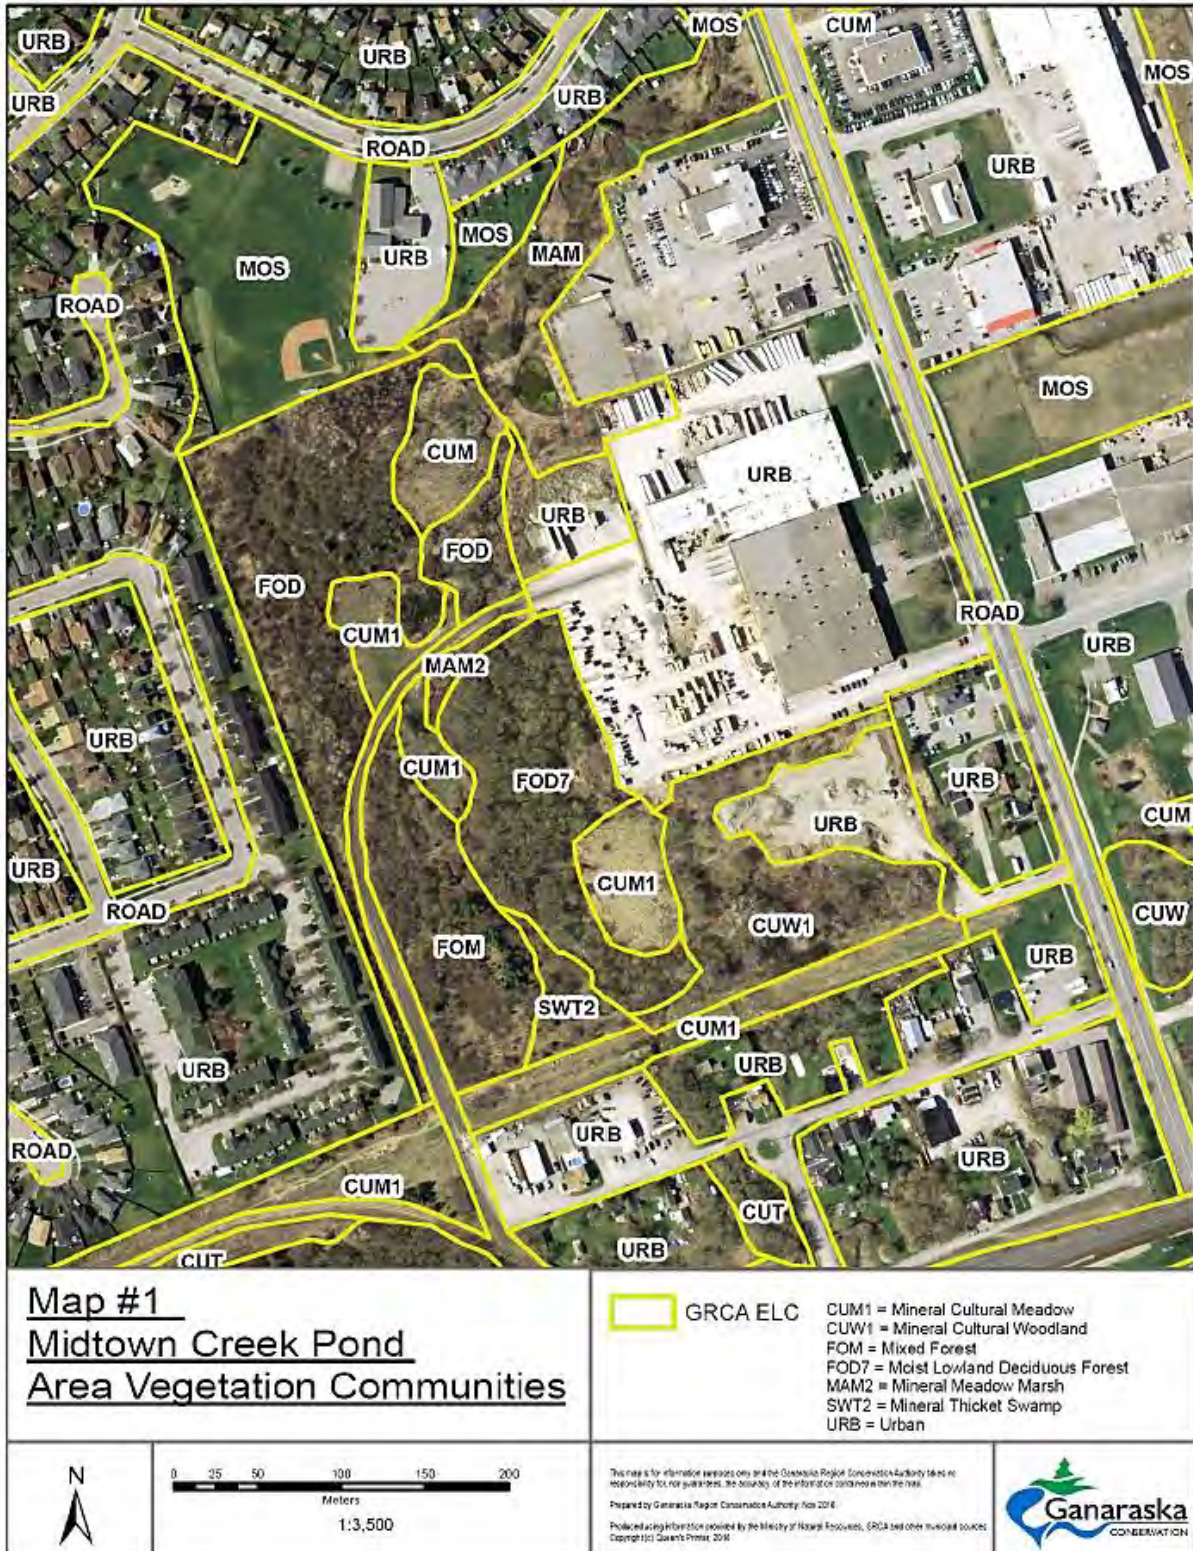
Figure 5 – Ecological Land Classification Map - 2016

This disturbed, culturally-influenced area is the largest vegetation community on the site. Due to the high level of disturbance soils within this area are inconsistent ranging from dry and sandy to loam that is moderately moist. Species range from a mix of grasses and wildflowers such as Black-eyed Susan (*Rudbeckia hirta*) and Spreading

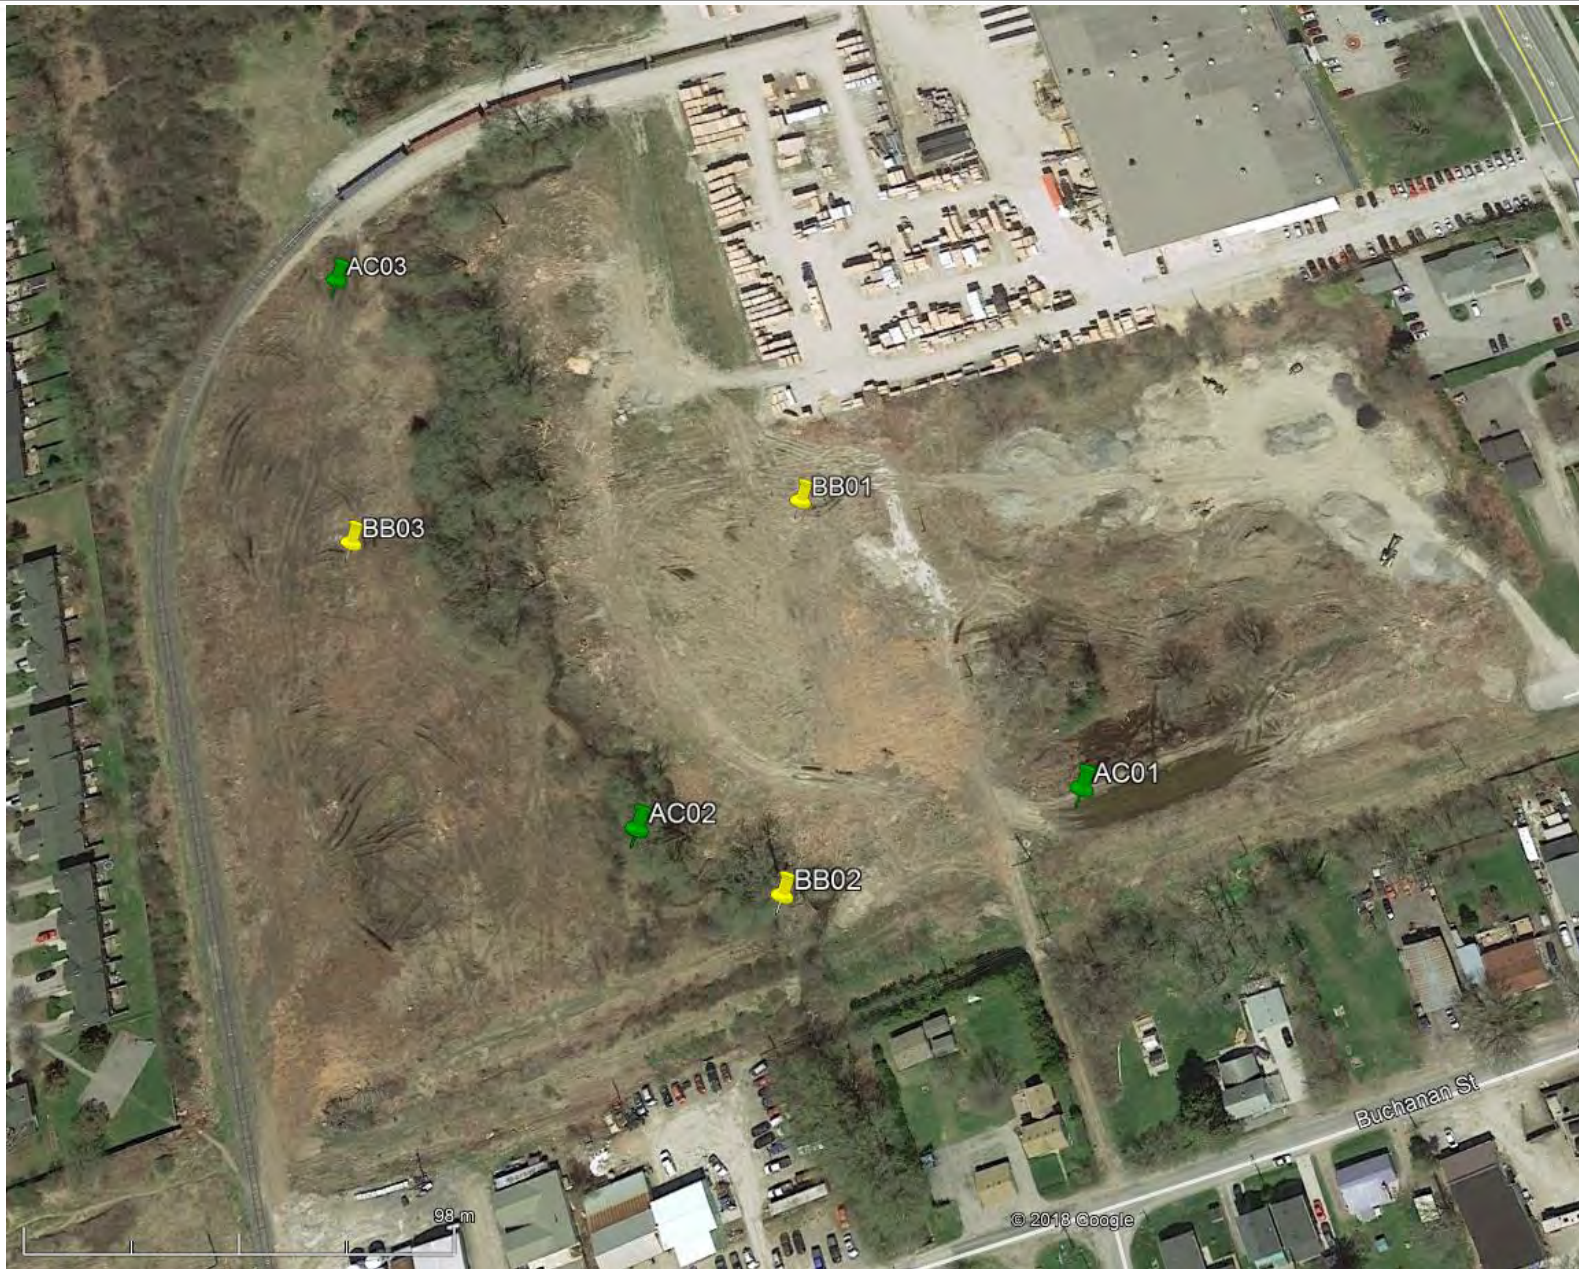
Figure 7
Amphibian and Breeding
Bird Survey Locations

Breeding bird surveys (Surveys) were completed on May 30, 2018 and June 21, 2018 following Ontario Breeding Bird Atlas (OBBA) standard procedures and protocols. Three (3) listening stations were determined prior to arriving at site (**Figure 7 – Amphibian Call and Breeding Bird Survey Locations**) following OBBA protocols. Surveys on May 29, 2018 commenced at 7:58 a.m. and at 8:15 a.m. on June 21, 2018. Audio recordings were taken at each listening station.

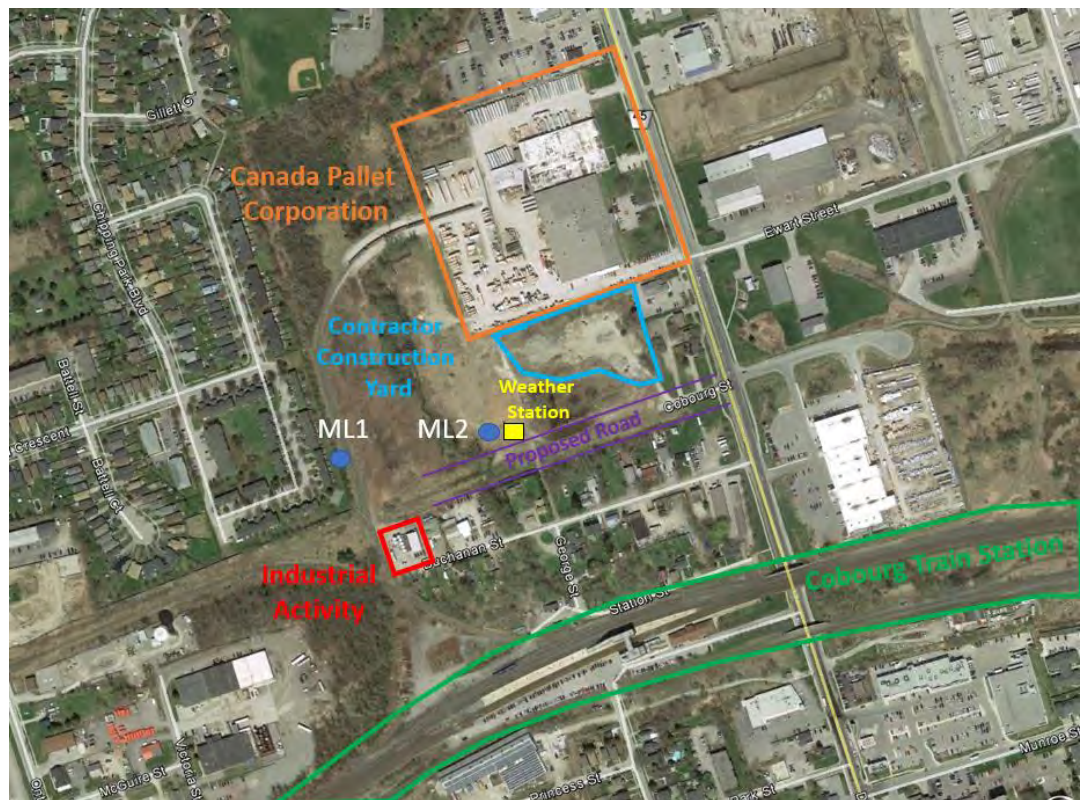
Image 1: Measurement Locations ML1 and ML2 in Relation to Significant Sources of Sound

A Noise Study was completed by RWDI in September 2018. RWDI set up two (2) noise monitoring stations near the residential areas adjacent to the site in order to collect sound level readings. The monitoring found that the sound levels ranged from 47 dBA to 58 dBA. The report concluded that the removal of the trees within the proposed flood ponding area would have a marginal impact on the adjacent residential properties; having a noise level increase of less than 4 dB. Adjacent land owners may
