# Phase Two Environmental Site Assessment

Proposed Mixed-Use Development  
540 King Street East  
Cobourg, Ontario

Report for:  
Sunnyside Village Inc.

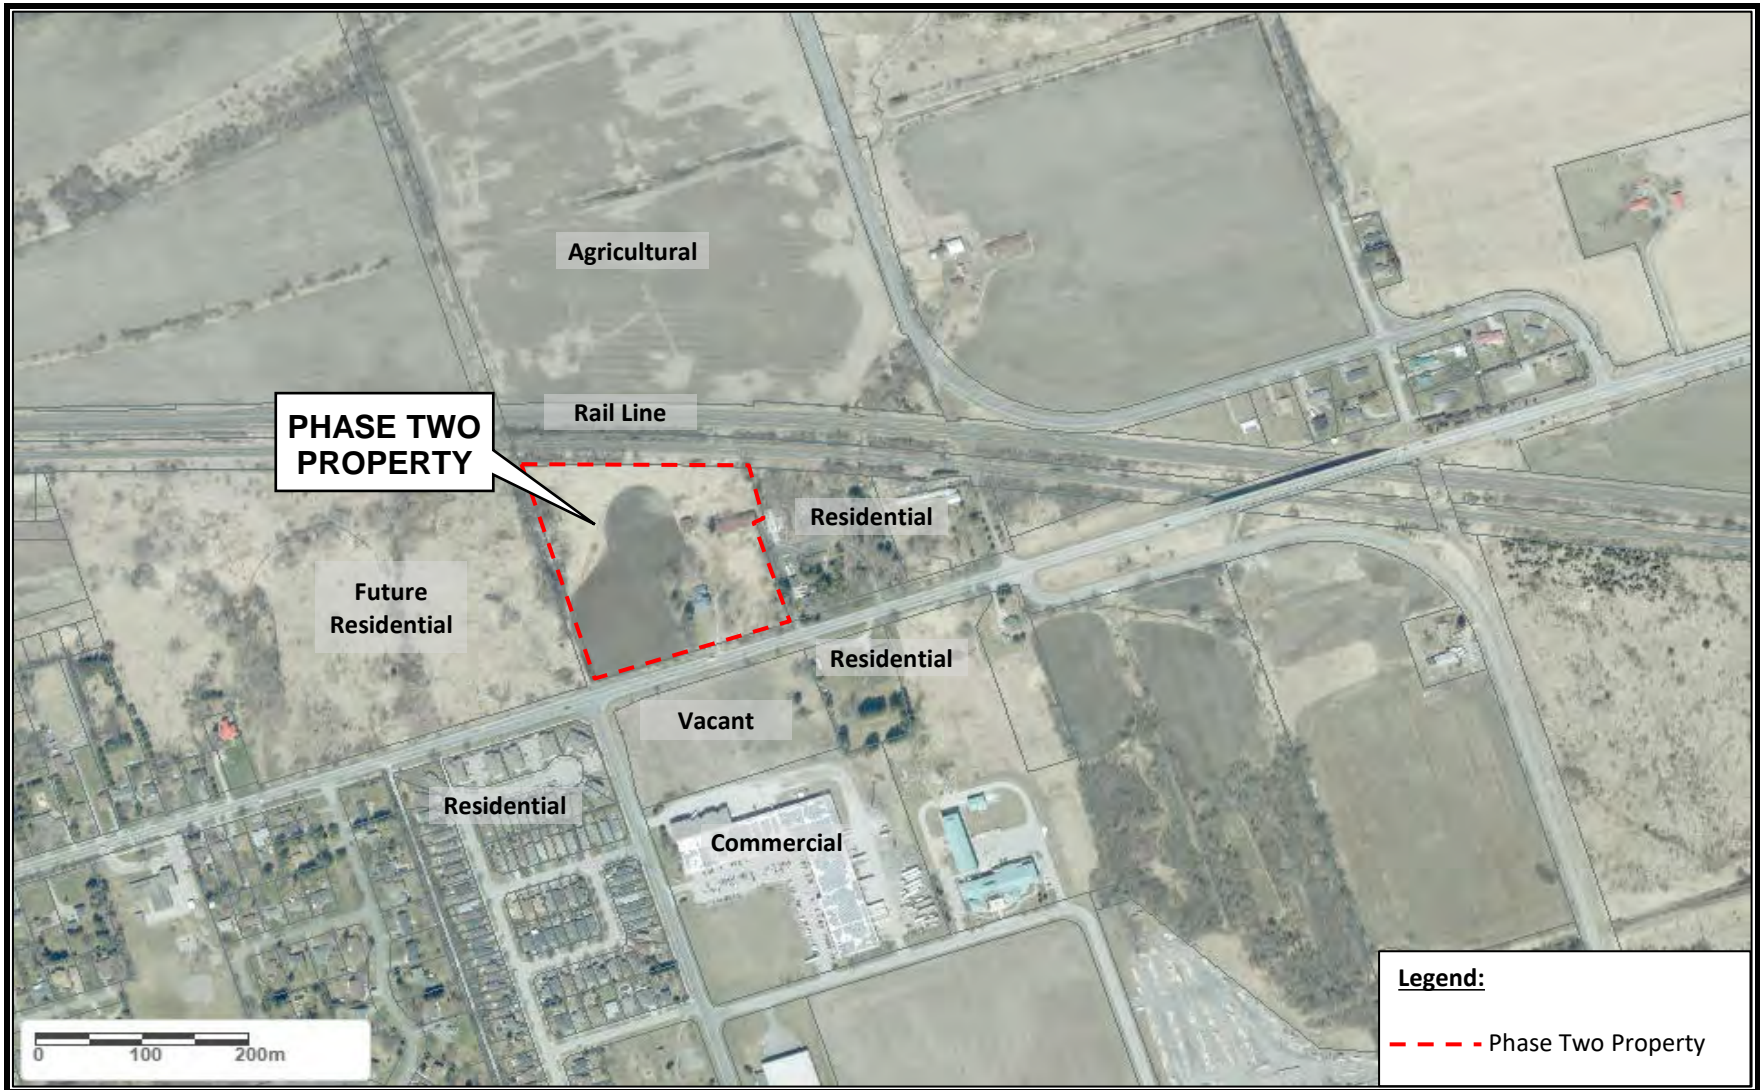
**FIGURE 2**

**Property Plan**

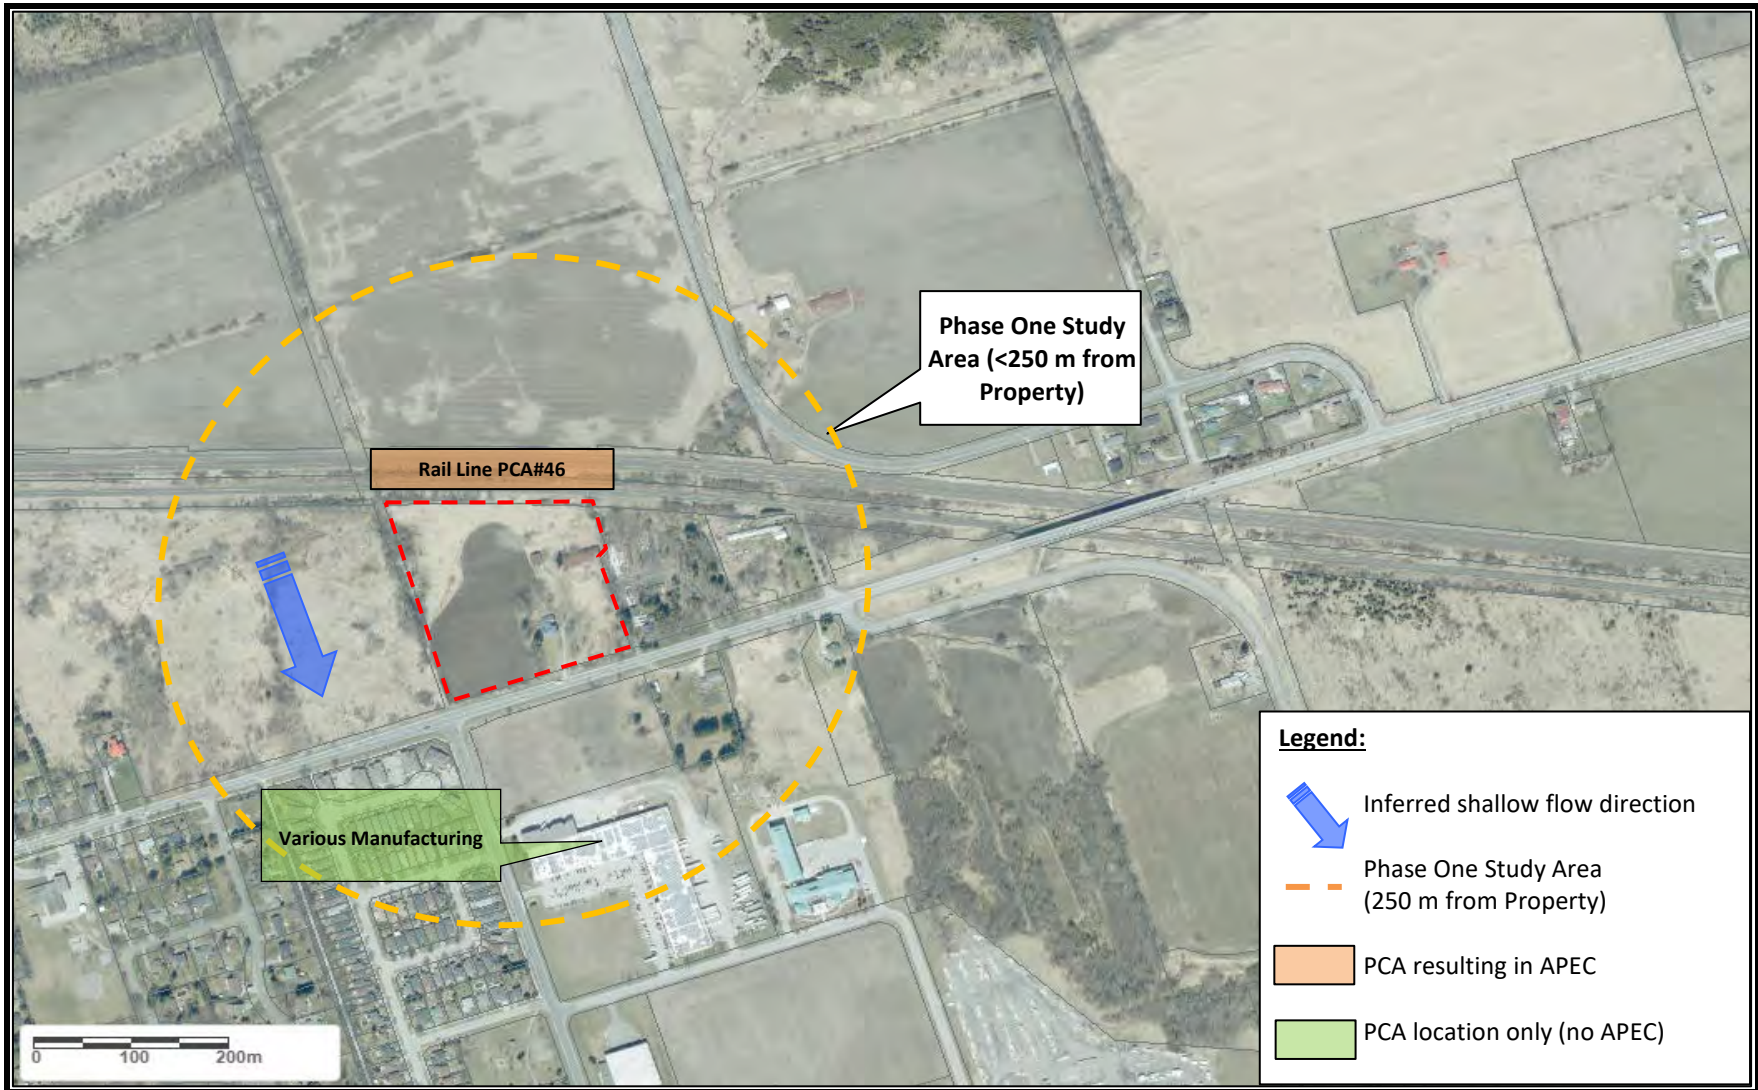
**FIGURE 4**

**CSM - Study Area**

A Phase One conceptual site model is presented on Figures 4 and 5. The model provides a basic overview, basic geological and hydrogeological information and any other pertinent data that may affect the Phase One ESA. The Property is situated within the physiographic region known as the Iroquois Plain (Chapman and Putnam, 1984).

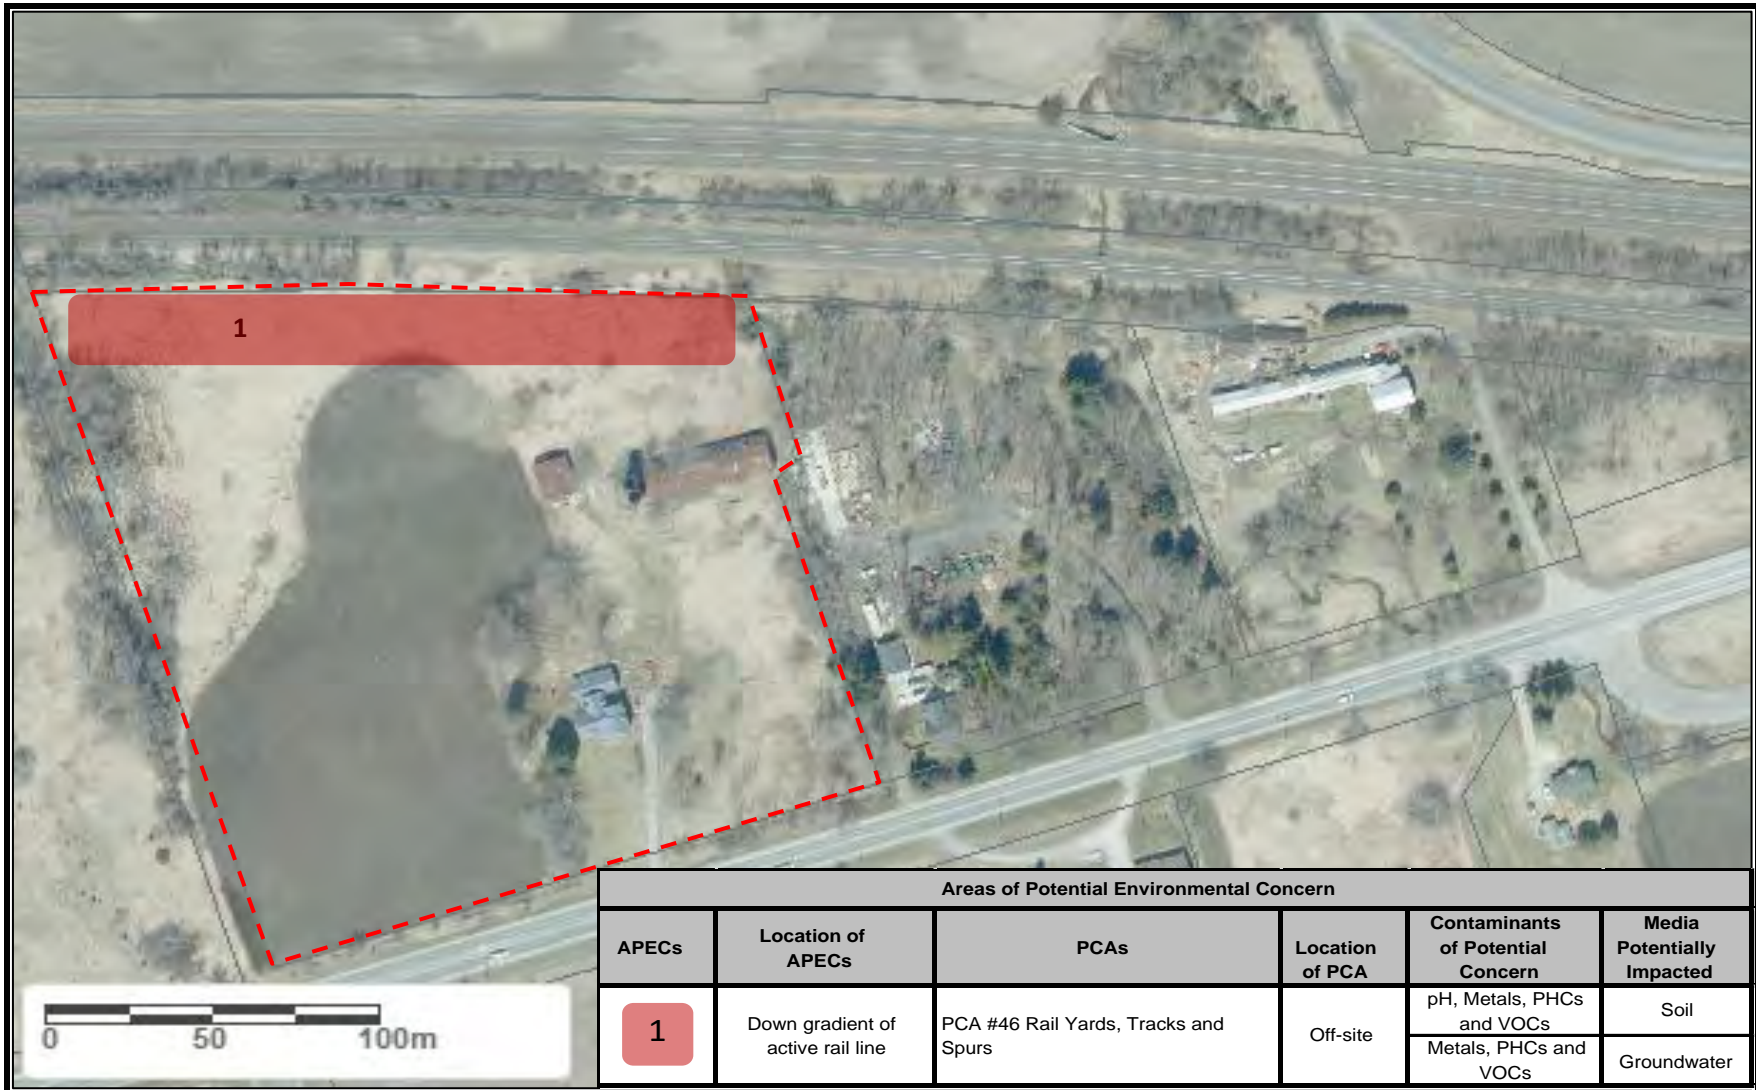
**FIGURE 5**

**CSM - Property**

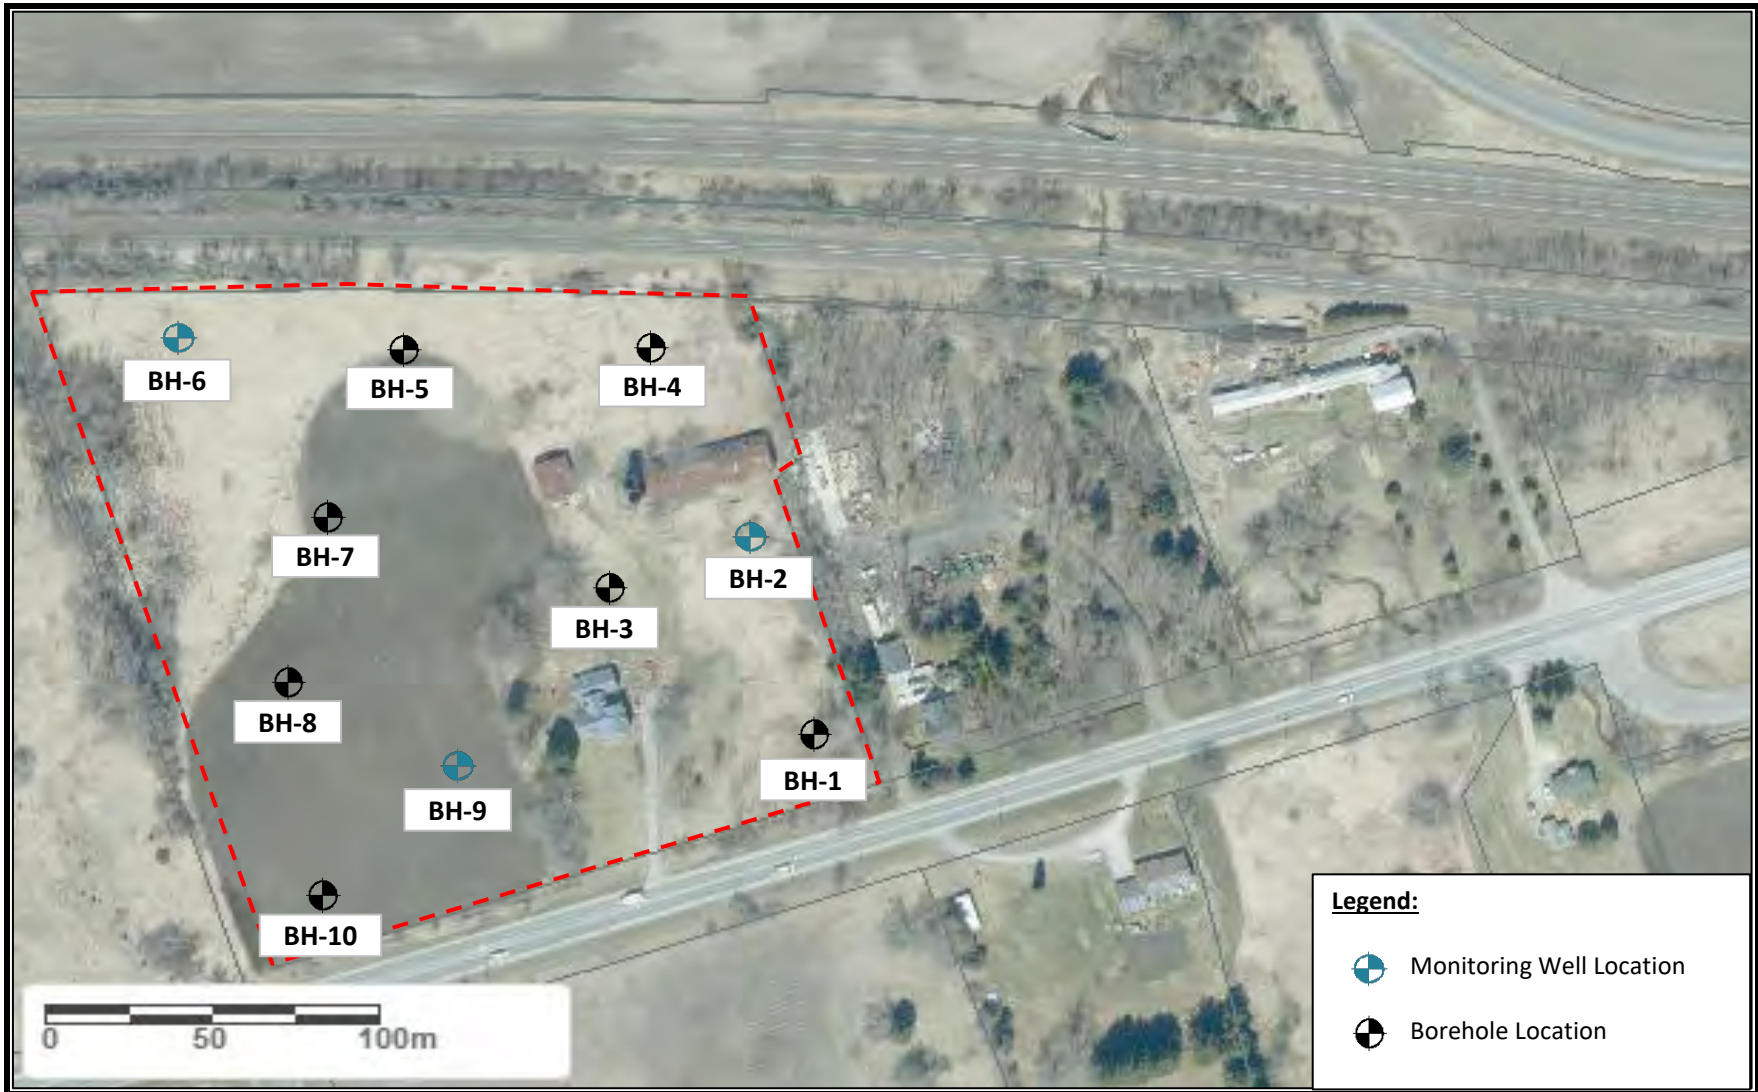
## FIGURE 6

## Test Hole Plan

The Phase Two investigation locations are presented on the Test Hole Plan, Figure 6. The following scope of work was conducted during the Phase Two ESA.

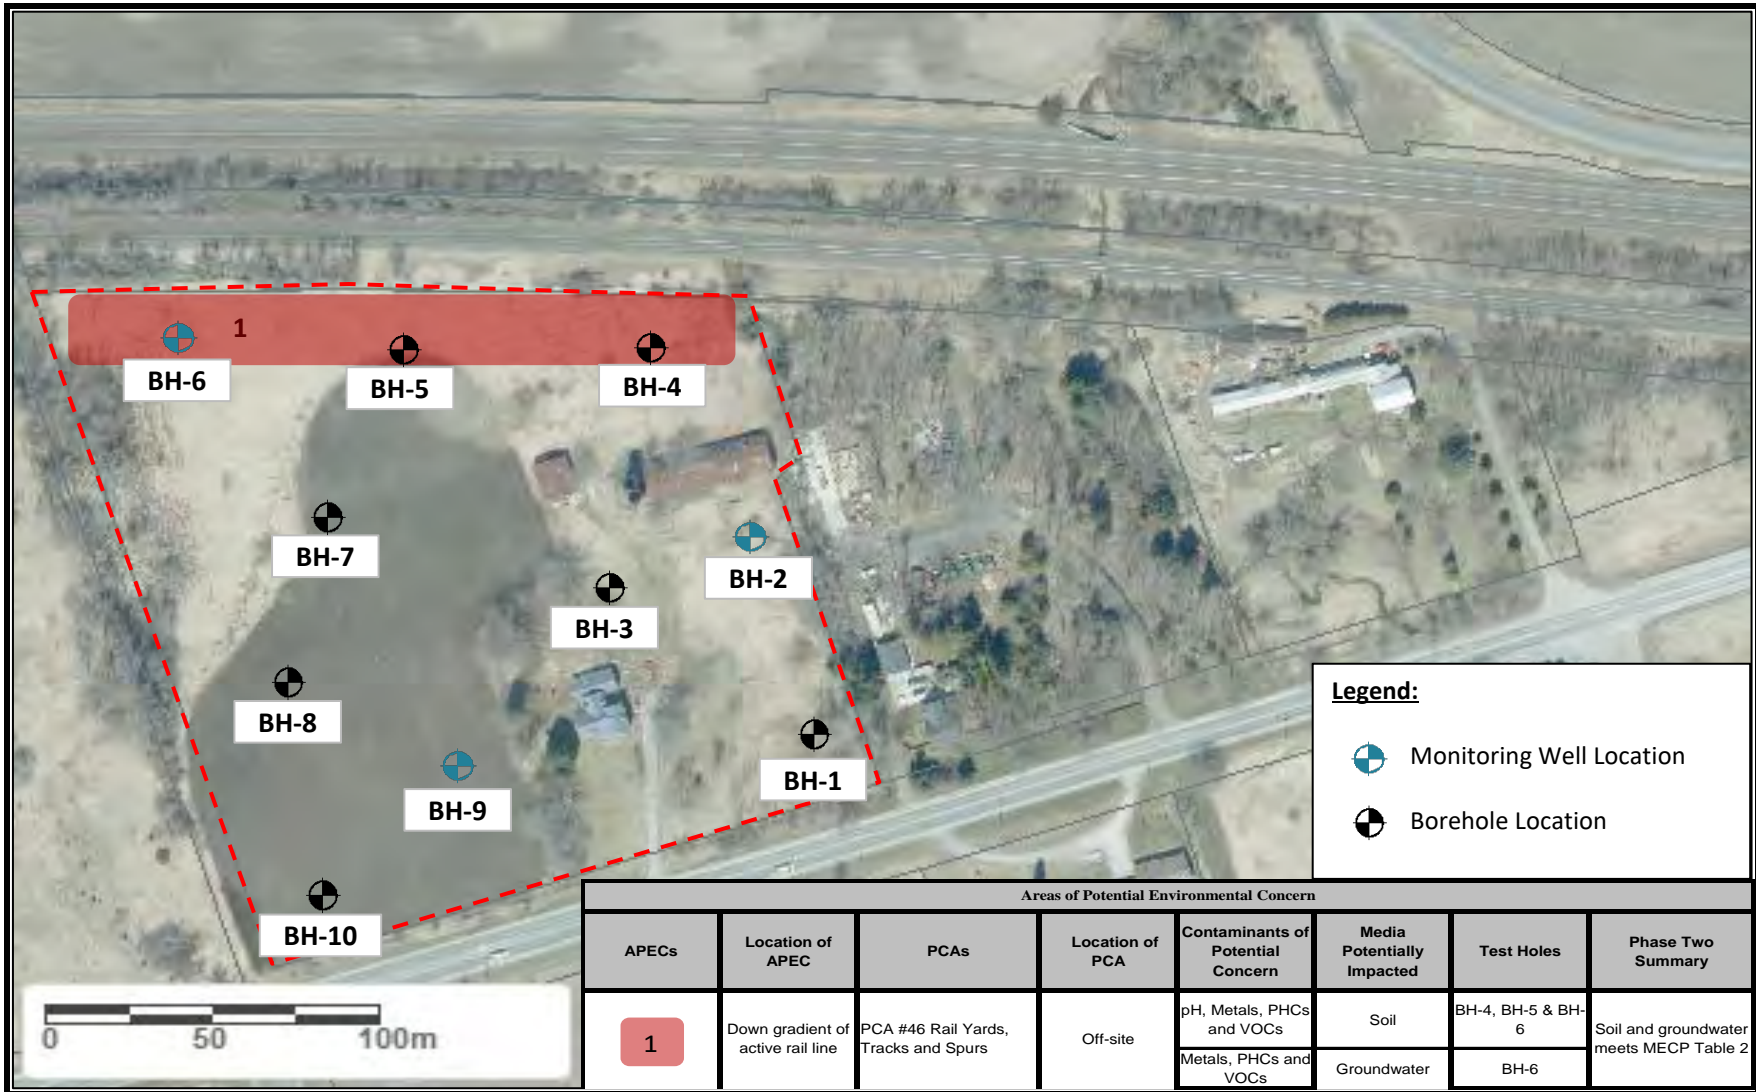
Based on the investigative work completed, a Phase Two conceptual site model has been prepared, and is summarized on Figure 6 showing test hole locations and summary of analytical results. The Phase Two ESA consisted of advancing ten (10) boreholes, including the installation of three (3) monitoring wells. The soil contaminants of concern included pH, metals, PHCs and VOCs. The groundwater contaminants of concern included metals, PHCs and VOCs.

The subsurface exploration program consisted of ten (10) boreholes drilled by GET Drilling Ltd. using a track-mounted drill rig on April 6 and 7, 2020. The boreholes were advanced in the locations illustrated on the Test Hole Plan, Figure 6 and extended to depths ranging from 4.6 to 5.2 metres (m).

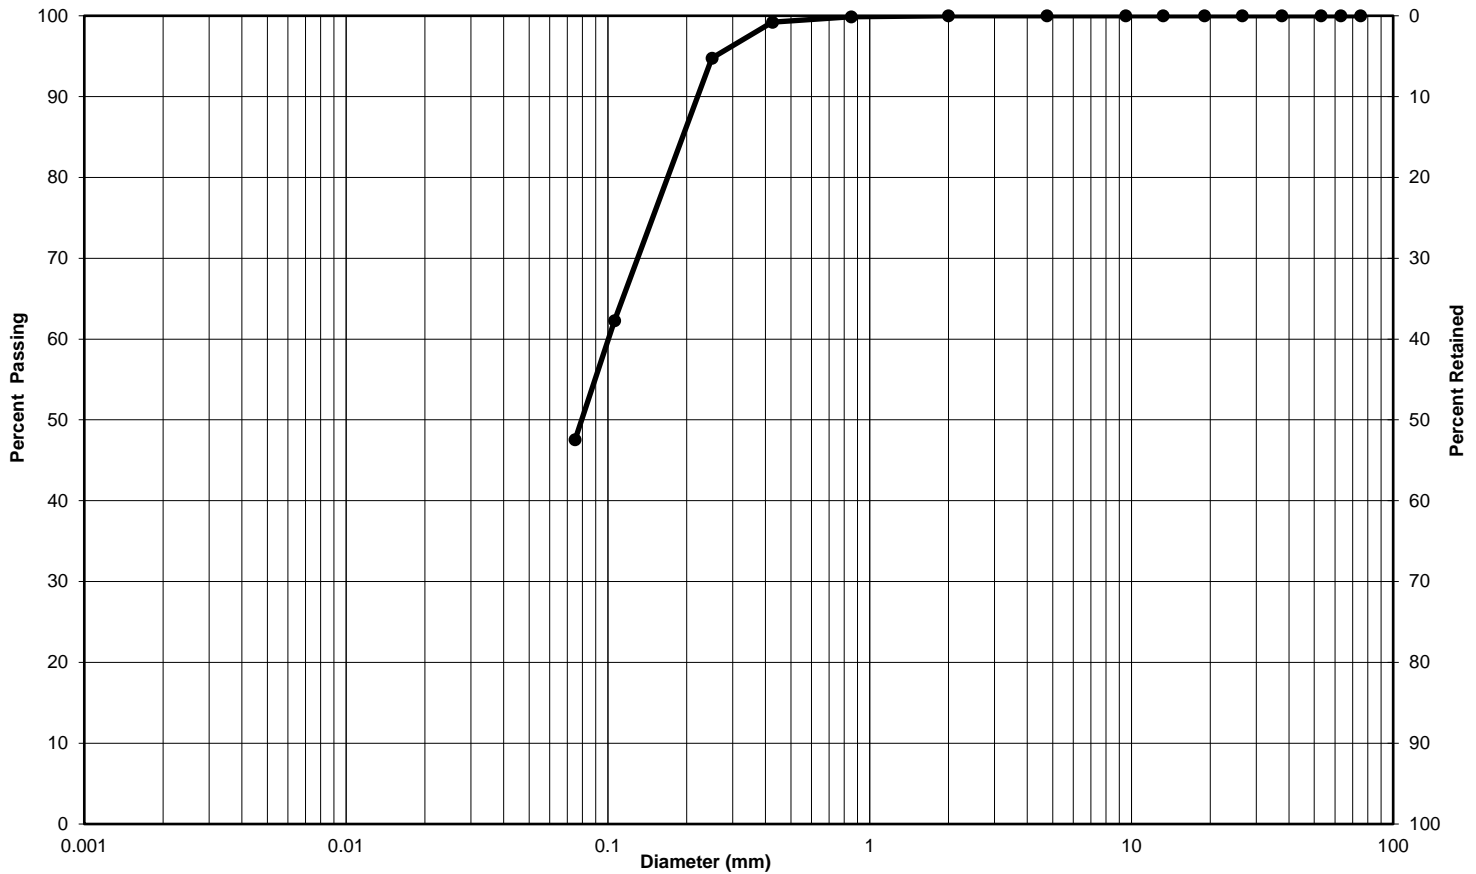
Particle-Size Analysis of Soils (Geotechnical)  
(USCS) (ASTM D422)

<b>Client:</b>	Sunnyside Village Inc.	<b>Lab no.:</b>	SS-20-19
<b>Project/Site:</b>	540 King Street East, Cobourg	<b>Project no.:</b>	11211226-01
<b>Borehole no.:</b>	BH-1	<b>Sample no.:</b>	SS-2
<b>Depth:</b>	2.5-4.5'	<b>Enclosure:</b>	F-11

Soil Description	Gravel	Sand	Clay & Silt
	0	52	48

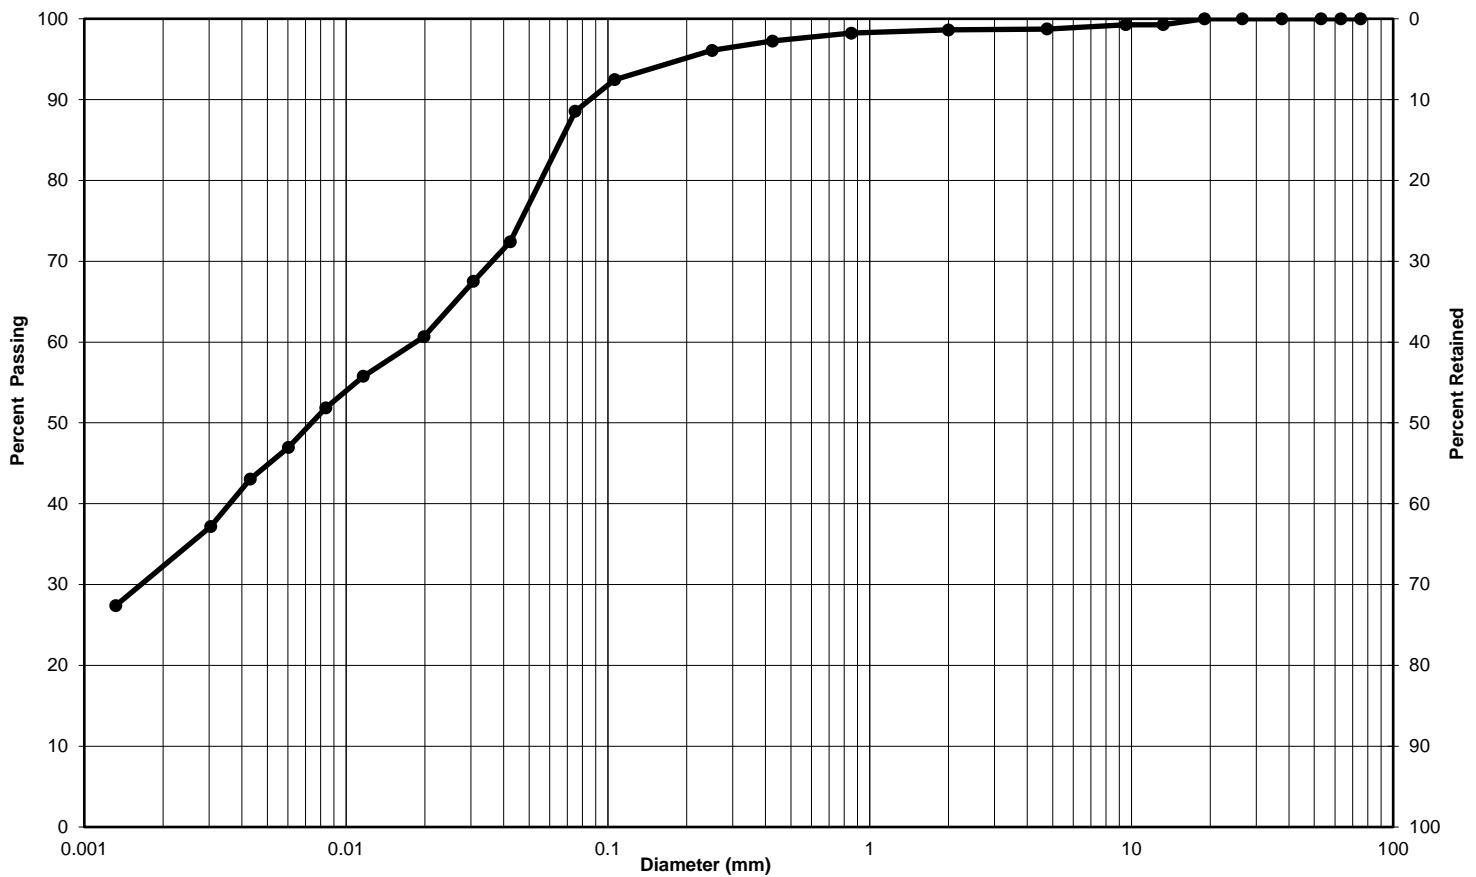
**Borehole no.:** BH-7 **Sample no.:** SS-3  
**Depth:** 5-7' **Enclosure:** F-13

Soil Description	Gravel	Sand	Clay & Silt
	1	10	89

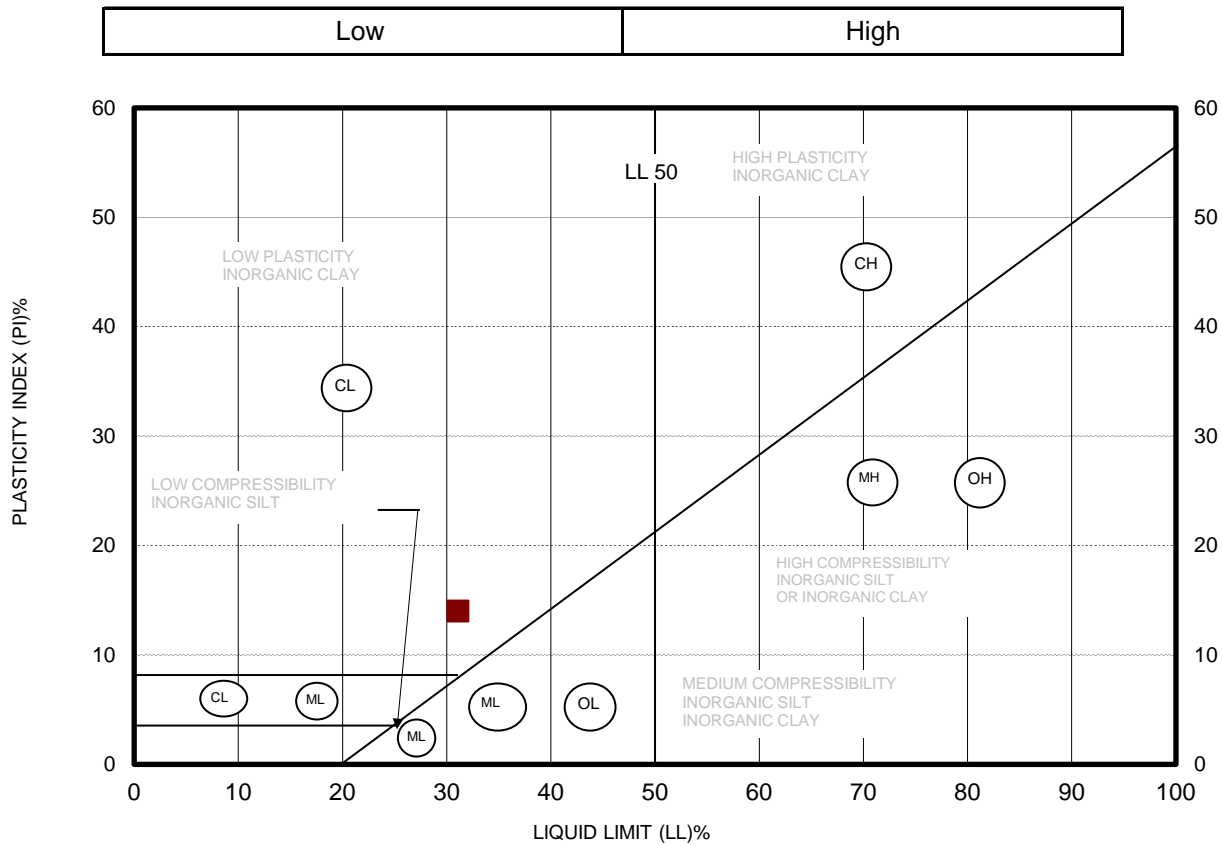
### PLASTICITY CHART

Project Name: 540 King Street East, Cobourg Project No.: 11211226-01  
 Client: Sunnyside Village Inc. Depth: 5-7'  
 Borehole No.: BH-7 Sample No.: SS-3

Symbol	Borehole	Sample	Depth	Sample Results	Value
■	BH-7	SS-3	7-9'	Plasticity Index (%)	14
				Liquid Limit (%)	31
