Part of Lots 11-13, Concessions A and 1, Block D
Elgin Street East, Cobourg, ON

Phase 1 Development – Hydrogeological Impact Assessment

PGL File: 4027-21.01

June 2019

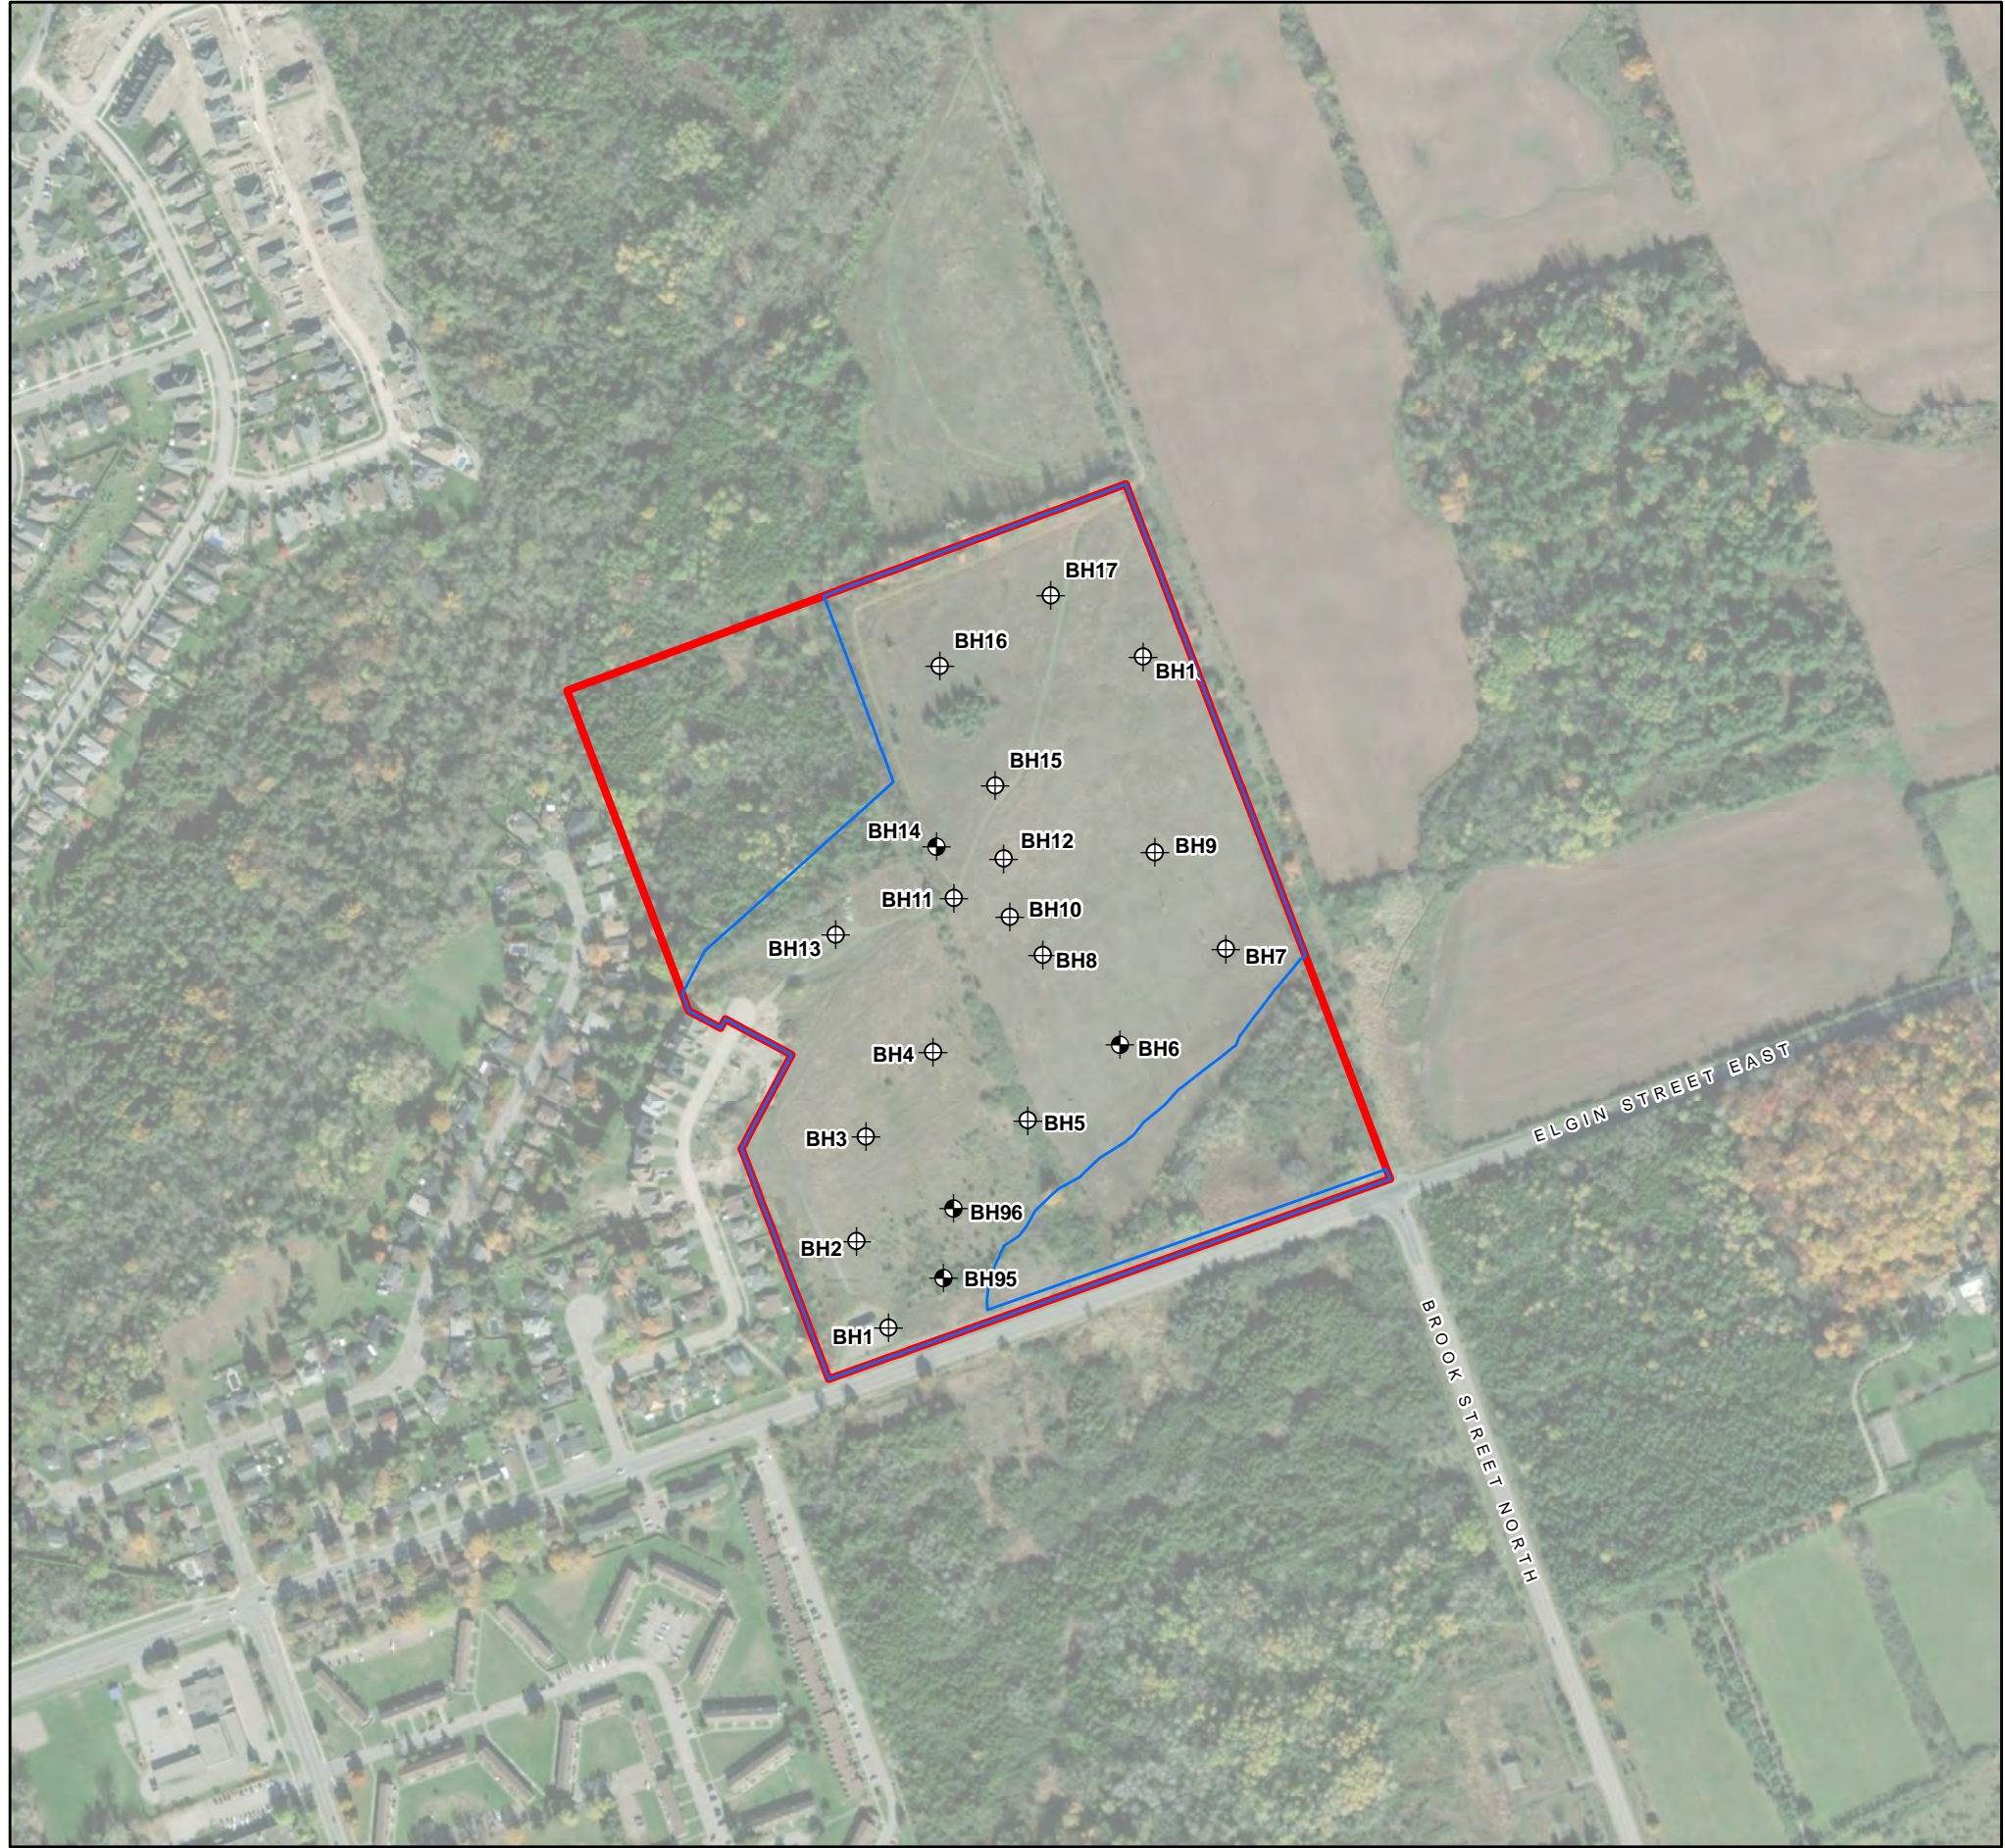
- Phase 1 Area
- Development Area
- Borehole
- Monitoring Well

Parcel: Approximate Image: ESRI Base Imagery					
SITE LOCATION					
Phase 1 - Proposed Subdivision, Elgin Street East Cobourg, Ontario					
RONDEAU (COBOURG) LTD.					
	File No.:	Date:	Dwg No.:	Drawn by:	FIGURE
	4027-21.01	JUN 2019	40272101-11	DPL	1

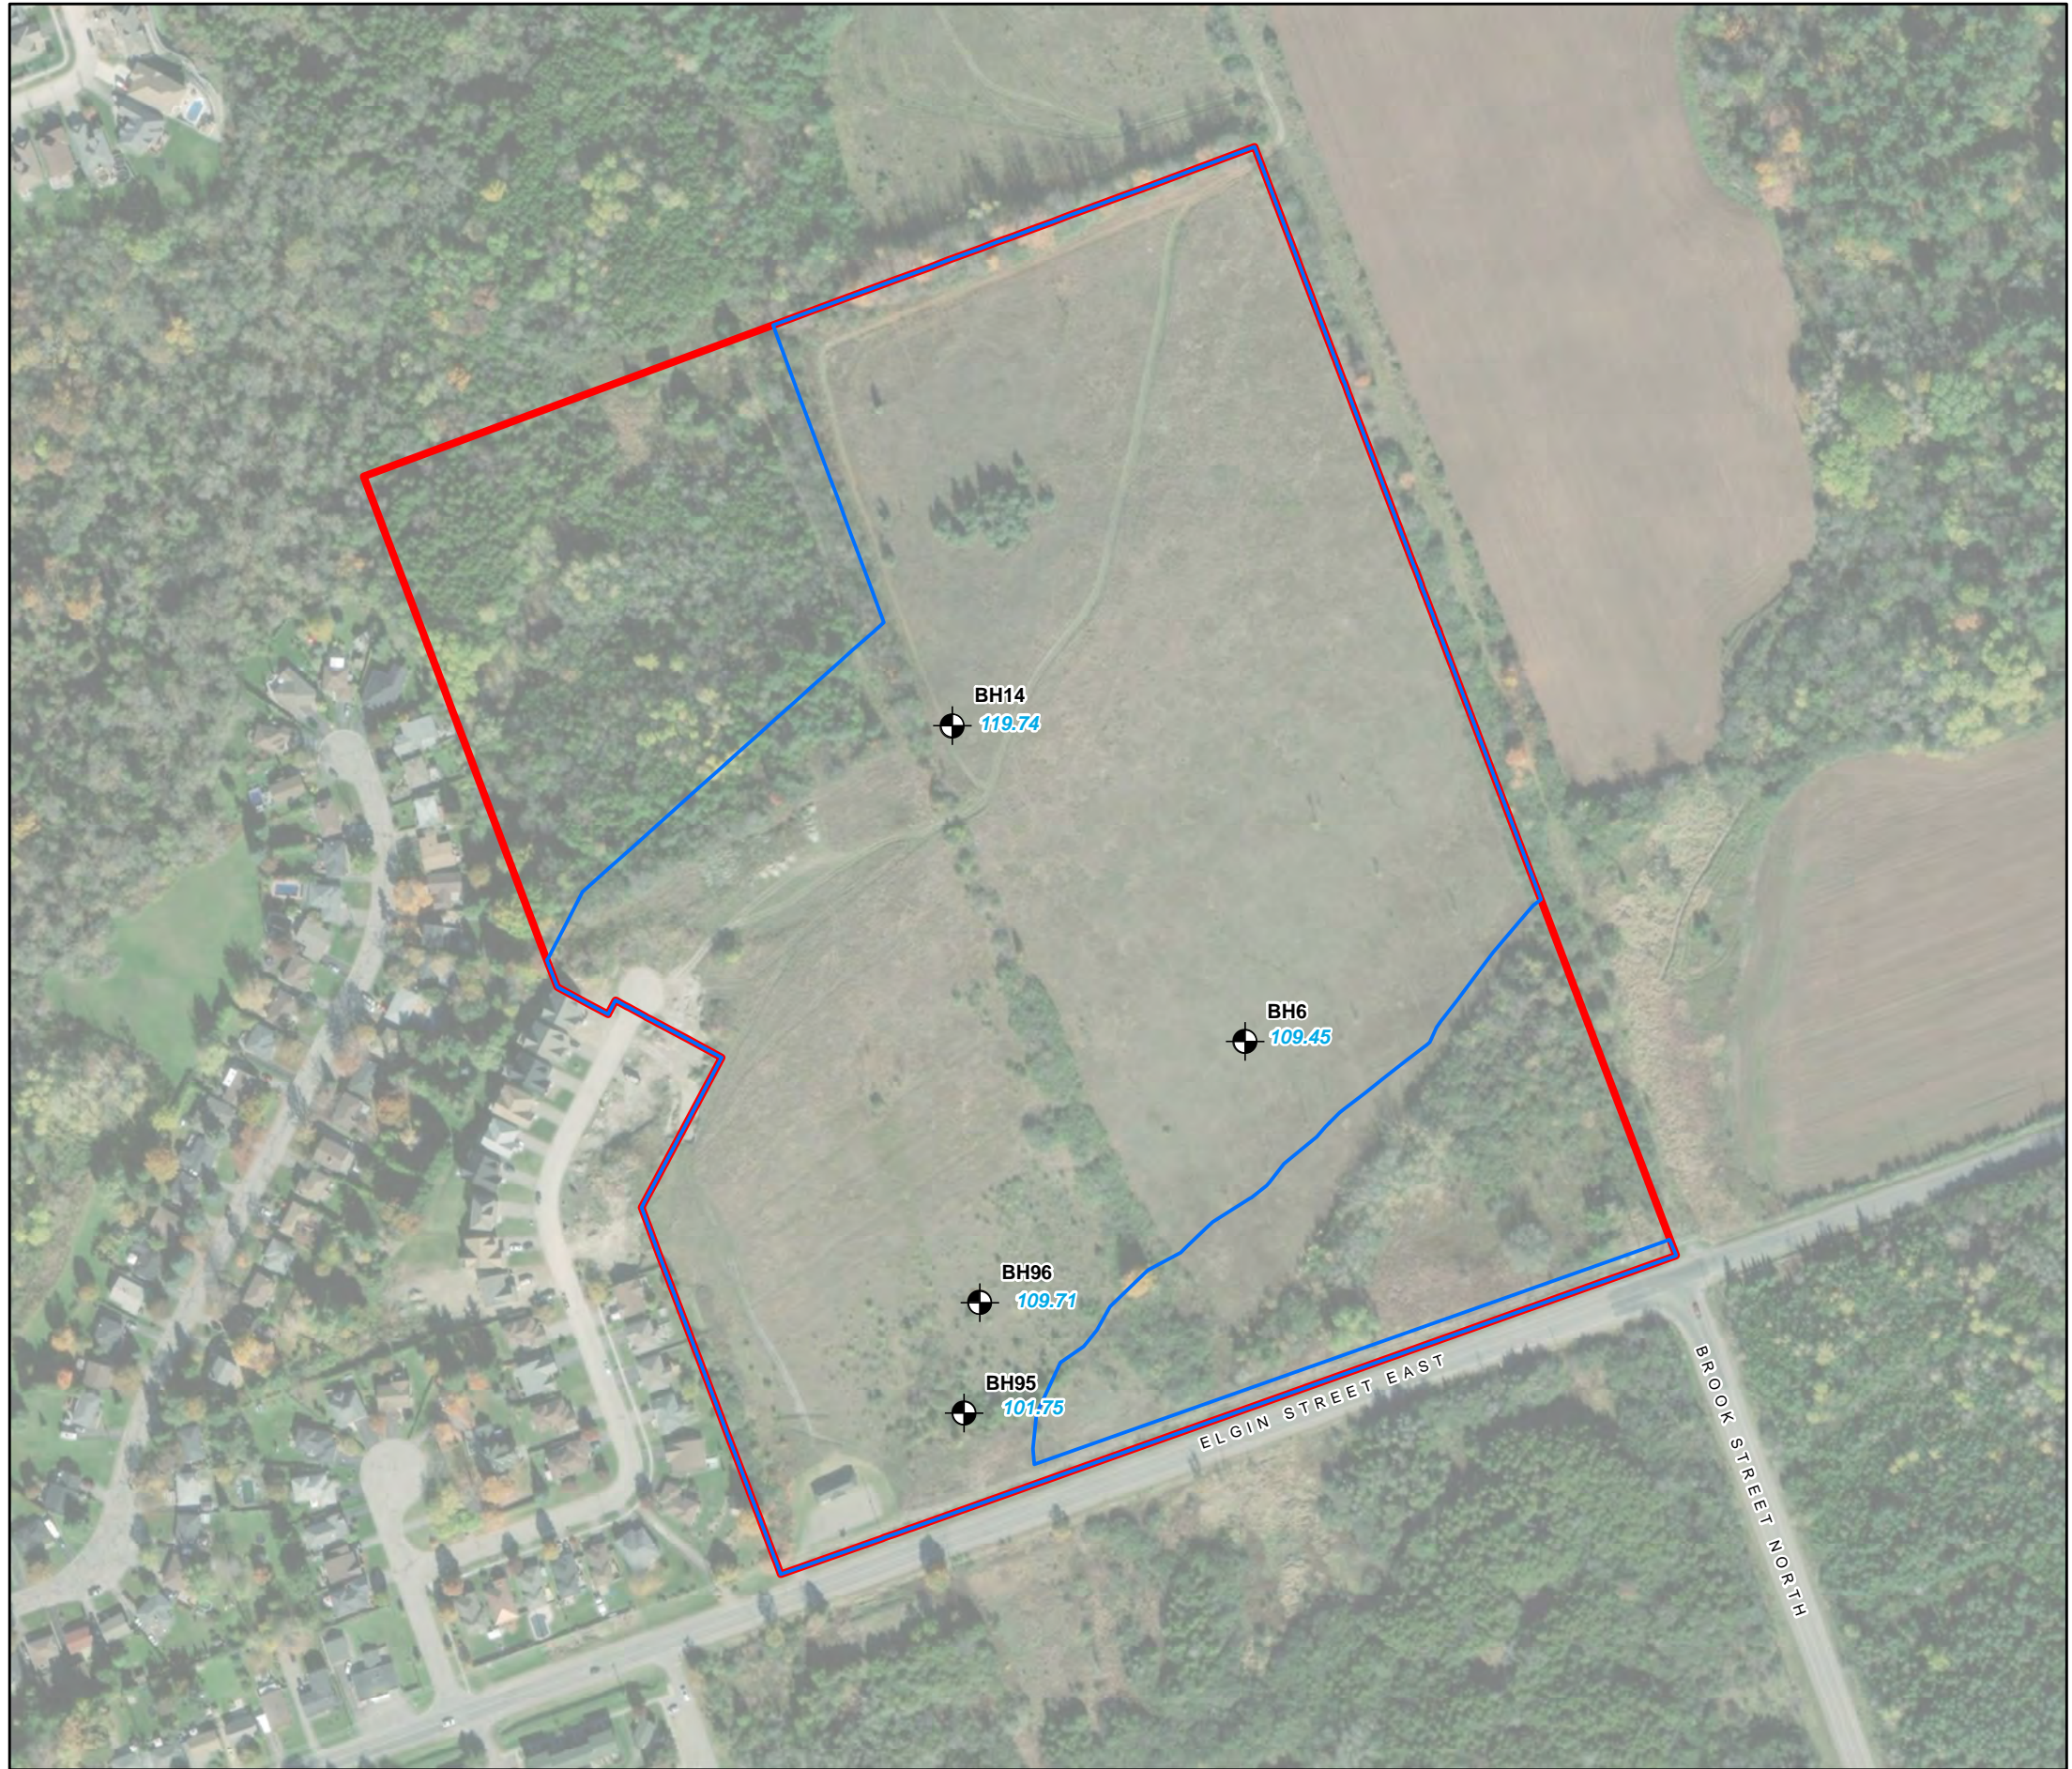
- Phase 1 Area
- Development Area
- Monitoring Well
- 109.45 Groundwater Elevation (m ASL)

PGL ENVIRONMENTAL CONSULTANTS	File No.:	Date:	Dwg No.:	Drawn by:	FIGURE
	4027-21.01	JUN 2019	40272101-21	DPL	2

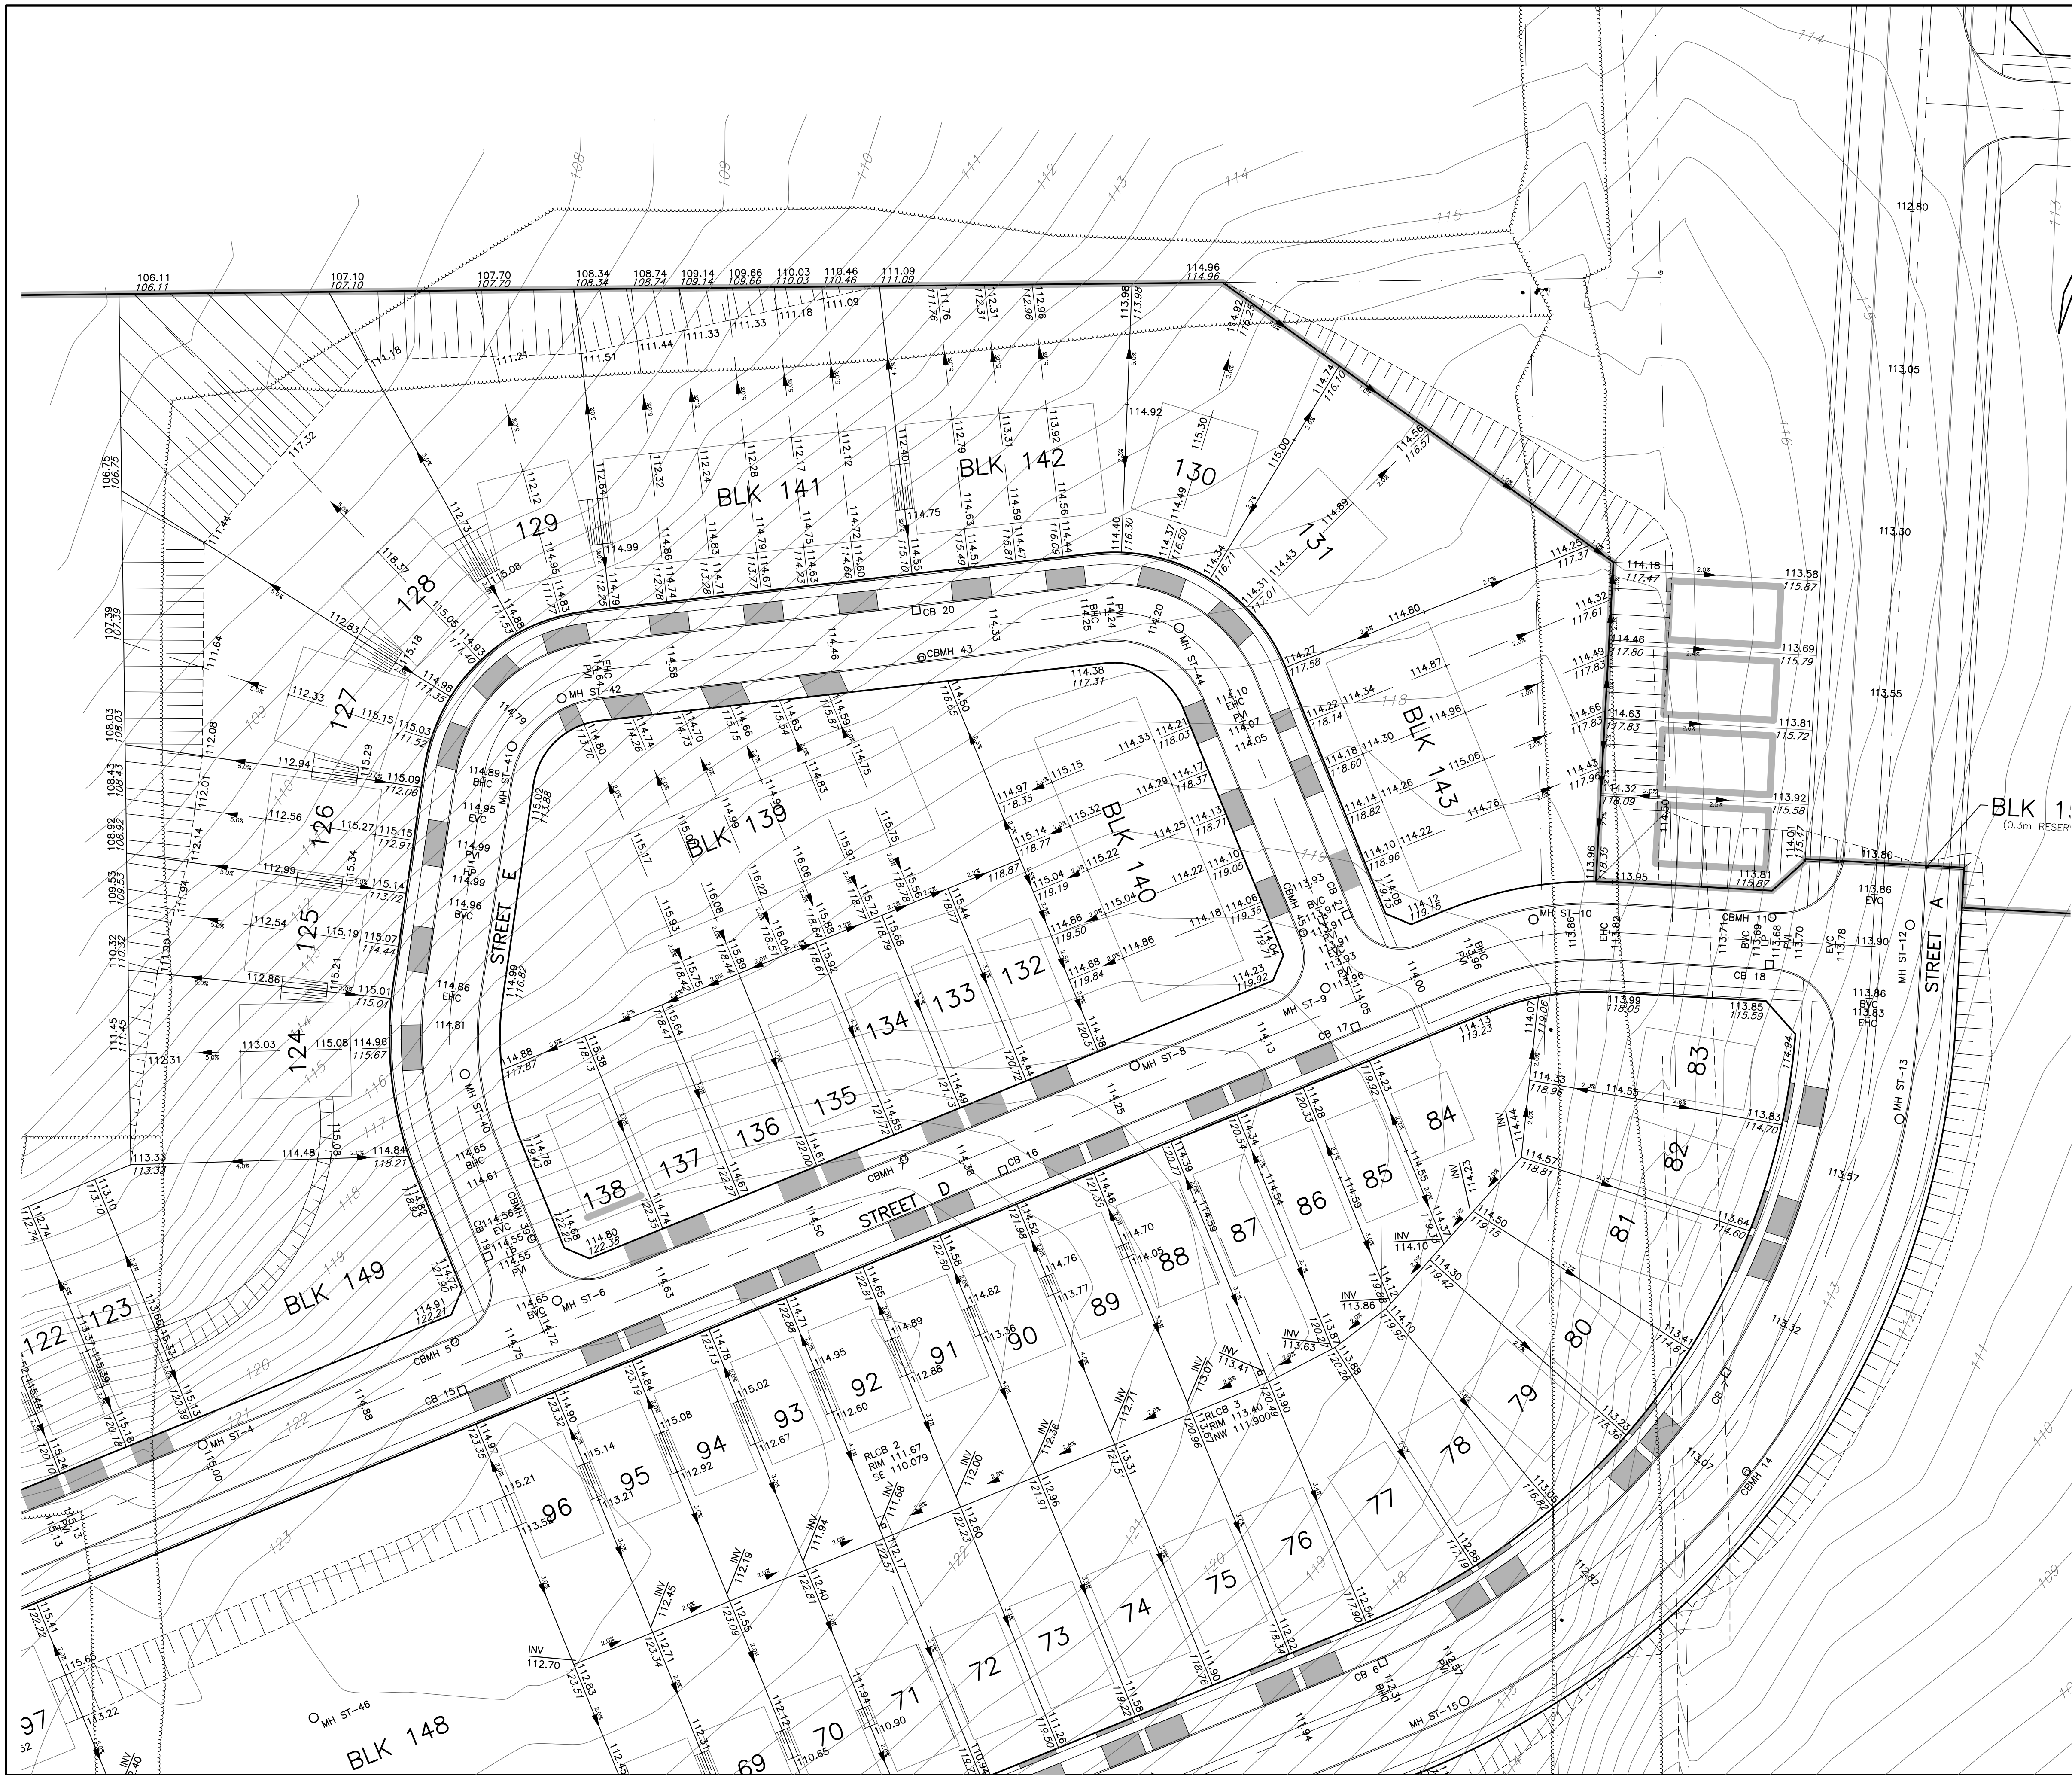
- NOTES**
- 1) LOT GRADES SHALL BE 2% MIN TO 5% MAX.
 - 2) SWALE GRADES SHALL BE 2% (MIN) TO 5% (MAX) UNLESS OTHERWISE NOTED.
 - 3) ALL SWALES SHALL HAVE 3:1 SIDE SLOPES (MAX) AND BE SODDED ON 150mm OF TOPSOIL.
 - 4) ALL SLOPES SHALL BE 3:1 (MAX) AND BE SODDED ON 150mm OF TOPSOIL.
 - 5) REAR YARDS TO BE RESTORED WITH 300mm TOPSOIL AND SOD.
 - 6) LIMIT OF ENGINEERED FILL SUBJECT TO ENGINEERED FILL REPORT.
 - 7) DISTURBED AREAS AND FUTURE DEVELOPMENT SHALL BE GRADED SUCH THAT THERE IS NO PONDING WATER AND DRAINAGE IS DIRECTED AWAY FROM PROPOSED LOTS.
 - 8) DISTURBED DITCHES AND BOULEVARDS ON MIDDLE ROAD TO BE RESTORED WITH 150mm TOPSOIL AND SOD.
 - 9) ALL VACANT BLOCKS SHALL BE SEEDED ON 150mm TOPSOIL AND MAINTAINED TO THE SATISFACTION OF THE DIRECTOR OF ENGINEERING SERVICES.

NO.	DATE	REVISION	BY
REVISIONS			
APPROVED		APPROVED	
DIRECTOR, ENGINEERING SERVICES MUNICIPALITY OF		DIRECTOR, ENGINEERING SERVICES REGION OF	
DATE		DATE	
THE CORPORATION OF THE TOWN OF COBOURG PUBLIC WORKS DIVISION - ENGINEERING DEPARTMENT VILLAGES OF CENTRAL PARK RONDEAU (Cobourg) Ltd.			
EARTHWORKS PLAN Phase 1

The construction dewatering has been considered in two stages. Firstly, the ground surface in the Phase 1 area will be re-graded, with the majority of the area being cut down to a lower elevation. Based on the current water level data and observed groundwater mounding, passive dewatering through the use of a channel to direct groundwater flow to surface discharge during this work would likely be sufficient (see discussion in Section 6.0 below).

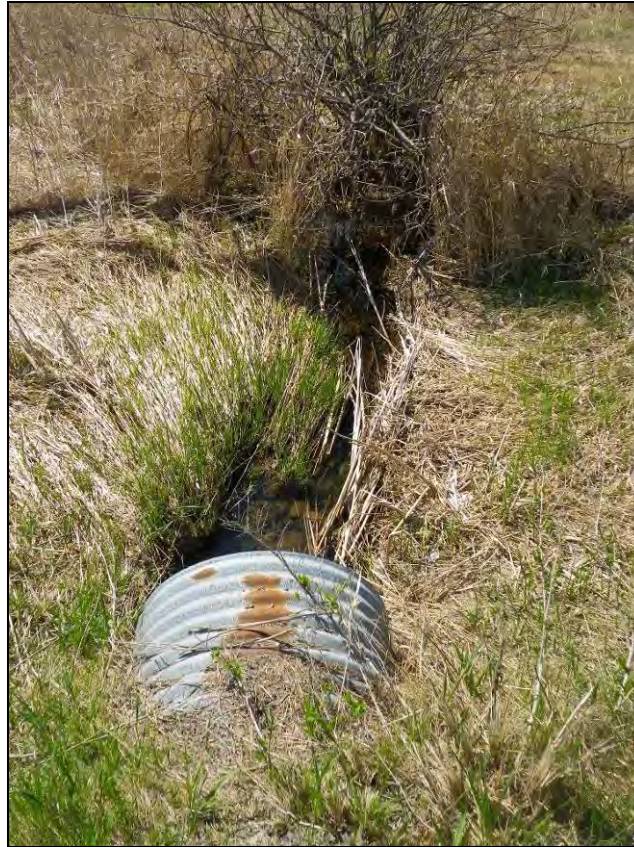
Photo 19. Habitat Zone 1, Brook Creek S of Elgin Street East, looking downstream, facing south (Photo taken May 7th 2015).

Habitat Zone 1 was located in the Brook Creek tributary located immediately north and south of Elgin Street East in the bell property. Habitat Zone 3 was also located in the Brook Creek tributary approximately 300 m northeast of Habitat Zone 1 in the woodlot (Figure 2). During the 2006 habitat assessments the tributary was mainly comprised of intermittent flows primarily in the north and western portions of the tributary. The south western portion of the tributary had a well-defined channel with evidence of erosion on both sides of the bank, the wetted water widths ranged from 0.3 m to 0.6 m with water depths of 0.03 m to 0.08 m. Due to a change in the flows to the south and abandonment of the natural flow pattern southwest across the Brook Road allowance, access to the upstream areas has been impeded (NEA, 2007). During the 2015 field visit there was no flowing water within the tributary, only pockets of standing water.

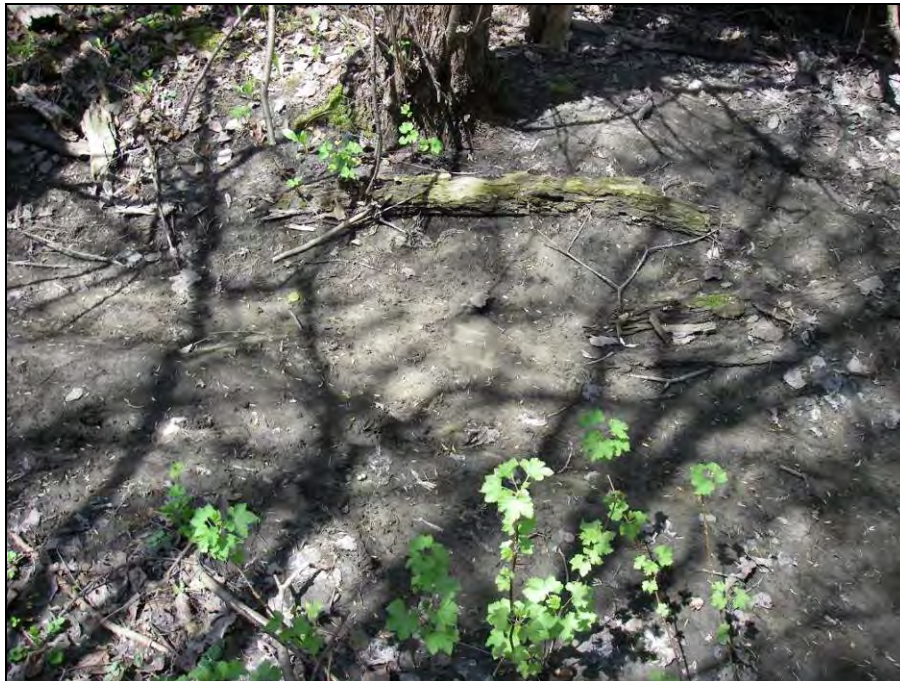
Photo 20. Habitat Zone 3, Brook Creek, photo showing no flow in tributary (Photo taken May 7th 2015).

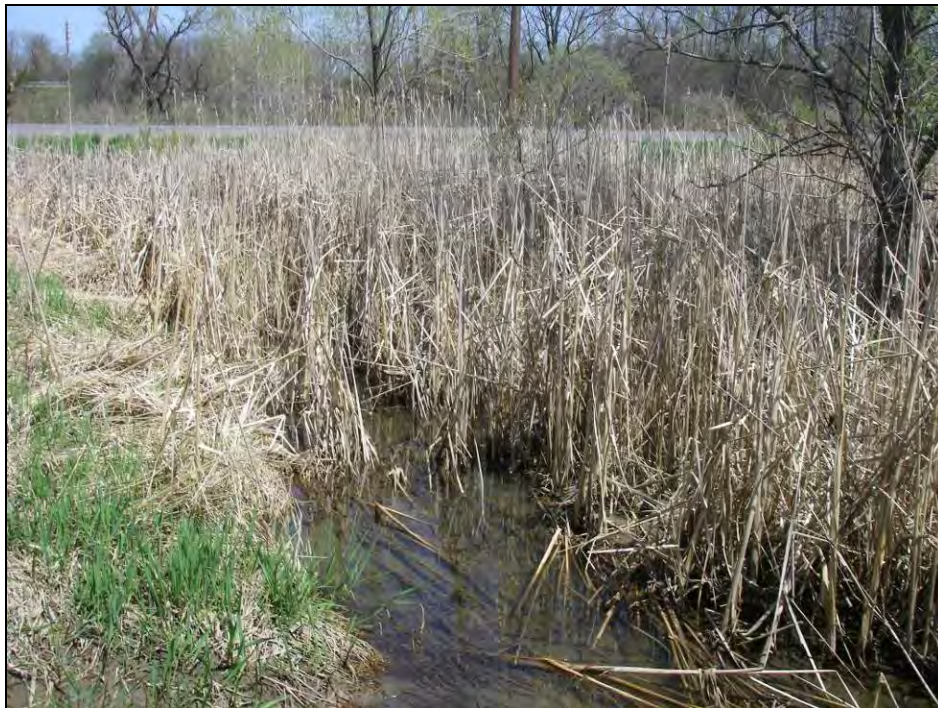
Photo 21. Habitat Zone 2, Midtown Creek, looking upstream facing north (Photo taken May 7th 2015).

Habitat Zone 2 was located in Midtown Creek, north and south of Danforth Road, approximately 800 m northwest of Habitat Zone 3 (Figure 2). During the 2006 assessments, the habitat upstream of the culvert located on Danforth Road was well defined with minimal flows due to overgrown terrestrial grasses; the substrate was dominated by silt and sand. Wetted widths ranged from 0.15 m to 0.3 m with depths of 0.10 m to 0.20 m. Downstream of the culvert the channel widened to approximately 1.2 m and eventually dissipated into a wetland habitat. The substrate directly downstream of the culvert was dominated by gravel and cobble (NEA, 2007). Similar habitat features were observed in 2015, with the exception of increased flow and local areas of higher velocity.

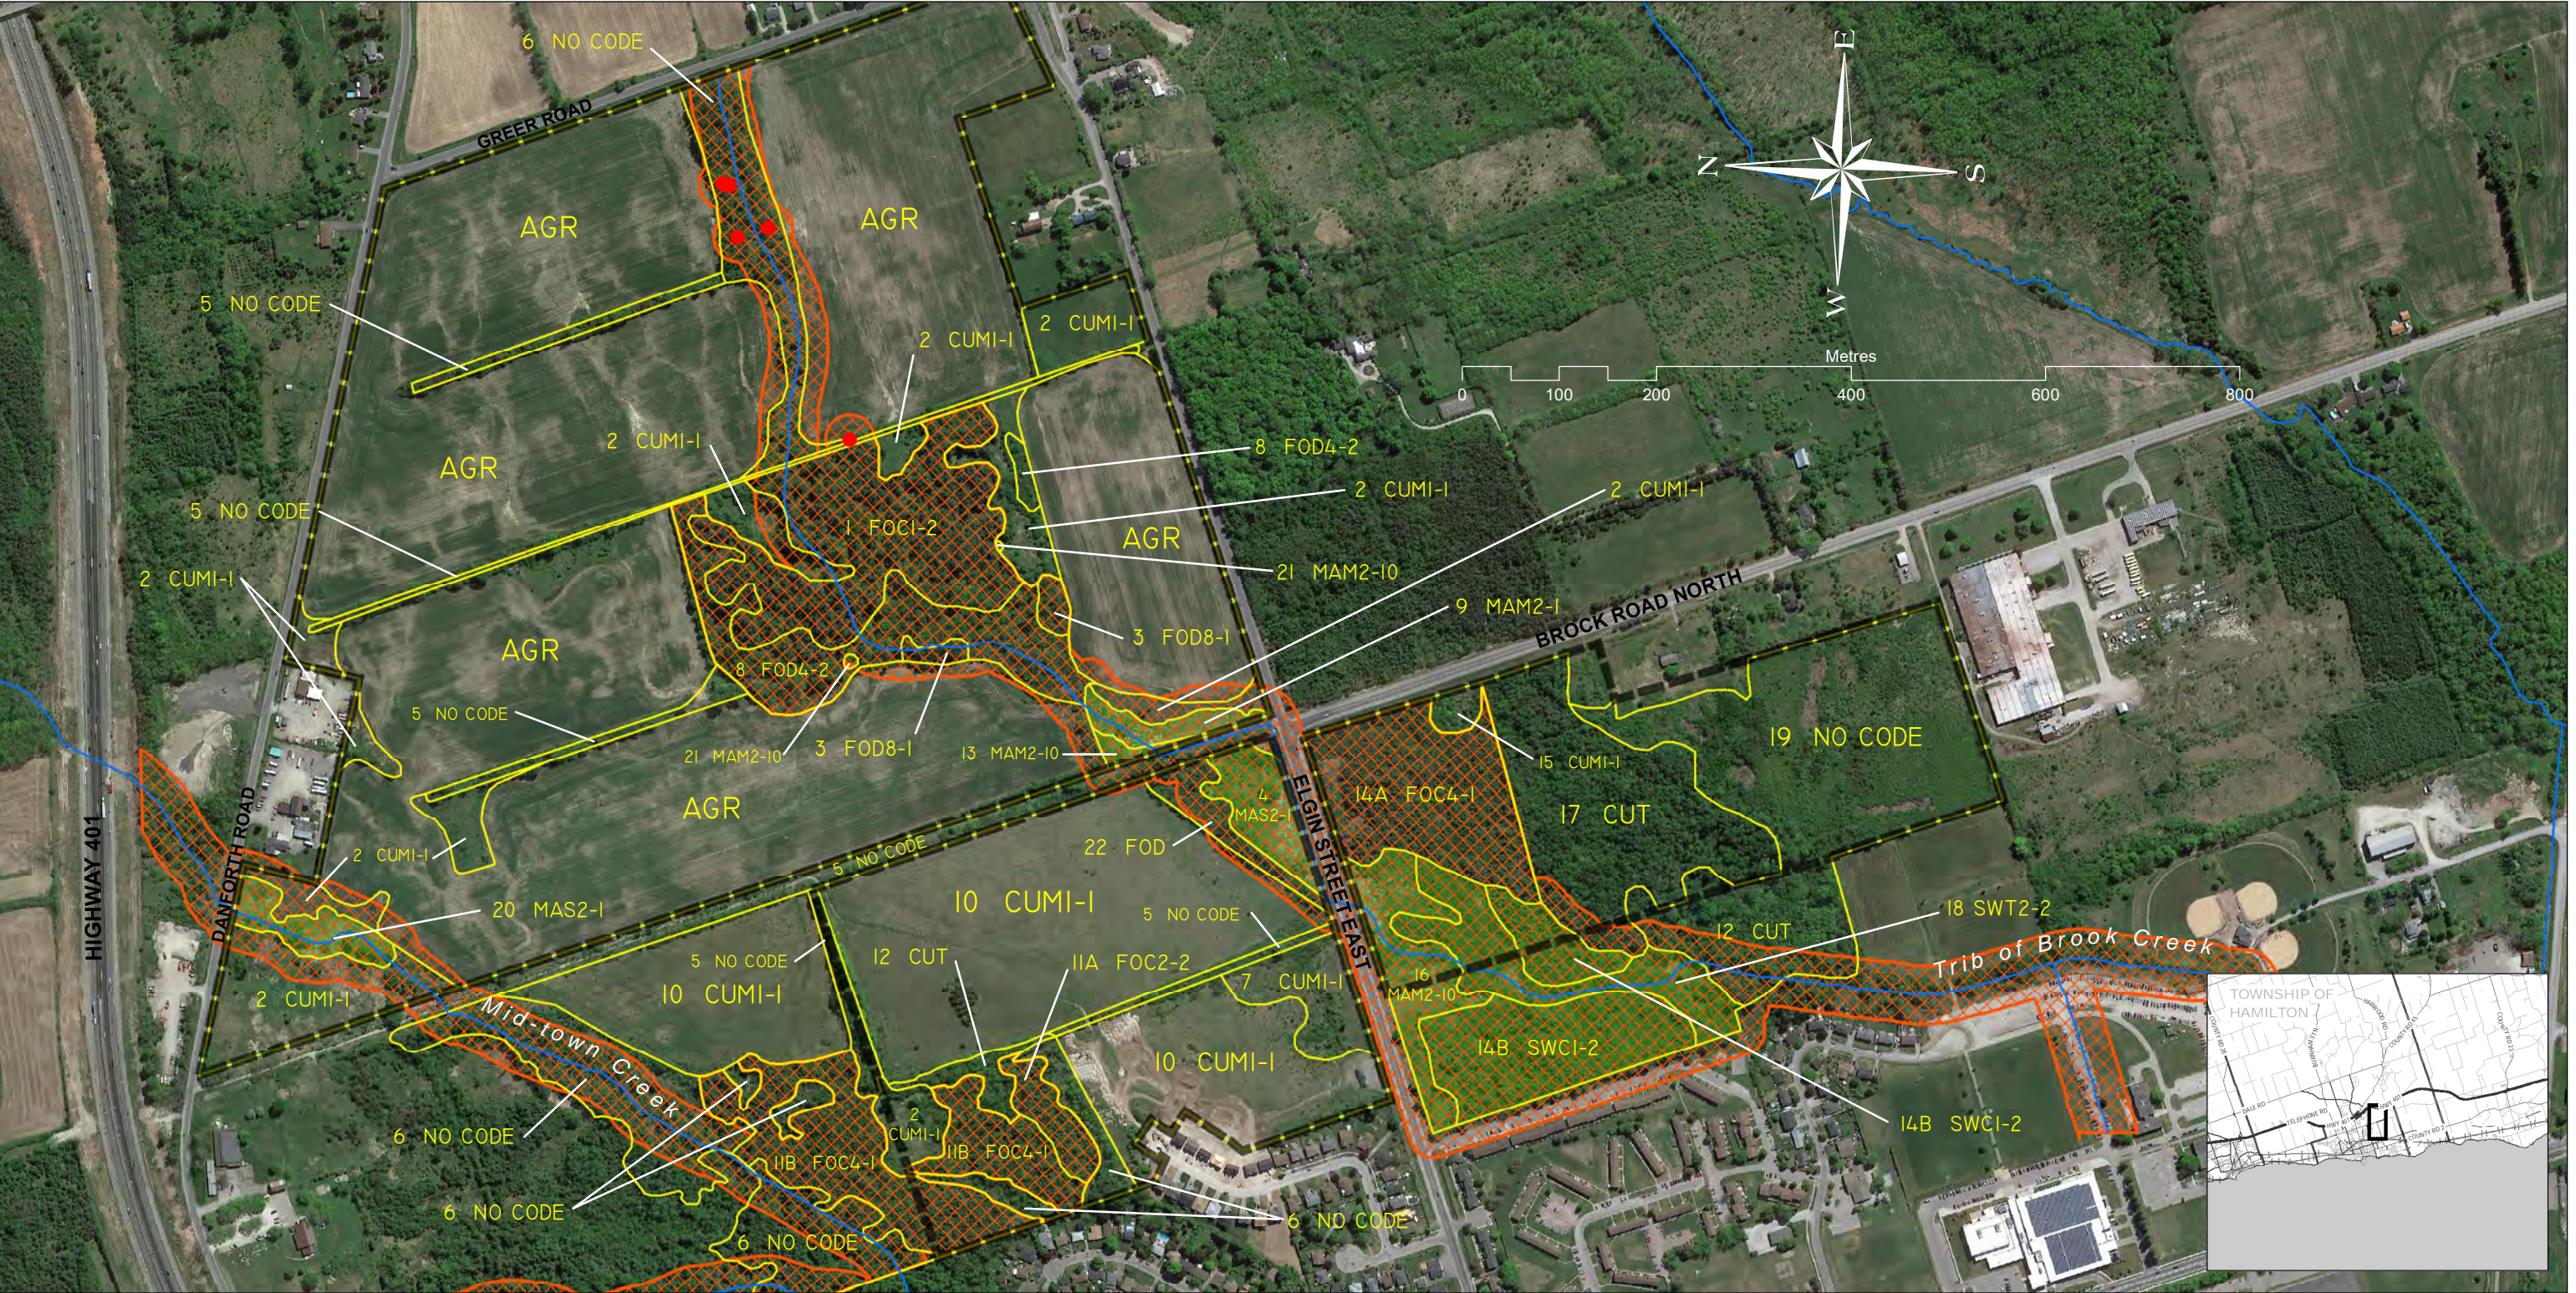
FIGURE 3: VEGETATION COMMUNITIES & CONSTRAINTS

- RETAINABLE BUTTERNUT
- CONSTRAINTS
- WATERCOURSE
- PROPERTY BOUNDARY
- VEGETATION COMMUNITY
- PARCEL FABRIC
- WETLAND COMMUNITY

The butternut has declined across Ontario due to the presence of a butternut canker or fungus that kills the tree. Fourteen trees were assessed by a certified Butternut Health Assessor and eight of these have been analyzed as retainable trees. Retainable trees are protected under the Ontario Endangered Species Act (2007). Butternuts require a buffer of 25 m from the base of the tree. A report will be sent to the local MNRF Species at Risk Biologist to provide details on the tree locations and BHA results. An ESA permit and planting plan are required if protection cannot be afforded and removal is necessary. The locations of the retainable trees are found on Figure 3.

will require protection with a buffer of 25 meters from the base of the tree (Figure 3). The trees themselves are inside the forest, which will be preserved but the buffer may extend beyond the forest edge. Discussions with the MNR will be required to determine the best management and protection practices.

A 30 m buffer from all wetlands has been recommended to preserve their features and functions (Figure 3).
