Tree Inventory & Preservation Plan

Infill Development 425 King Street East Cobourg, ON

February 2018 REVISED AUGUST 2019

Treescape Consulting Project TC258

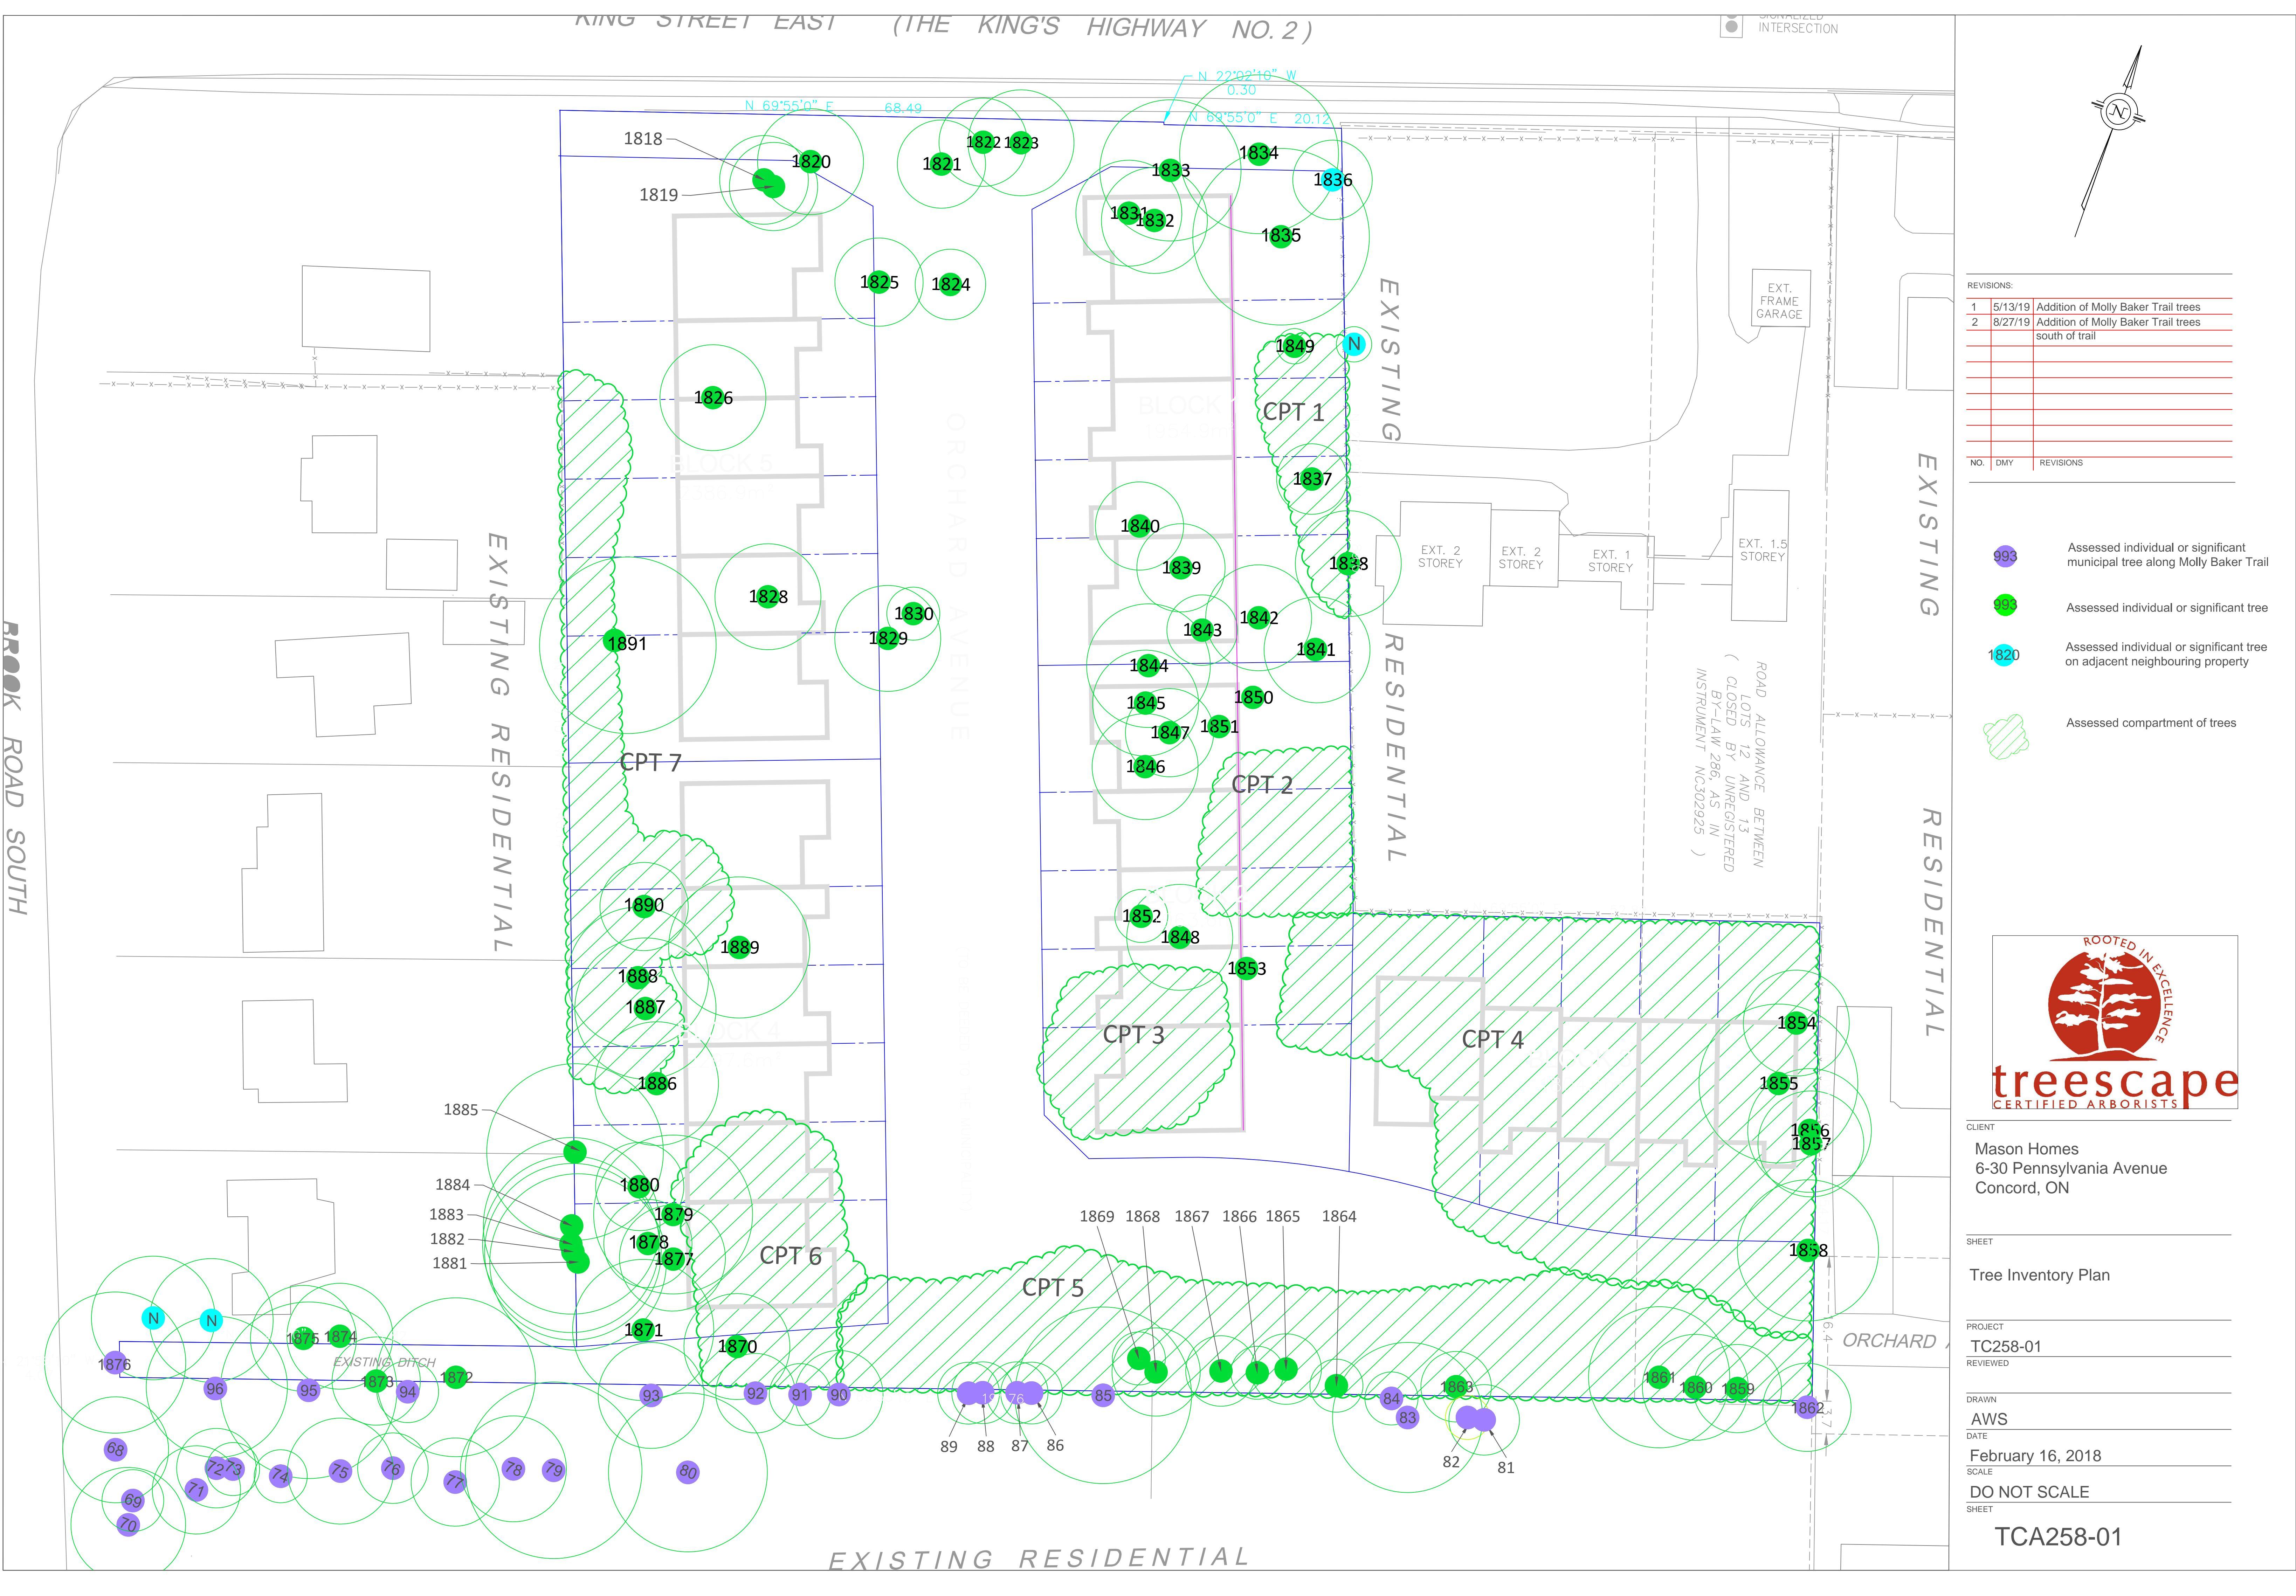
Table 1 below includes the assessment of all trees and treed compartments within the proposed development area. The appended plan TC258-01 identifies the locations of the individual trees and treed compartments. Plan TC258-02 shows removals and tree protection to be read in conjunction with Table 2 below.

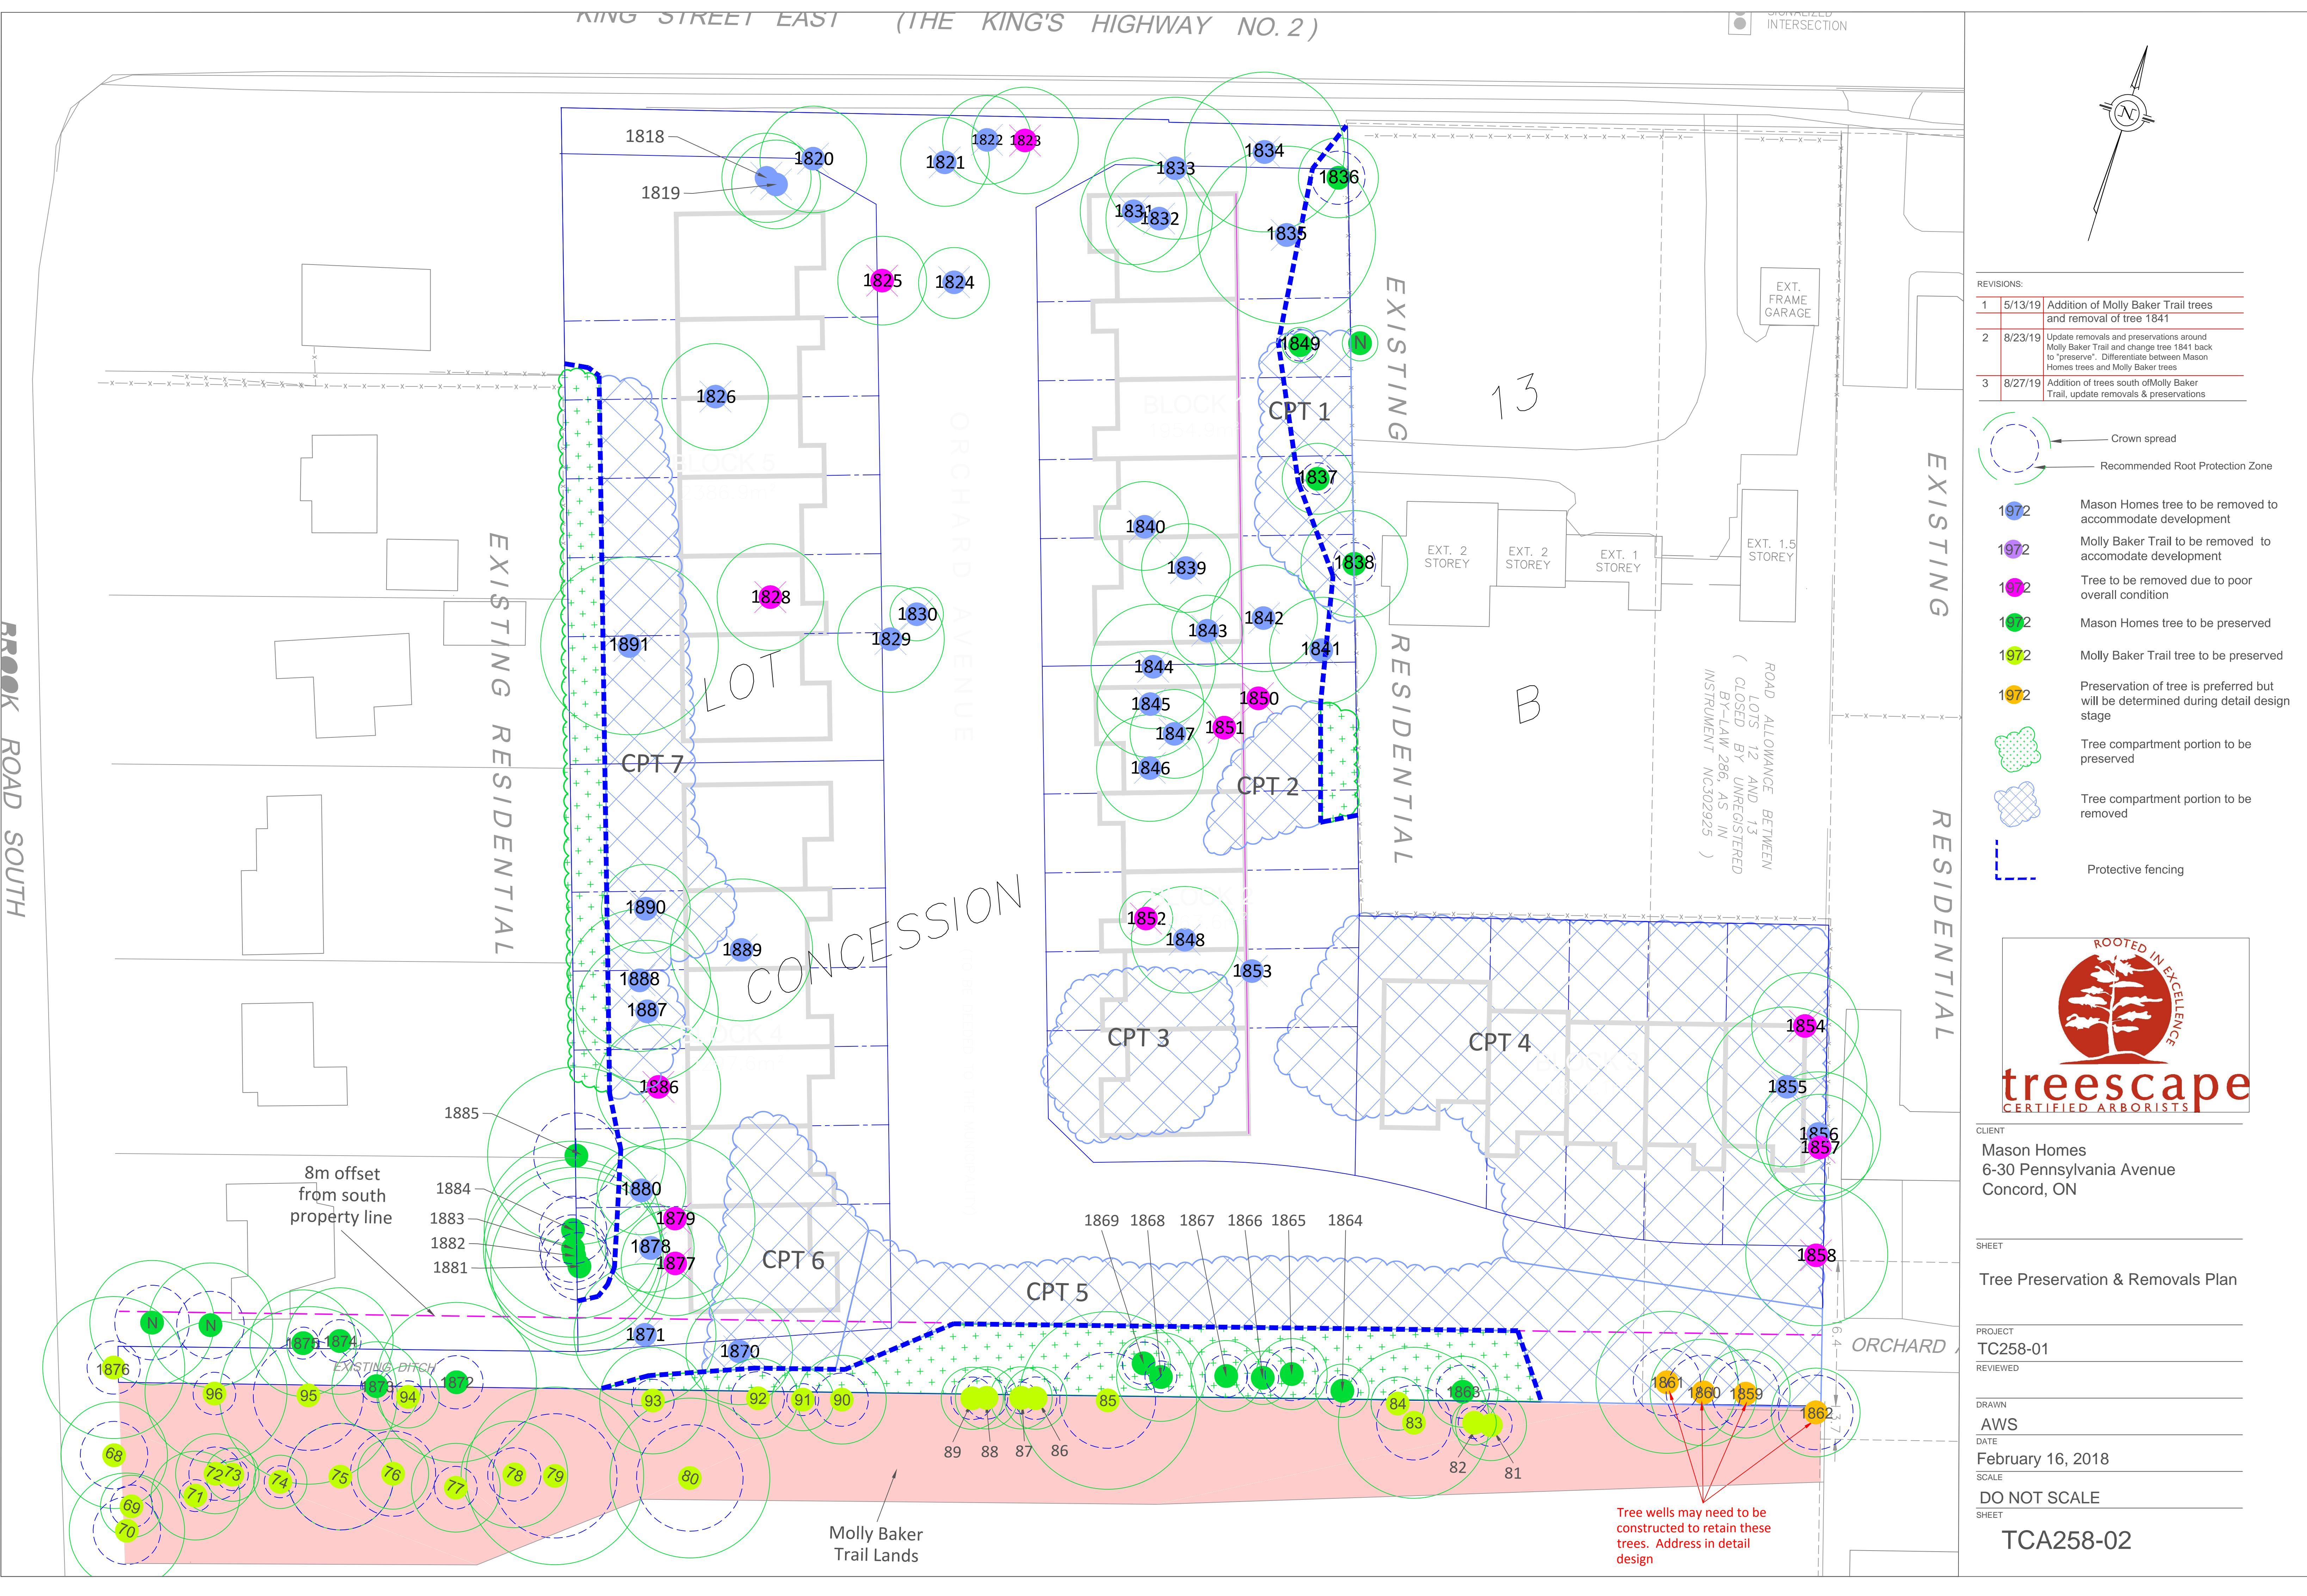
The distances are shown in the inventory are based upon a radius of protection measured from the edge of the tree trunk and are minimum protection distances. The tree protection areas are shown on the TC258-02

Compartment (CPT) / Tree #	Development Impact	Recommendation
68-96	These trees are municipal trees found along the Molly Baker Trail and are in proximity to various elements of the development footprint. Trees < 30cm Dbh were not assessed for development impact as suggested by Rory Quigley, Town Arborist.	Preserve trees - establish prescribed tree protection zone (TPZ) and install protective fencing as specified.
1836, 1837, 1838, 1849, 1872, 1873, 1874, 1875, 1881, 1882, 1883, 1884 and 1885	These trees are significant specimens worth retaining that are within, or encroaching, the development footprint. The overall impact to these trees is deemed to be minimal. Final grading plan is required to confirm this.	Preserve trees - establish prescribed tree protection zone (TPZ) and install protective fencing as specified.
1863, 1864, 1865, 1866, 1867, 1868, 1869 and 1876	These trees are significant specimens worth retaining that are within, or encroaching, the development footprint. They also fall within an 8m offset area from the property line to be reviewed.	Preserve trees - establish prescribed tree protection zone (TPZ) and install protective fencing as specified.

1859, 1860, 1861 and 1862	These trees are significant specimens worth retaining but their crown and/or root system is in extremely close proximity to, or in direct conflict with the development footprint. The preliminary site plan suggests these trees will be impacted to varying degrees during construction. The extent of injury can be mitigated to a tolerable level through a combination of acceptable aboricultural practices and/or design modifications.	 Preservation of trees is preferred. During the detail design stage, have consulting arborist review final grading plan and reassess proximity of trees to the development footprint. Species specific relative tolerance to development impacts (Matheny & Clark) should be considered. For trees that are ultimately retained, an experienced ISA certified arborist needs to be retained to: set appropriate crown reduction limits and supervise crew performing the pruning (prior to any excavation), determine acceptable modifications to the recommended root protection zone and supervise the adjustment to all tree protection fencing, determine the feasibility of installing tree wells adjacent to road grading as

a mitigating option, provide onsite supervision of all excavation and grading that encroaches TPZ, perform, or oversee, any required root pruning. prescribe and oversee post construction plant health care measures, and reassess trees annually for a prescribed period of time. Note: Permission will be required from municipality if tree 1862 is to be removed.
CPT 2	Limits of excavation for the development footprint encroaches the western portion of this compartment. Removal of some, or all trees is required. There will be approximately 3 Spruce trees remaining all of which have been crown raised significantly (assuming by adjacent neighbour) and will no longer provide any significant screening or privacy. In addition, root disturbance due to required removal and grubbing of Buckthorn and scrub brush around tree will have a negative impact on these trees.	Removal of all trees is recommended and replant more suitable specimens to create a natural screen to adjacent neighbouring property. OR Remove and/or prune trees as necessary for development. Provide TPZ fencing along drip line of remaining retained trees adjacent to the construction (preferably to the edge of construction/grading limits).

CPT 5 and CPT6	Limits of excavation for the development footprint encroaches the southern portion of these compartments. Removal and/or pruning of some trees is required.	Remove and/or prune trees as necessary for development. Provide TPZ fencing along drip line of remaining retained trees adjacent to the construction (preferably to the edge of construction/grading limits).
CPT 7	Limits of excavation for the development footprint encroaches the eastern portion of this compartment. Removal and/or pruning of some trees is required.	Remove and/or prune trees as necessary for development. Provide TPZ fencing along drip line of remaining retained trees adjacent to the construction (preferably to the edge of construction/grading limits).

Compartment (CPT) / Tree #	Development Impact	Recommendation
CPT 1	Overall development impact on trees in this compartment is deemed to be minimal to nil. With the exception of marked individual trees, this compartment consists of young, insignificant volunteer broadleaf trees, related saplings and Buckthorn.	Removal of all trees is recommended and replant more suitable specimens to create a natural screen to adjacent neighbouring property. OR Retain a portion of compartment as a naturalized buffer to adjacent property by removing and/or pruning trees as necessary. Provide TPZ fencing along drip line of remaining retained trees adjacent to the construction (preferably to the edge of construction/grading limits).
1818-1826, 1828-1833, 1834, 1835, 1839, 1840- 1848, 1850, 1851, 1852, 1853, 1854, 1855, 1856, 1857, 1858, 1970, 1971, 1877, 1878, 1879, 1880, 1886, 1887, 1888, 1889, 1890, 1891, CPT 3 and CPT 4	These trees are in direct conflict with various elements of design footprint. Modifications to the design and/or grading plan is neither practical nor feasible.	Remove trees. Notes: Tree 1841 is included as a removal due its close proximity to rear catch basin construction and final grading as well as the imminent, and significant, root disturbance due to required removal and grubbing of Buckthorn and scrub brush around tree. Trees 1870 & 1871 fall within the 8m zone for review but need to be removed to accommodate construction and grading limits of southwest unit.
